Steep Climb and Uncontrolled Descent During Takeoff  
National Air Cargo, Inc., dba National Airlines  
Boeing 747 400 BCF, N949CA  
Bagram, Afghanistan  
April 29, 2013

NTSB/AAR-15/01  
PB2015-104951

# Aircraft Accident Report

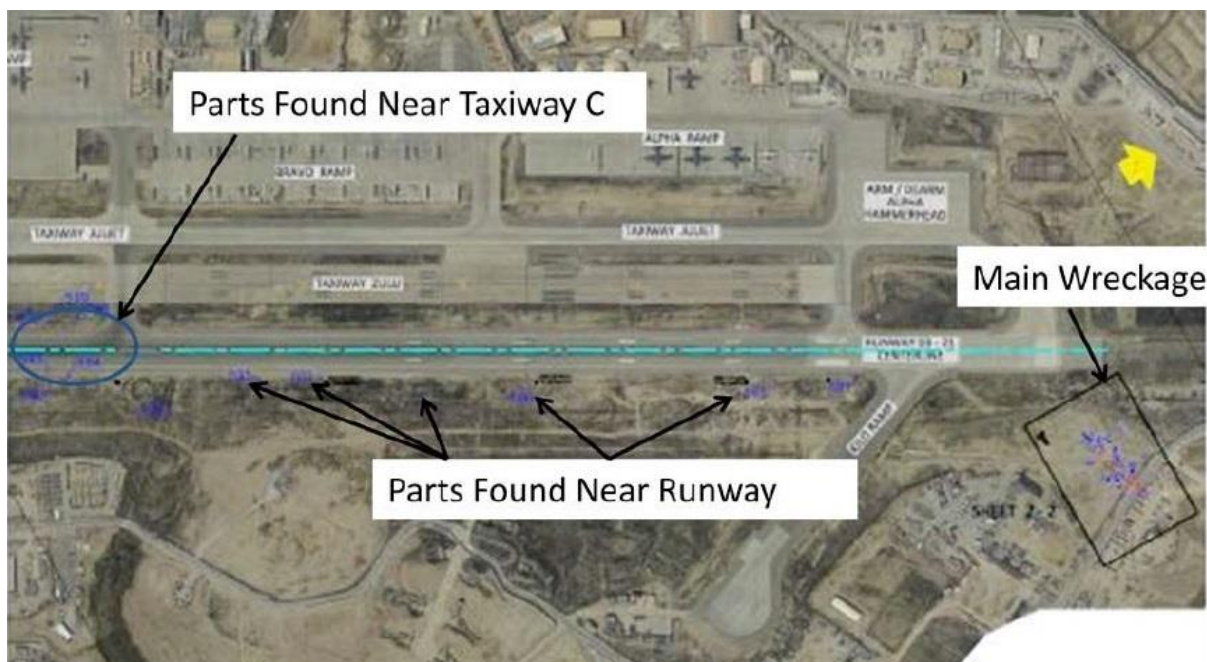
**Figure 5.** Overview image of runway 3 with locations of parts debris and the main wreckage noted.

The debris found on runway 3 in the area of taxiway C included two small pieces of blue-and-white painted airplane fuselage skin, a segment of white-painted hydraulic return tubing, a section of the E8 rack support stanchion (colored green), a reinforcement bracket (for a hydraulic line pass-through a fuselage frame), and part of a M-ATV antenna assembly.

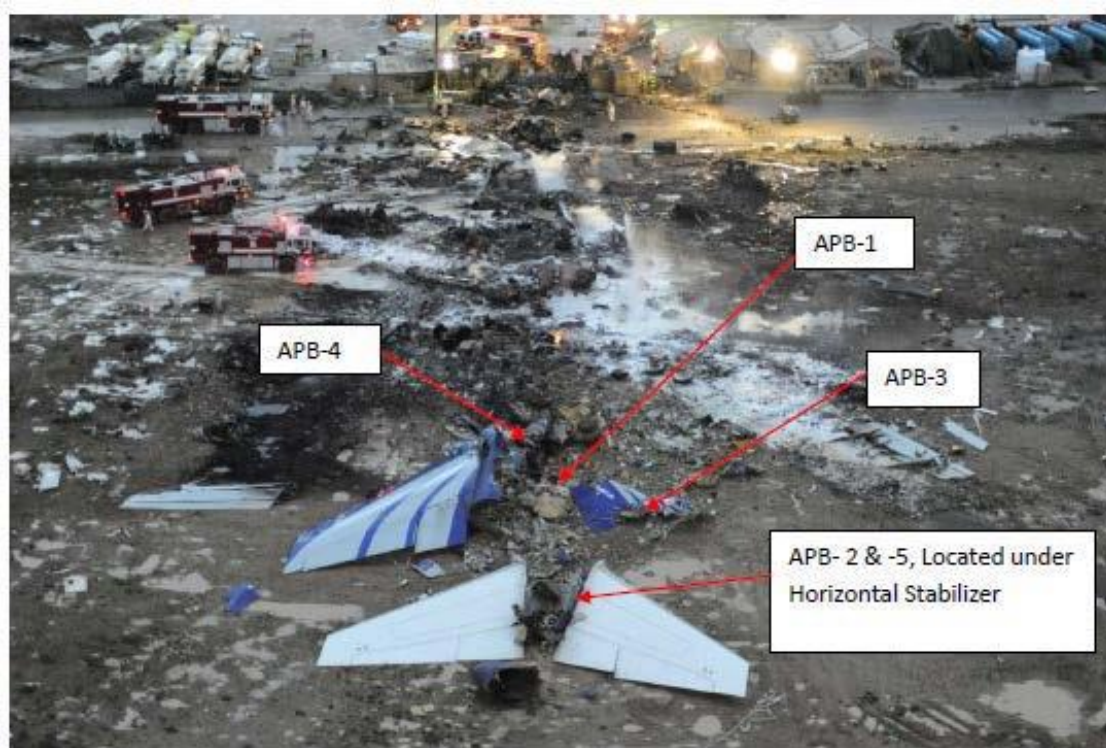
The APB, the installed location for which was in the back of the airplane (aft of the cargo) at BS 2360, was found in five main sections, labeled APB-1 through -5 by investigators. Sections APB-3, -4, and -5 were found attached to corresponding fuselage structures and skin panels. Sections APB-1 and -2 were not connected to any fuselage structure. Sections APB-2 and -5 were found under the horizontal stabilizer. Figure 8 shows where each APB section was found at the accident site.

**Figure 8.** Photograph showing where five sections of the APB were found at the accident site.

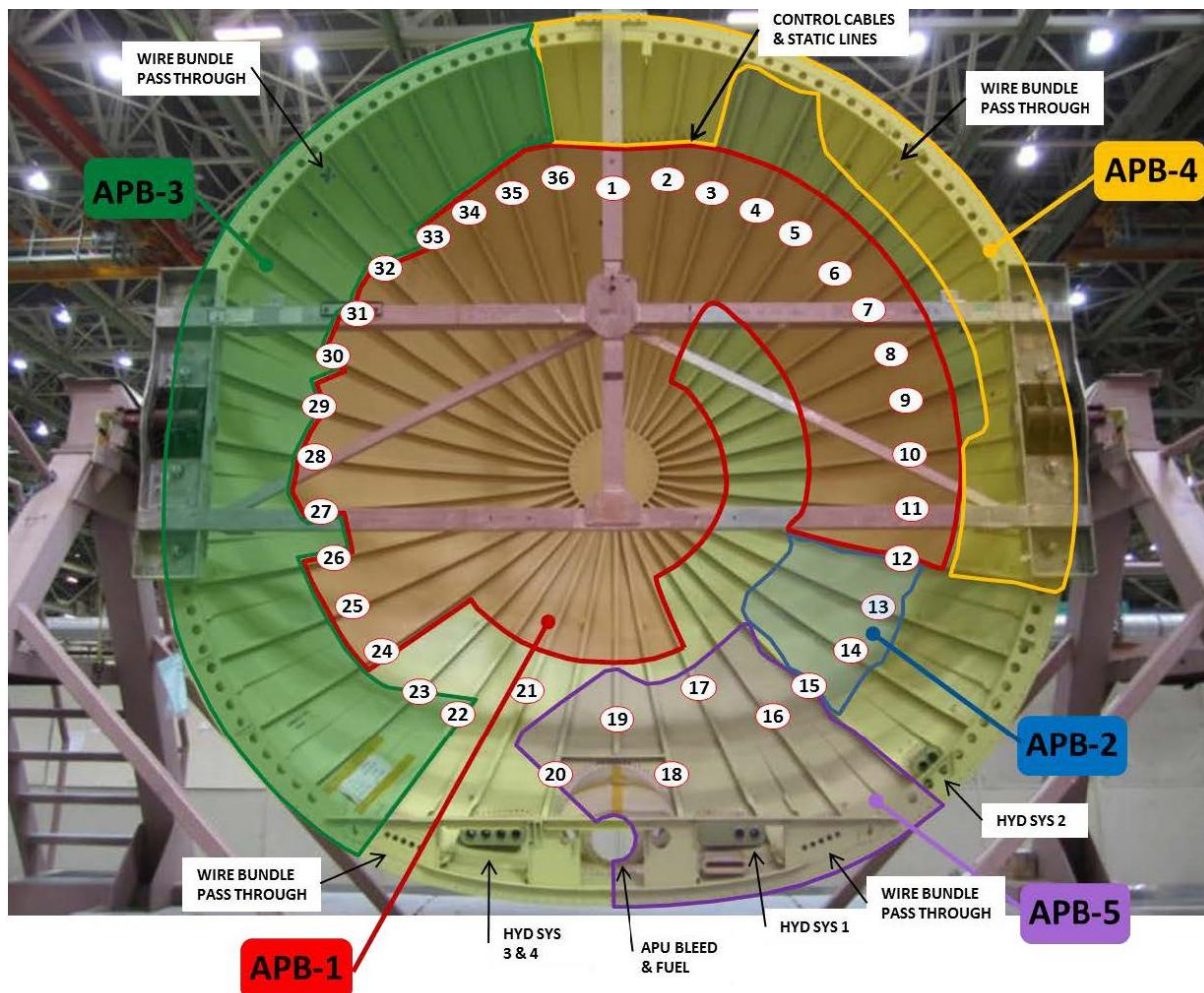
**Figure 9.** Photograph of an intact APB, looking aft, superimposed with color-shaded and labeled areas showing the installed location of each of the APB sections.

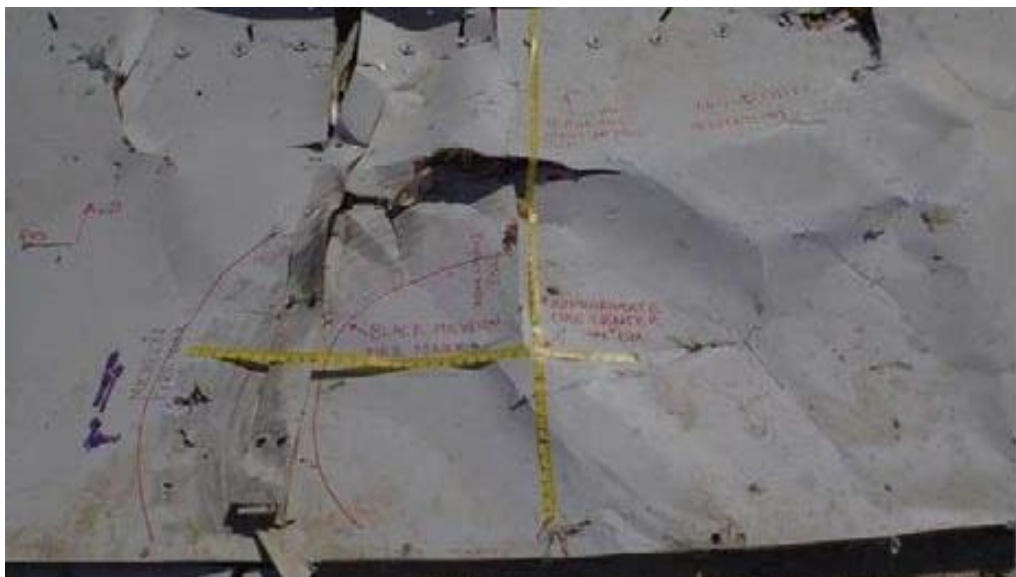
The upper left quarter panel of the APB liner showed a black mark from a 44-inch-diameter tire from a M-ATV. The installed location of this APB liner upper left quarter panel is immediately aft of and adjacent to the E8 rack. The tire imprint was consistent with a tire being parallel to the APB and the tire center located 81.5 inches above the main deck cargo floor (see figure 10).

**Figure 10.** Photograph of M-ATV tire mark on the upper left quarter panel of the APB liner.

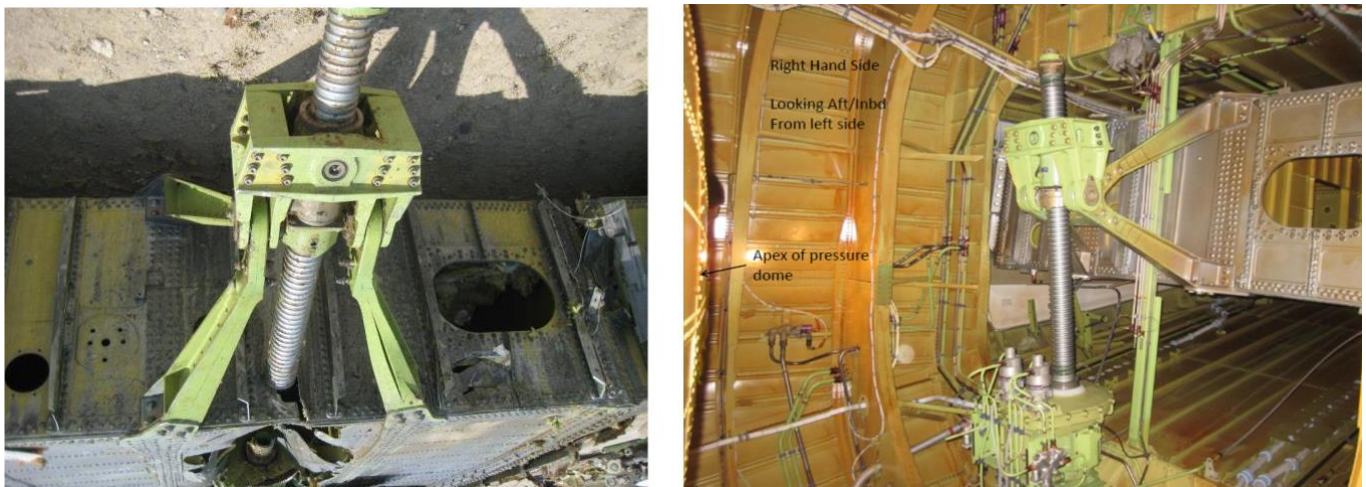
the APB was found at the stabilizer actuator. (The APB and insulation were installed forward of the stabilizer actuator.) The horizontal stabilizer jackscrew (also known as the ballscrew) was severed on its lower end about 1.5 inches above the drive assembly. A crack about 4 inches long extended longitudinally from the jackscrew's fractured end toward the upper gimbal support structure. The jackscrew drive assembly was aft of its installed location and was embedded in the lower horizontal stabilizer structure (see figure 11). The hydraulic drive motors were broken away from their housing and dislodged but were connected to brackets and tubing. The length of exposed jackscrew threads from the upper stop to the end of the threads was about 9.56 inches.

One of the legs of the upper gimbal support structure that attaches the horizontal stabilizer jackscrew to the forward side of the stabilizer structure was distorted and fractured. The yoke of upper gimbal support structure was gouged and showed material smearing on the forward surface. The installed location of yoke upper gimbal support structure is about 8 ft above the main cargo deck floor.

**Figure 11.** Photographs (left) showing the accident airplane's jackscrew and horizontal stabilizer in the wreckage and (right) showing an exemplar jackscrew in its installed position aft of the APB and forward of the horizontal stabilizer.

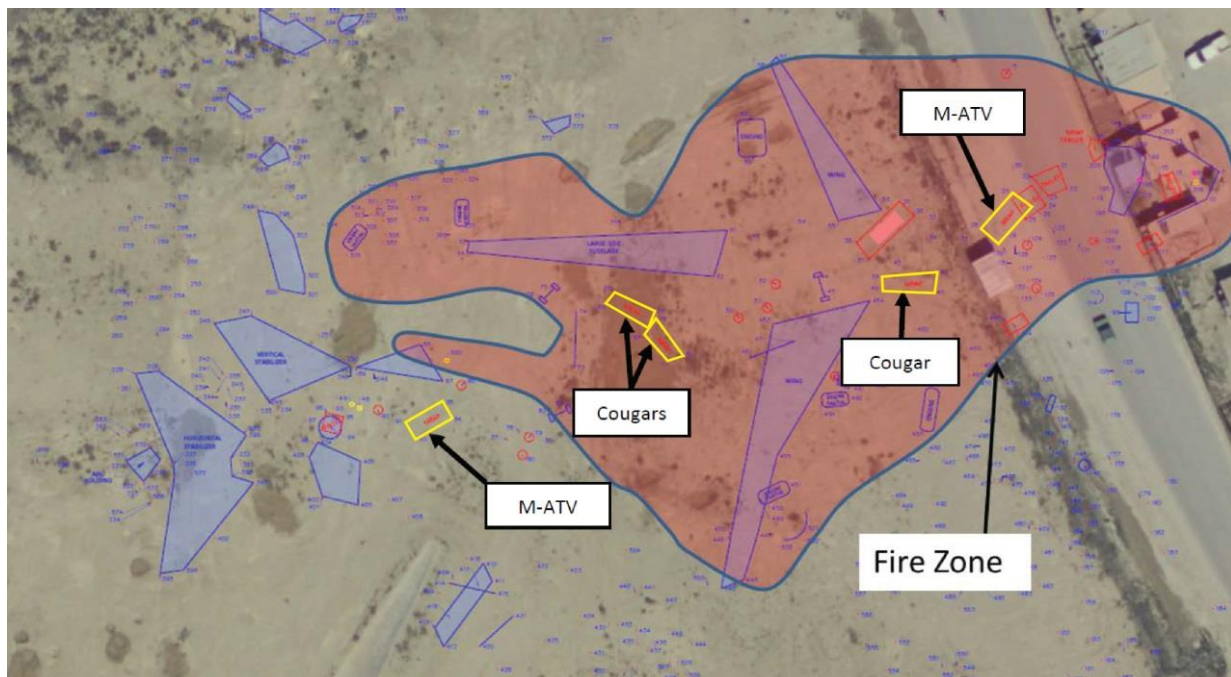
The M-ATV that was loaded in the back of the airplane was found in the wreckage in the area not consumed by fire; this area included other structure from the empennage, including the horizontal stabilizer and the vertical stabilizer (see figure 12).

**Figure 12.** Overview of the accident debris field showing the respective locations of the MRAP vehicles and fire zone.

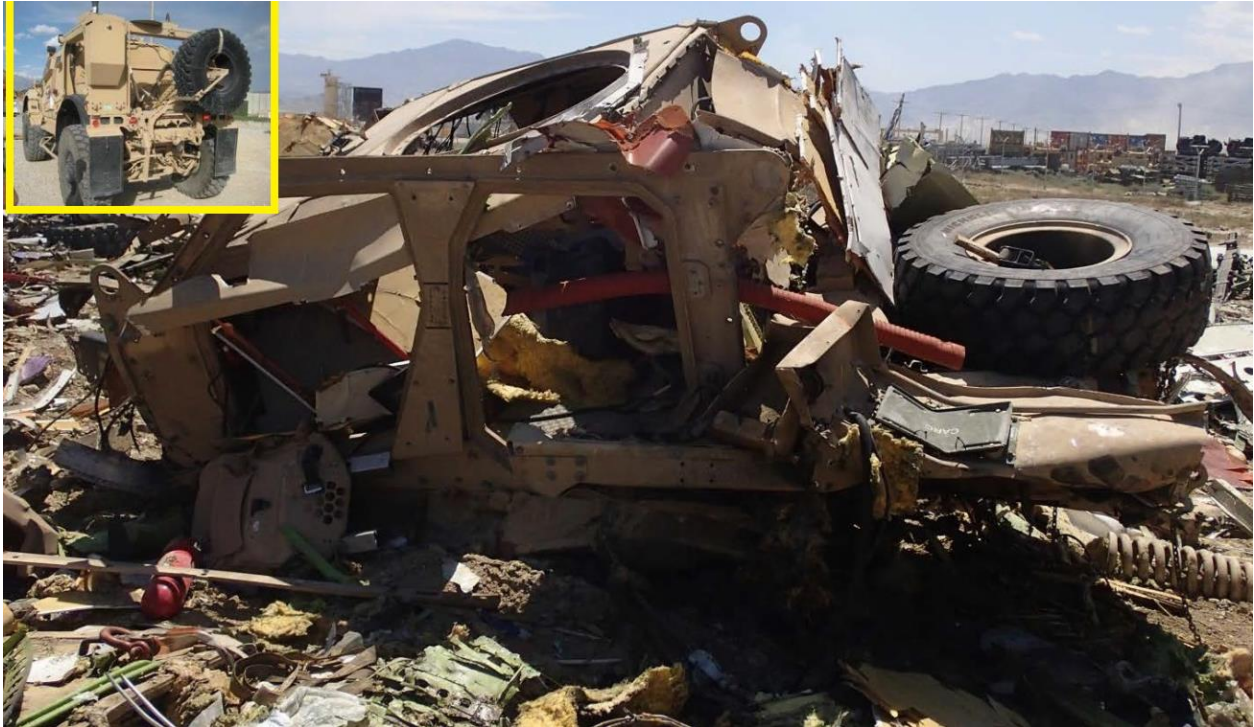
**Figure 13.** Photograph of the left side of the rear M-ATV as found in the wreckage and an inset diagram showing the installed position.

An orange transfer mark was noted on the back of the M-ATV on the antenna mounting structure on the upper left side (the location of the orange transfer mark was about 104 inches from the ground on an intact M-ATV). A comparative analysis of the orange transfer mark, which was performed using an infrared microspectrophotometer, determined that the spectrum of the transfer mark on the M-ATV was similar to other spectra of paints, indicating that the transfer was likely paint. A comparison of the transfer mark with a paint sample from the FDR chassis found that the spectra shared three similar peak patterns; however, the origin of the orange paint transfer could not be determined by spectral analysis.
