# **AIRCRAFT ACCIDENT REPORT 1/2015**

**Report on the accident to  
Airbus A319-131, G-EUOE  
London Heathrow Airport  
24 May 2013**

**Air Accidents Investigation Branch**

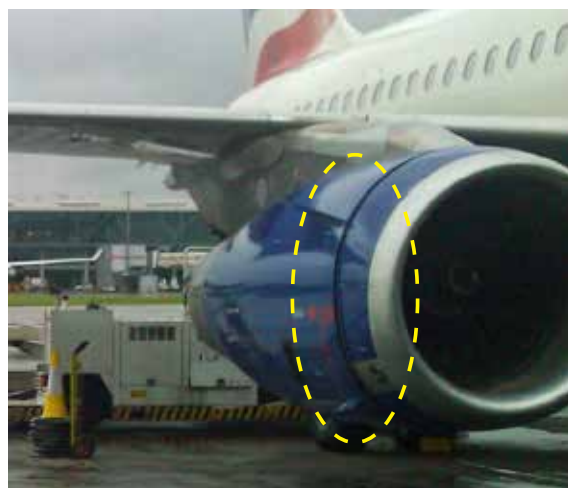
**Figure 1**  
G-EUOE right engine, outboard fan cowl door,  
showing gap with nose cowl (circled)

While the aircraft was being prepared for flight, a member of the operator's staff happened to take a sequence of photographs of the ground handling activities for the purpose of a ground handling training video. The photographs had inadvertently captured evidence that the fan cowl doors on both engines were in the unlatched condition. On the right engine this is indicated by the gap between the outboard fan cowl door and the nose cowl (Figure 1) and on the left engine by two latches protruding visibly below the cowl doors (Figure 2).

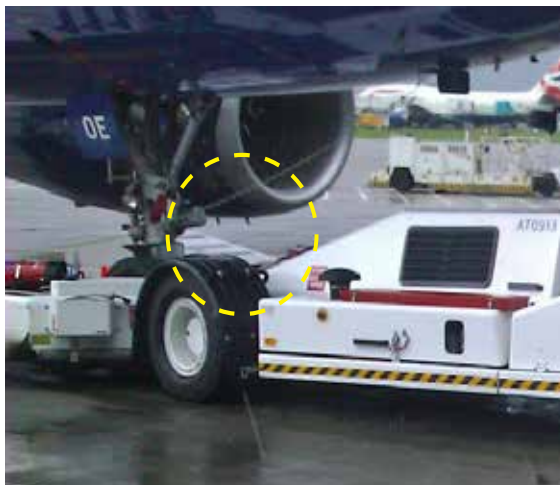
**Figure 2**

G-EUOE left engine fan cowl door latches visible in unlatched condition (circled)

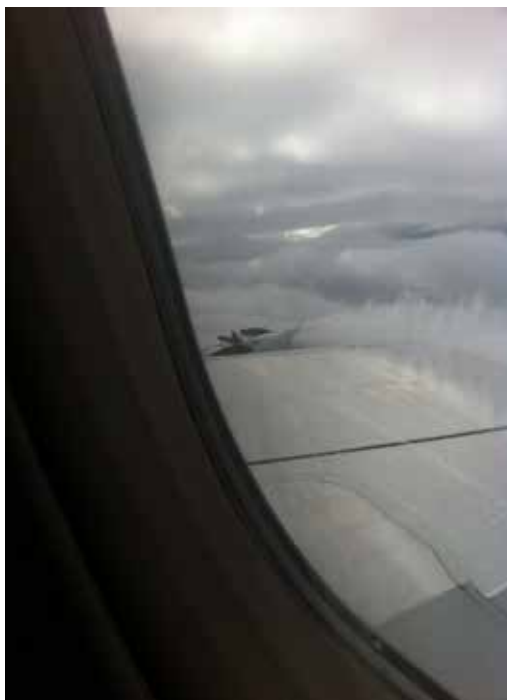
**Figure 3**

A number of passengers saw fuel leaking from the right engine. One passenger highlighted the leaking fluid to a member of the cabin crew, stating that it appeared to be fuel, but was told that it was not. Photographs taken by passengers show a significant fluid leak from the right engine (Figure 3).

Photograph taken by a passenger showing right engine fuel leak

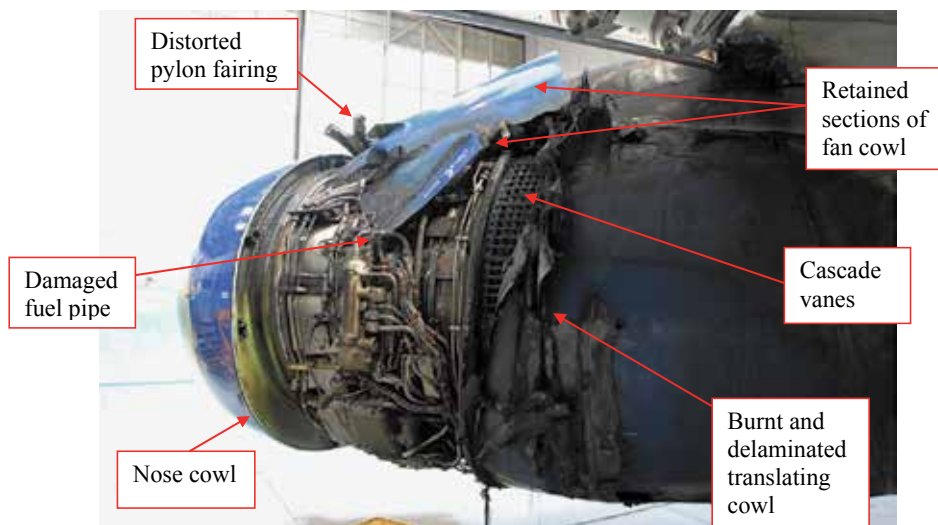
**Figure 5**

The right engine and its attached cowlings were extensively heat damaged. The most significant damage was concentrated in the left and right thrust reverser C-ducts. These consist of two large half-annulus shaped doors extending from the rear of the engine fan case to the common nozzle assembly at the rear of the core engine. The outer 'barrel' of the front section of each C-duct consists of a carbon fibre grid structure called cascade vanes. These are normally covered by an outer sleeve. When thrust reverse is selected, the sleeve slides backwards and blocker doors extend into the duct, directing engine bypass air forward through the cascade vanes.

The translating sleeve and cascade vanes on the right engine were heavily fire damaged, particularly on the inboard side of the engine. The resin bonding the layers of carbon cloth together to form the sleeve had been consumed across a significant section, allowing the carbon cloth plies to separate and peel backwards. The underlying carbon fibre cascade vane grid structure had also been burnt away in large sections in the lower inboard quadrant. On

View of inboard side of the right (No 2) engine

Two large sections of the inboard fan cowl door remained attached to the right engine (Figure 5). The large section was attached to the hinge line along the top of the engine; the smaller section, incorporating the aerodynamic strake, was trapped behind a large diameter fuel pipe mounted on the fan case. Both attached sections showed extensive burning along their leading and lower edges. The fuel cooled oil cooler (FCOC) supply and return fuel pipes, behind

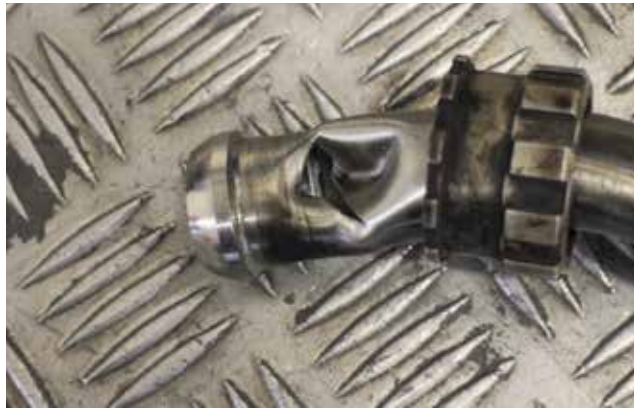
**Figure 6**

which the smaller section of fan cowl door was trapped, were also distorted. When the section of fan cowl was removed, puncture damage from the cowl was visible on the rear of the fuel metering unit (FMU) spill return pipe (Figure 6).

Damaged FMU spill return pipe after removal from the engine

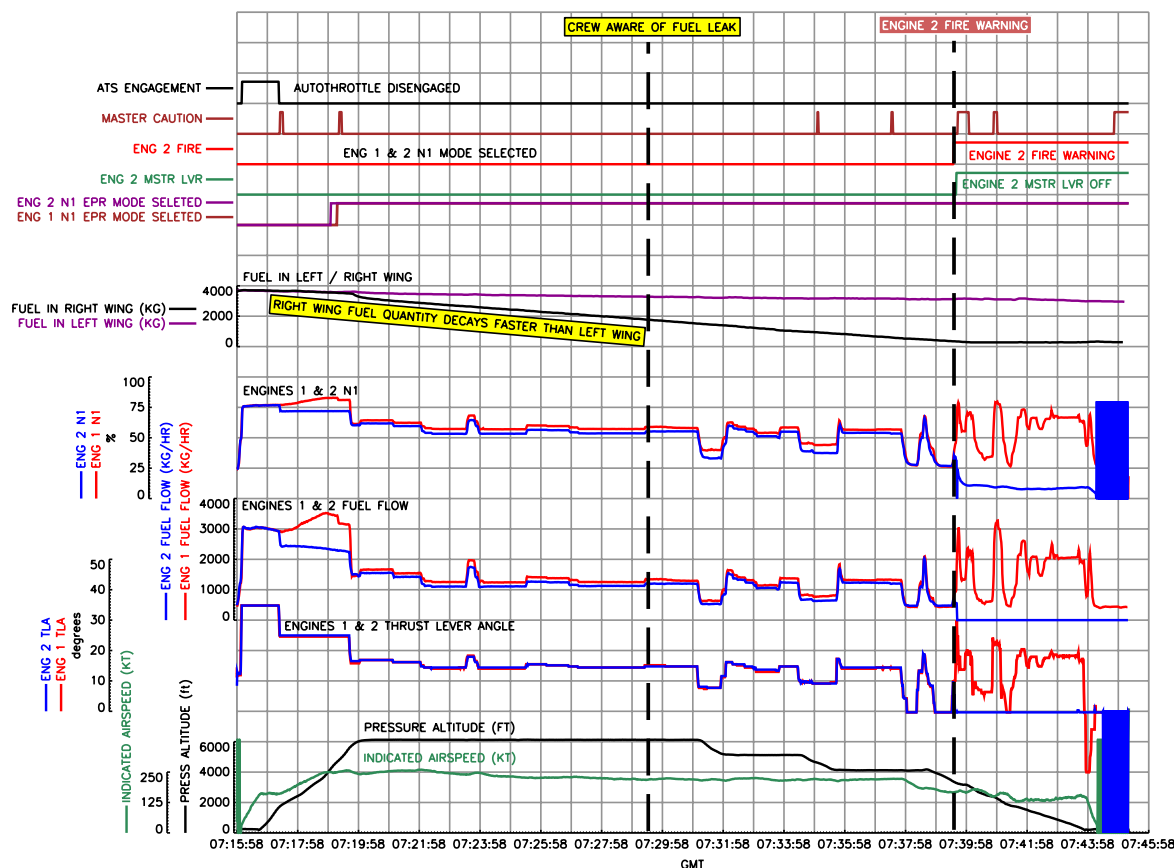
Figure 16

At this point, there was 333 kg of fuel remaining in the right wing, with touchdown four minutes later. Had the engine continued to run, assuming an average leakage rate of 127 kg/min, it is likely that the fuel supply to the right engine would have been exhausted prior to landing.

The total fuel consumption, calculated by integrating fuel flow rate over time, revealed that both engines had used approximately the same quantity of fuel and the aircraft manufacturer confirmed that the consumption rate of fuel for both engines was as expected. Calculations suggest that a total of 2,887 kg of fuel had leaked from the right engine.

G-EUOE engine and fuel usage data

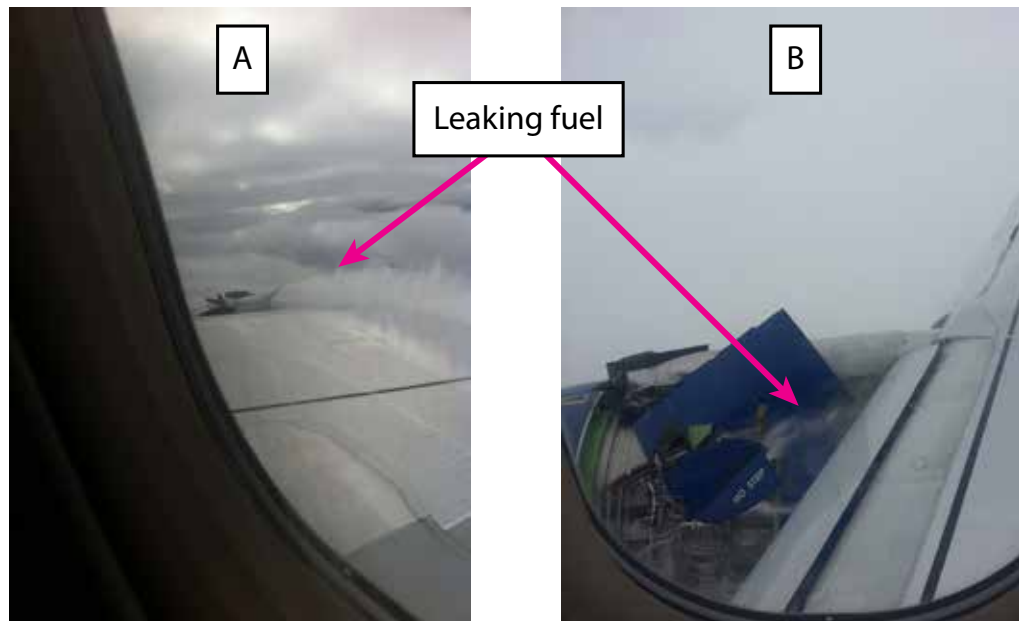
**Figure 18**

The aircraft rotated at 07:16:39 hrs and it is at approximately this point that fan cowl door sections from both engines were observed to have departed the aircraft. Within three seconds, the engine control system on the right engine identified a fault with the P2/T2 probe heat system. At 07:17 hrs a Yellow hydraulic system reservoir low level warning occurred indicating a leak of hydraulic fluid. At 07:19:21 hrs a Yellow hydraulic system low pressure warning was triggered. Variations in the right wing fuel tank quantity versus engine fuel flow provided the first evidence, 90 seconds after rotation, that fuel was leaking from the right engine, although the crew would not have been aware of this. Evidence from passenger witness reports confirmed that as the flight continued there was a significant fuel leak from the engine, though no reports of a fire at this stage. Picture A in Figure 18 was taken at 07:23:14 hrs. Picture B was taken at 07:39:14 hrs. The recorded data shows that the leak rate was effectively the same in both pictures, but the deployment of the leading edge slats by the time the second photograph was taken had significantly changed the airflow and thus the dispersal of the fuel as it left the engine.

Passenger photographs showing the fuel leak

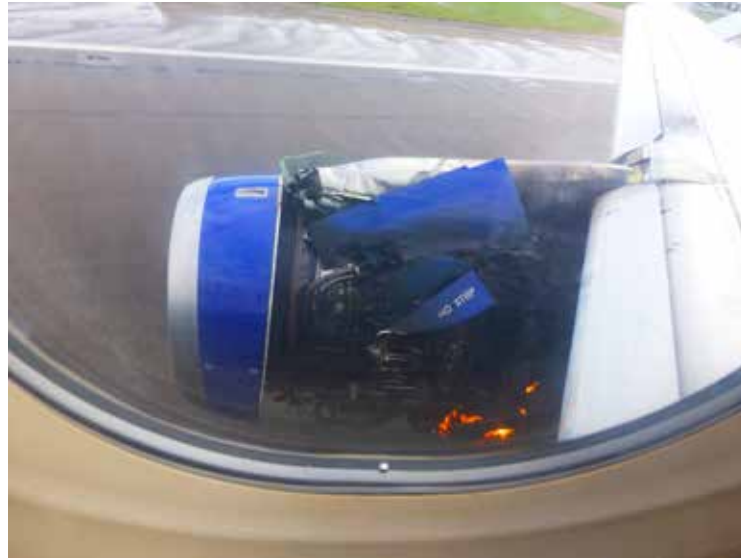
**Figure 19**

A photograph, taken by a passenger during the landing roll (Figure 19), shows that a fire continued to burn in the lower section of the engine until the end of the flight. Video evidence and witness statements from the attending airfield operations staff and firefighters who attended the aircraft, describe the fire intensifying again once the aircraft came to a stop on the runway. However, it was quickly extinguished by the AFRS and London Fire Brigade (LFB) assets, who had attended as part of the pre-determined response to the ATC declaration of 'Aircraft Accident Imminent'.

Engine fire during landing roll

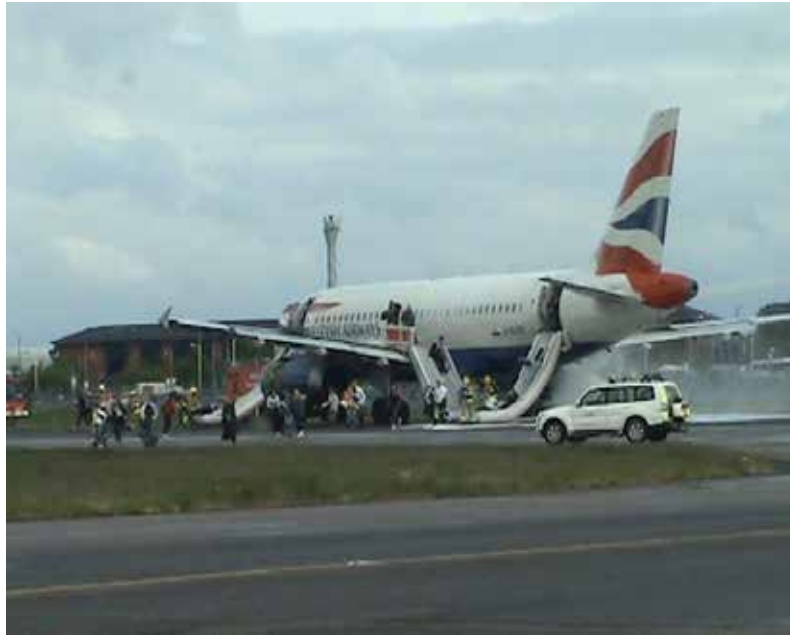
**Figure 20**

Still image from evacuation video  
(fire-fighting continues on right side of aircraft)

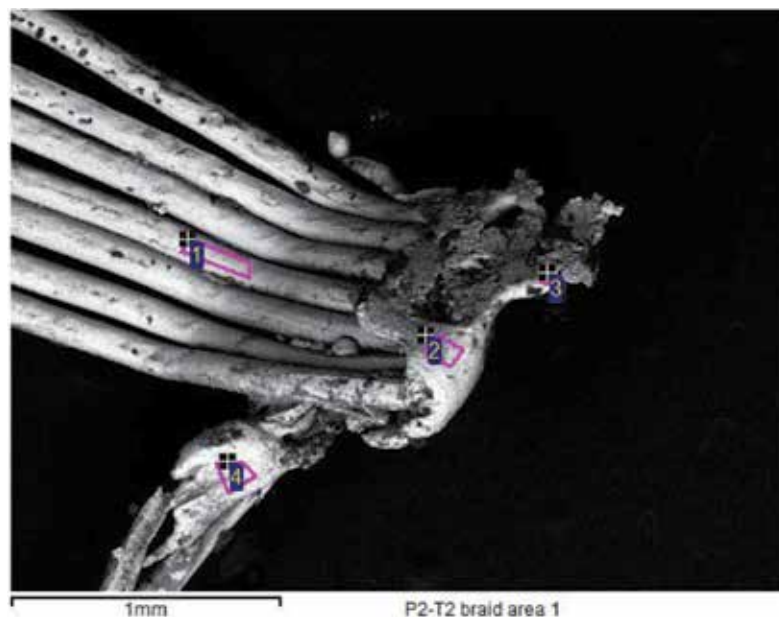
**Figure 21**

Of these looms, only the P2/T2 loom exhibited evidence of arcing. The temperatures associated with an electrical arc can reach several thousand degrees centigrade and it therefore provides a ready ignition source. The P2/T2 wiring loom contains the probe heater supply, which is 115 V AC. Mechanical damage was identified on the loom 90 mm from the connector. This damage exhibited evidence of arcing. Energy Dispersive X-ray (EDX) analysis of the copper wiring core, using a Scanning Electron Microscope (SEM), identified that it was contaminated at points 2, 3 and 4 (Figure 21) by traces of a stainless steel material, indicating that arcing had occurred between the cable and a component made from this material. The melting point of stainless steel is approximately 1,500°C, depending on the grade of steel.

SEM image of the P2/T2 wiring loom
