BULLETIN

Serious incident

30-5-2019

DE HAVILLAND CANADA DHC-8-202

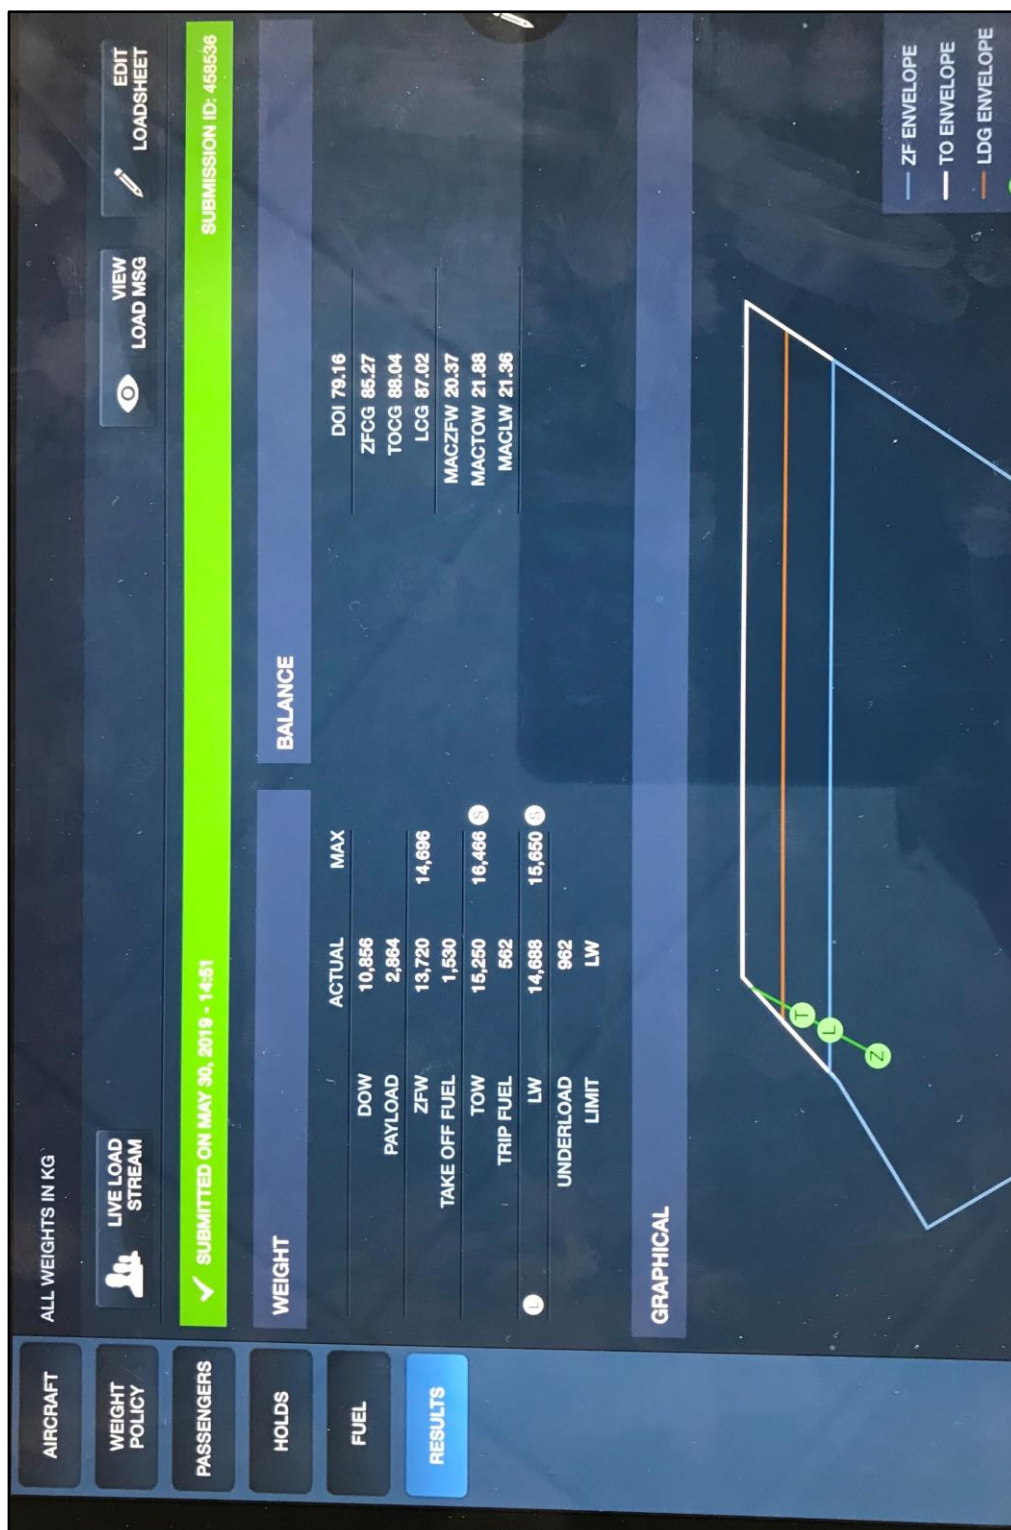
APPENDIX 2

The flight crew electronic presented mass and balance results - [see appendix 2](#).

The Dry Operating Weight (DOW) included 64 kg of catering.

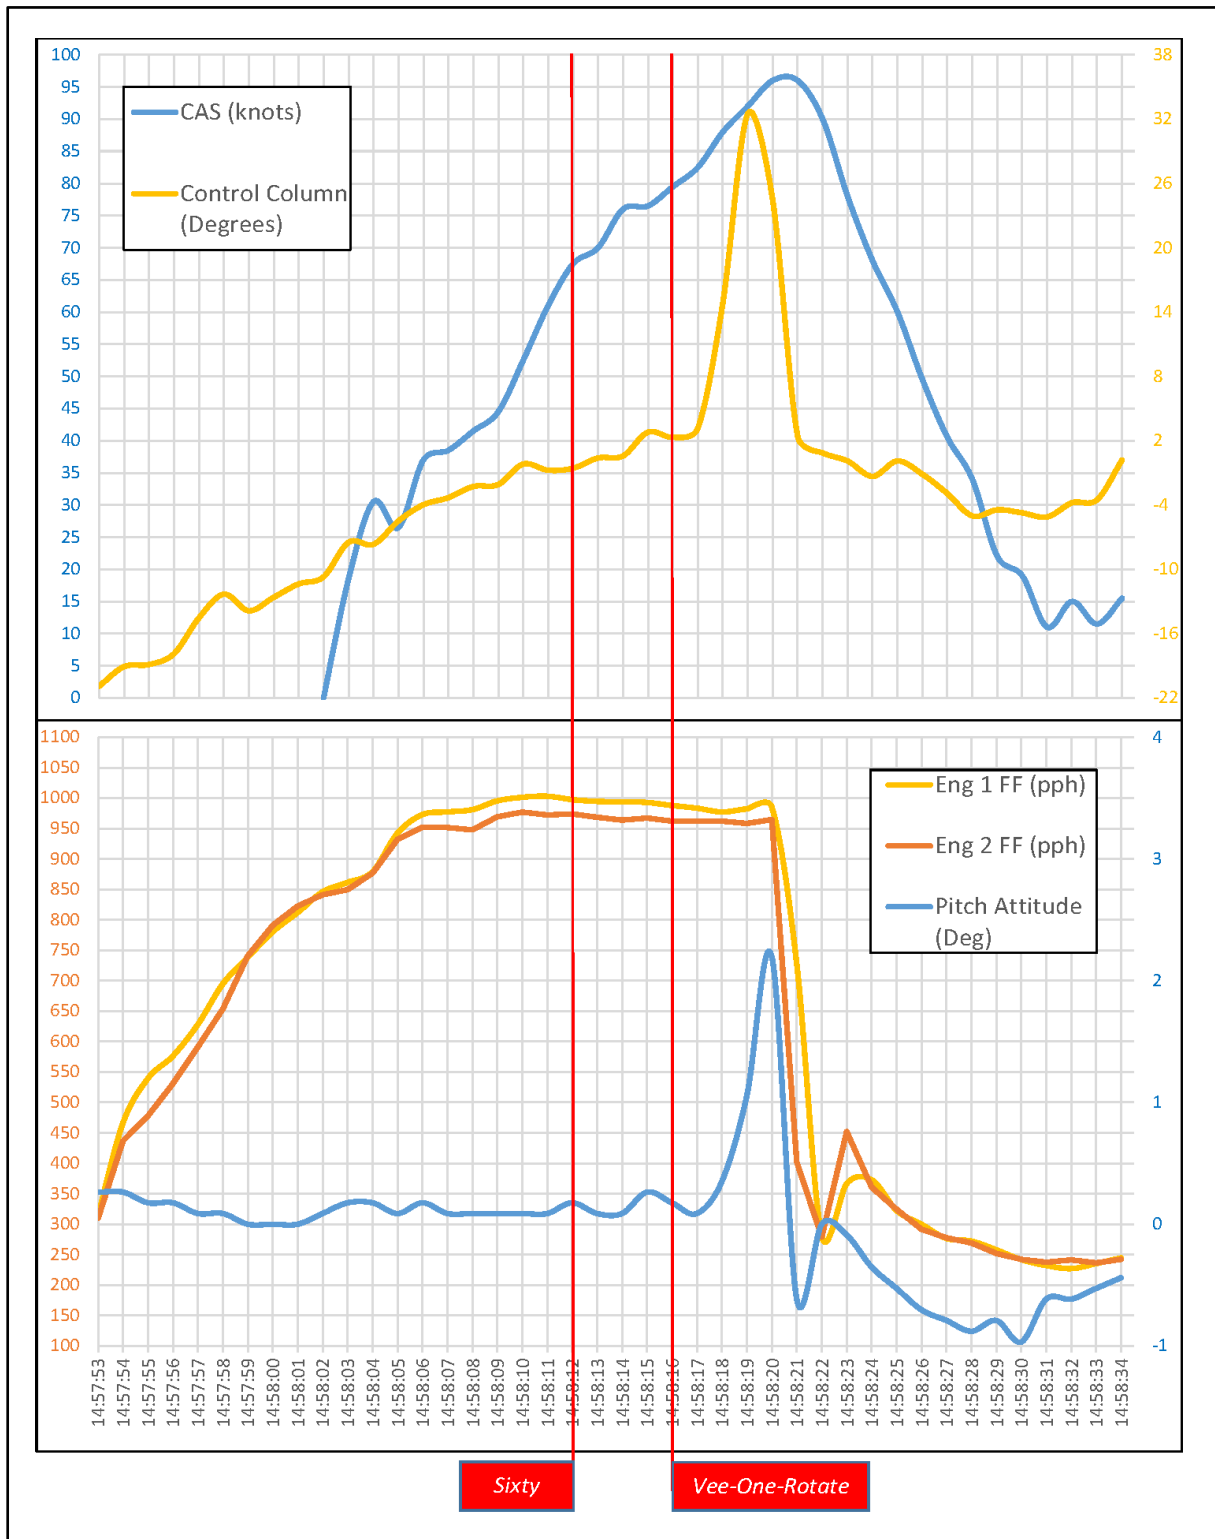
APPENDIX 7

With the addition of the CVR *Sixty* and *Vee-One-Rotate* callouts, the AIB generated a QAR data plot - [see appendix 7](#).

Note. The elevator position attained was sufficient to rotate an aircraft loaded within the operational CG envelope (elevator position not presented in this plot).

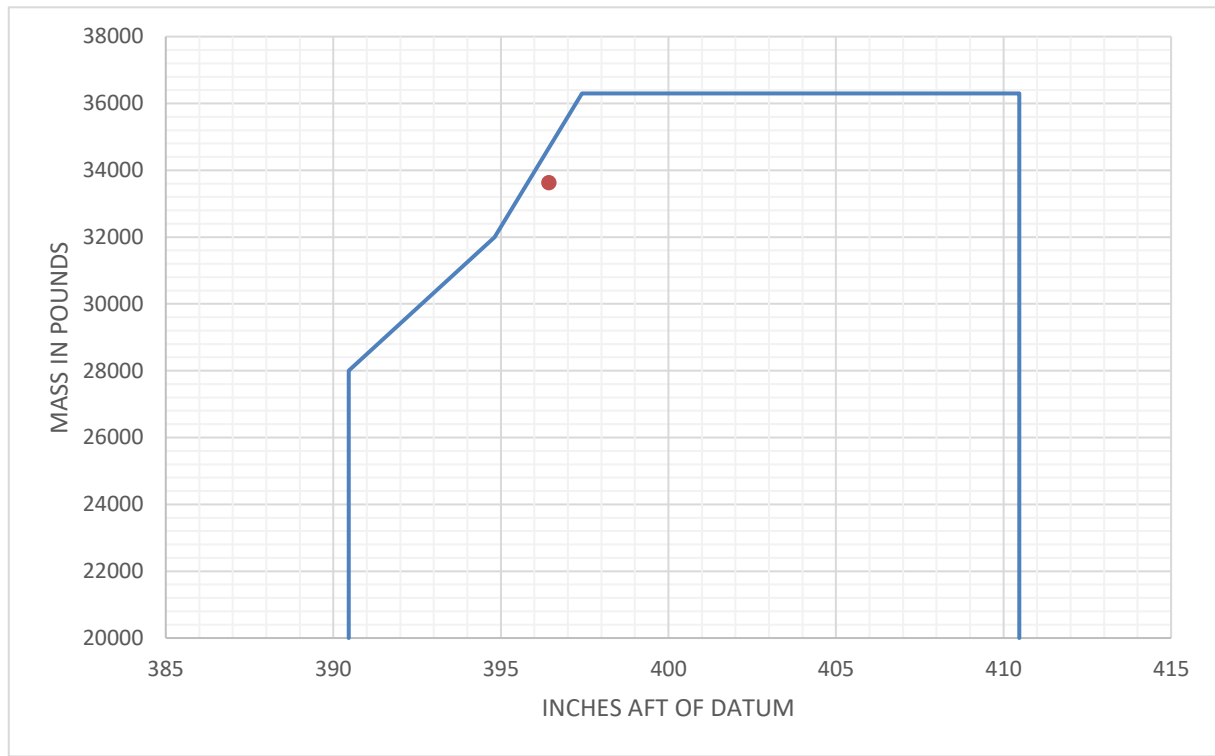
Mass and balance diagram

Description	Mass (Lbs)	Arm (In)	Moment (InLbs)
Basic empty mass	22.243,70	395,91	8.806.544,00
Standard loose equipment	1.008,40	427,34	430.934,00
Pilots	374,79	152,00	56.967,38
Observer	0,00	185,00	0,00
Wardrobe	0,00	210,00	0,00
CA	165,35	229,00	37.864,35
Catering	141,10	230,00	32.452,01
Row 1	743,49	276,00	205.202,99
Row 2	743,49	307,00	228.251,15
Row 3	743,49	338,00	251.299,31
Row 4	743,49	371,00	275.834,45
Row 5	743,49	402,00	298.882,61
Row 6	743,49	433,00	321.930,78
Row 7	929,36	464,00	431.223,67
Cargo Compartment A	0,00	514,40	0,00
Cargo Compartment 1	44,09	571,00	25.176,76
Cargo Compartment 2	879,64	624,00	548.897,47
Fuel	3.373,07	408,20	1.376.886,60
Total	33.620,43	396,44	13.328.347,53

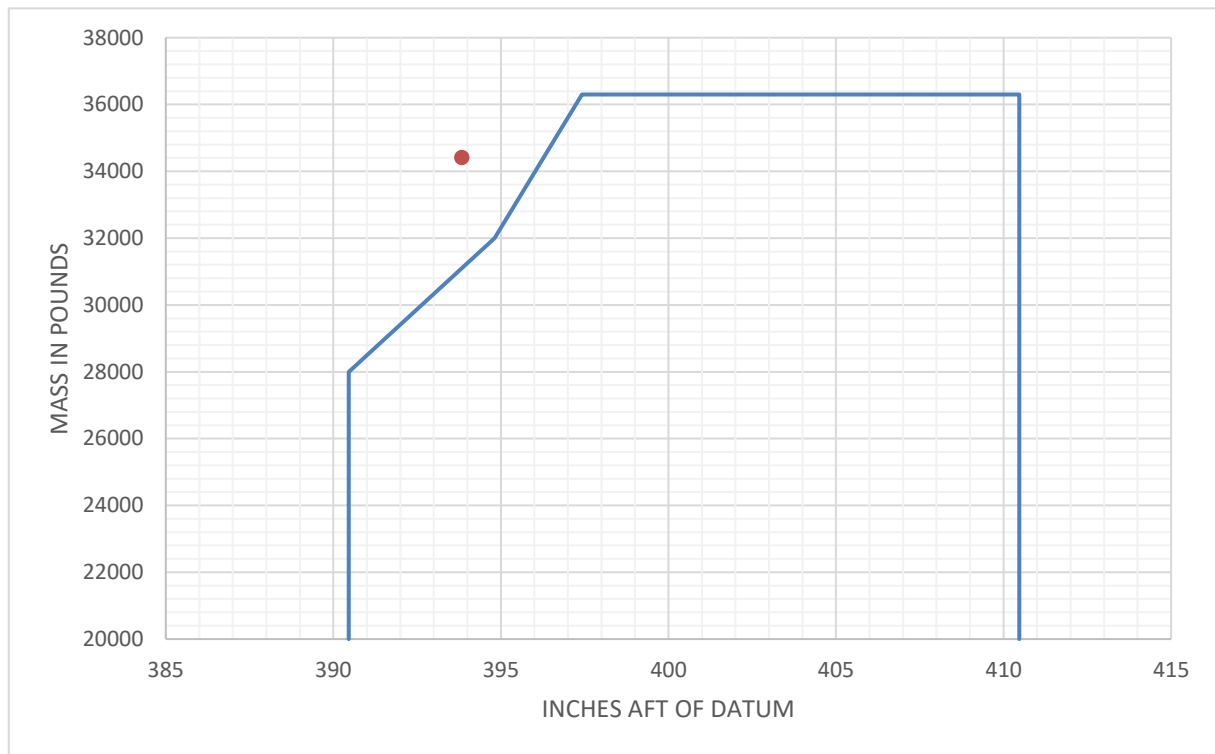
Mass and balance diagram

To the AIB, actual masses above standard masses resulted in the CG being forward of and outside aircraft operational CG limitations and was the root cause to reduced aircraft rotation ability.

Description	Mass (Lbs)	Arm (In)	Moment (InLbs)
Basic empty mass	22.319,50	395,87	8.835.630,00
Standard loose equipment	945,10	419,90	396.854,00
Pilots	443,13	152,00	67.355,55
Observer	0,00	185,00	0,00
Wardrobe	46,30	210,00	9.722,37
CA	178,57	229,00	40.893,50
Catering	141,10	230,00	32.452,01
Row 1	903,89	276,00	249.474,80
Row 2	908,30	307,00	278.849,16
Row 3	967,83	338,00	327.125,92
Row 4	890,67	371,00	330.437,26
Row 5	670,20	402,00	269.422,20
Row 6	824,53	433,00	357.020,57
Row 7	877,44	464,00	407.131,58
Cargo Compartment A	0,00	514,40	0,00
Cargo Compartment 1	44,09	571,00	25.176,76
Cargo Compartment 2	879,64	624,00	548.897,47
Fuel	3.373,07	408,20	1.376.886,60
Total	34.413,36	393,84	13.553.329,76
