## Incident to the BOEING 737-900ER registered 4X-EHE

on 27 October 2019

at Paris-Charles de Gaulle (Val-d'Oise)

## Cargo fire warning before taxiing, use of fire extinguishers, and disembarkation of passengers

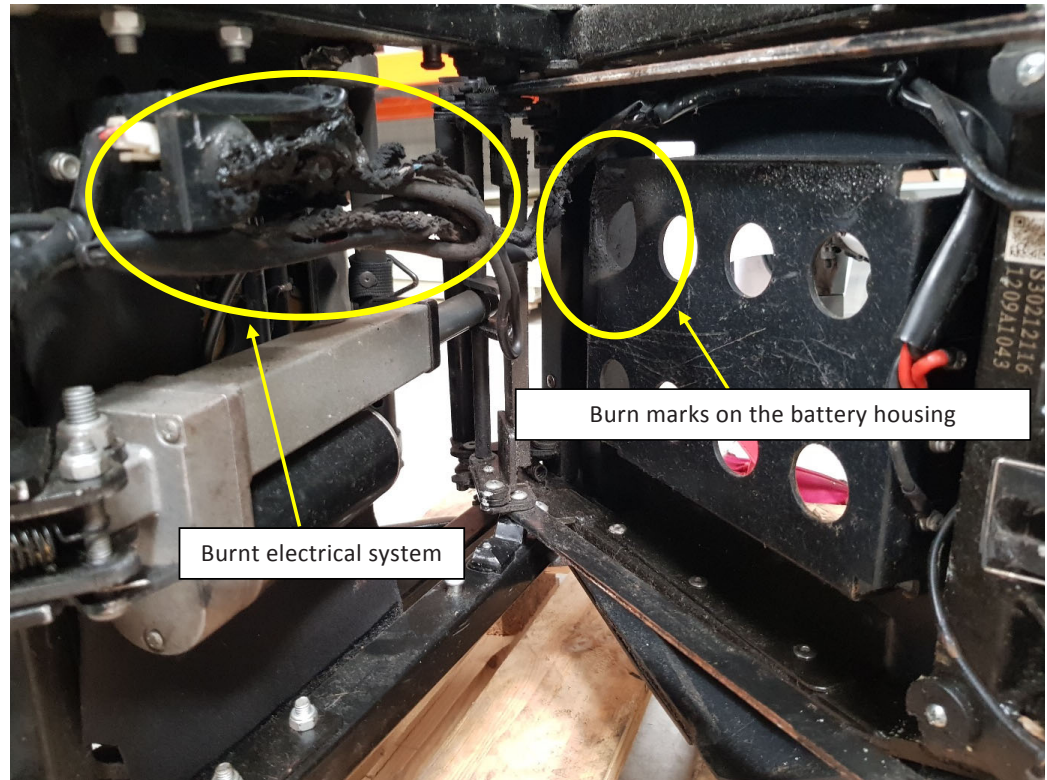
The wheelchair was severely damaged, probably due to the electrical system overheating. The battery showed no obvious signs of damage except for a few external burn marks which corresponded to the openings in the battery housing. A red canvas pouch was attached to the chair's handles and exhibited burn marks. When the chair is in a vertical position, this pouch touches the battery.

Figure 2: Position of battery housing in relation to burnt electrical system, wheelchair partially unfolded

After the wheelchair had been secured in the aft hold of the aeroplane, a short circuit occurred in the wheelchair's electrical system for unknown reasons. The battery, still connected, sustained this short circuit which resulted in incipient combustion. The battery was in immediate contact with the combustion zone which could have created thermal runaway inside the battery.

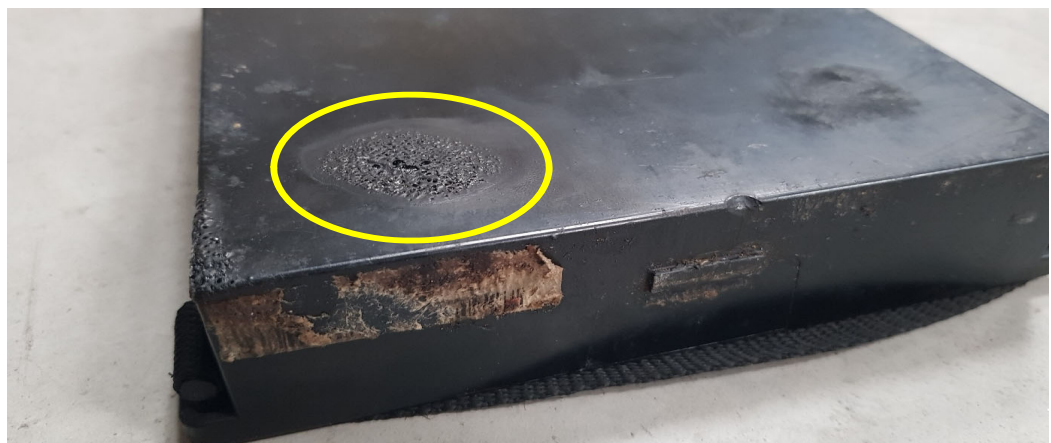
Figure 3: Burn marks on battery body, in relation to visible burn marks on housing

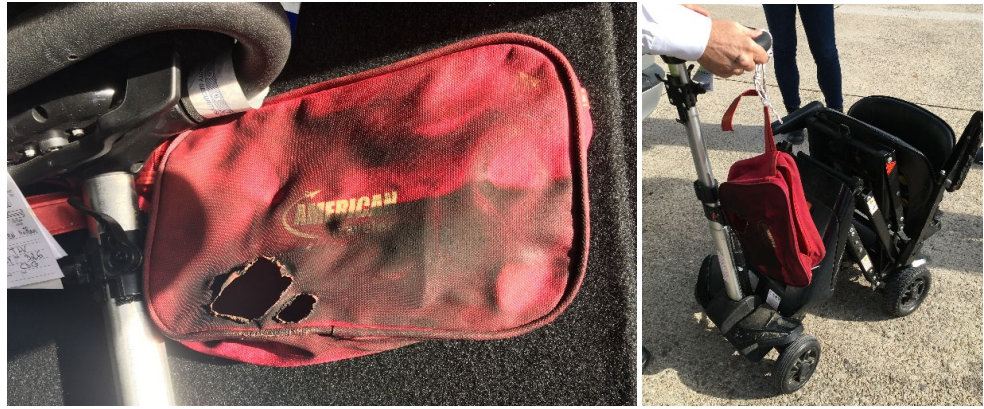
Figure 4: Red canvas pouch attached to wheelchair handle

The EL AL’s security agent took the wheelchair onto the tarmac to hand it over to the Alysia luggage handlers (“ramp” service). The supervisor saw a red pouch attached to the wheelchair which he thought seemed full and heavy. He supposed that the battery was in the pouch but was not able to check this as the procedures prohibit him from opening passengers’ personal effects. The wheelchair was then loaded and secured in the aeroplane’s aft hold.
