# Loading event involving Airbus A320, VH-VFN

Sydney Airport, New South Wales, 8 September 2016

**ATSB Transport Safety Report**  
Aviation Occurrence Investigation  
AO-2016-119  
Final – 14 December 2016

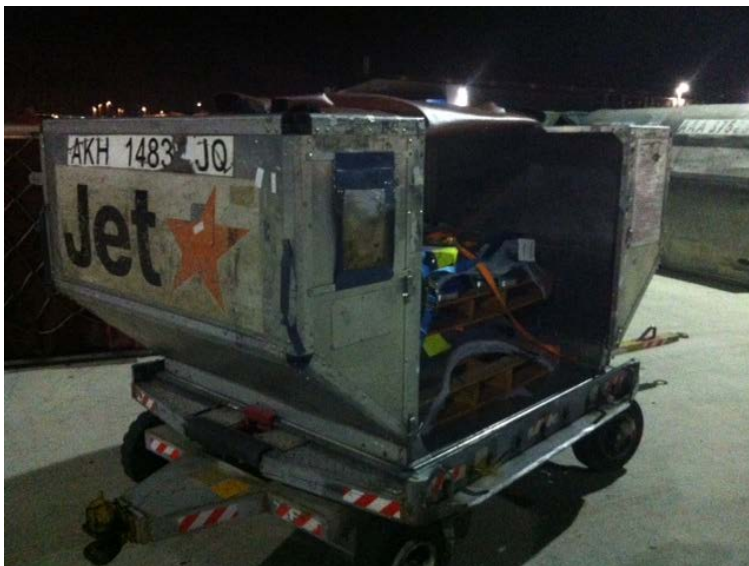
**Figure 1: Container AKH 1483 JQ**

The leading hand assigned to loading the aircraft had received the deadload weight statement<sup>1</sup> (DWS) for the cargo from the cargo terminal operator (CTO), and printed out a copy to refer to while loading the aircraft. The DWS listed three containers of freight, which the leading hand reported was usually loaded onto the aircraft before the passenger bags. The CTO had previously delivered the three containers to the loading bay from their facility. The leading hand checked the containers with those listed on the DWS – crosschecking the container numbers and the flight details, and confirming that the sum of the weight of the three containers corresponded to the total gross weight on the DWS. Two of the three listed containers were correct, however, the third was listed on the DWS with number 4183 and a gross weight of 240 kg, while the container on the bay was number 1483 (Figure 1), which was subsequently found to have had a gross weight of 900 kg.

Subsequent investigation revealed that the incorrect container was delivered for loading; the CTO had delivered container 1483 (which weighed 900 kg) instead of 4183 (which weighed 240 kg).

The aircraft operator advised that a member of the freight company misread the digits on the container (confusing 1483 for 4183) and transported it to the incorrect bay while delivering the correct DWS and container card.

Ground crew have been reminded to offload any freight where there is a discrepancy in the paperwork.
