# AIR ACCIDENT INVESTIGATION SECTOR

## SERIOUS INCIDENT INVESTIGATION REPORT

### Pushback Collision

Airbus A330-243 [A6-EYN]

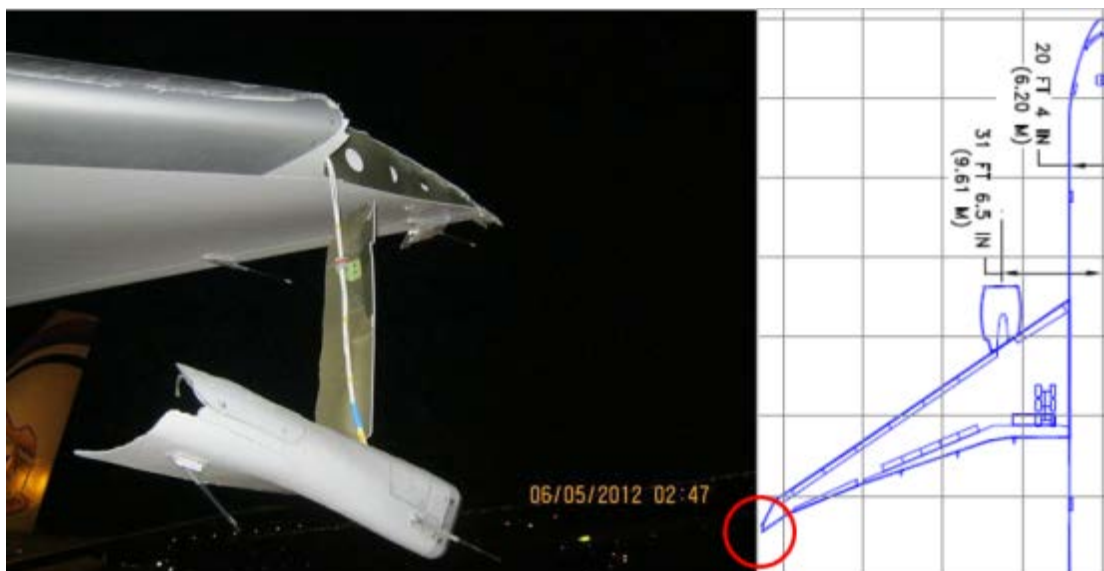
Figure 3 B777 LH Wingtip Damage

The left hand wingtip/winglet assembly was damaged beyond acceptable dispatch limits. Significant structural damage to the secondary structure component assembly required the assembly replacement.

The aircraft was declared AOG, the passengers were disembarked and aircraft towed to a repair facility.

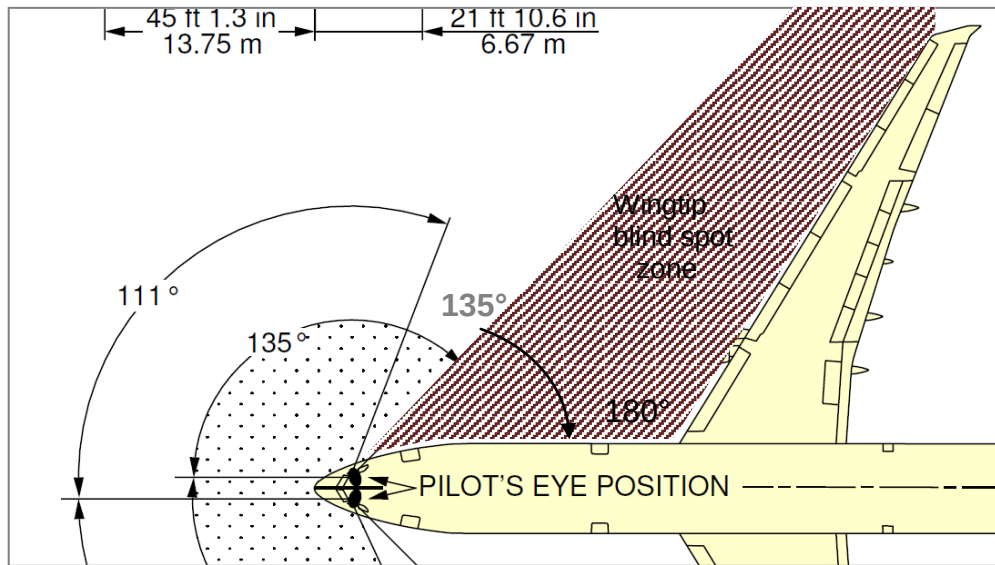
Figure 4 Visibility from A330 Cockpit in a Static Position

Pilot's view from the First Officer position when seated, head up in the F.O. seat, with the seat restraints attached [seat belts] is limited to a cone range of 135° from the aircraft's longitudinal axis.

From 135°-180° from the static position is a wingtip blind spot. The visual field of the human eye spans approximately 120 degrees of arc from the static position, most of the arc range is peripheral vision only.

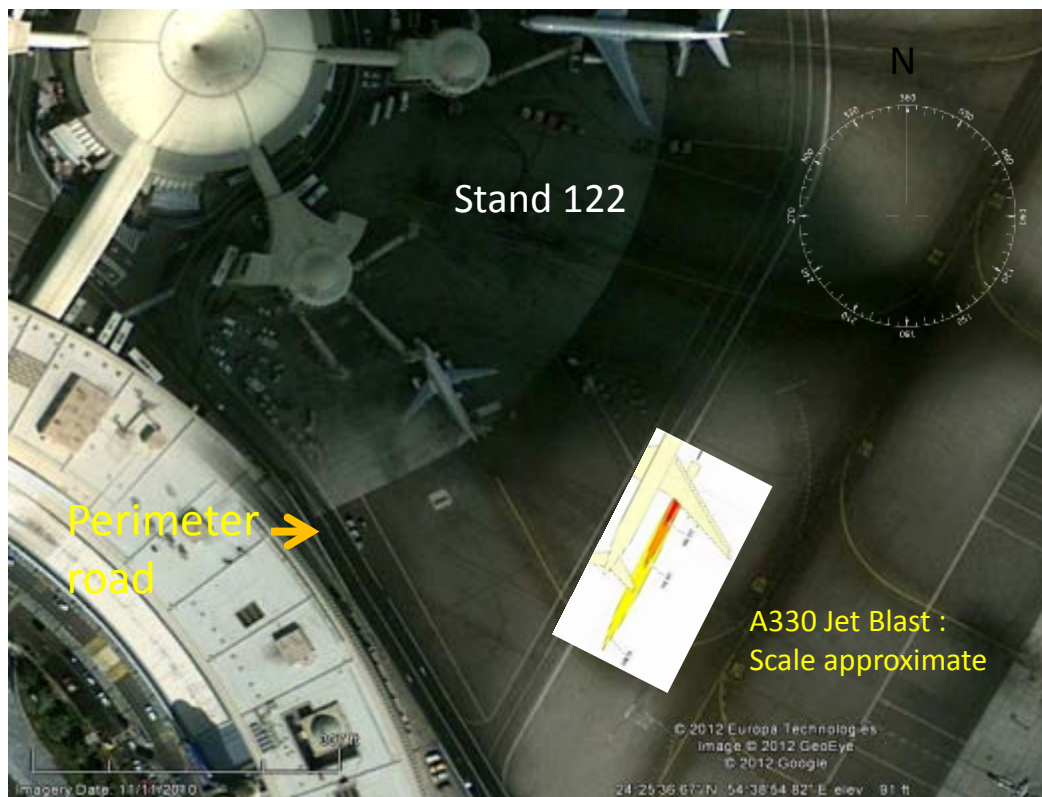
Figure 9 Overview Engine Exhaust and the Perimeter Road Boundary

There is currently no requirement to friction test the airside boundary roads or make safety risk assessment for jet blast induced vehicle displacement.

This recommendation shall include quantified aerodrome data for safe engine exhaust velocity [EEV]side loads on aerodrome vehicular traffic. The impact of severe EEV on single vehicle traffic should be obtained on as many vehicles as possible within the aerodrome to define the safety case.

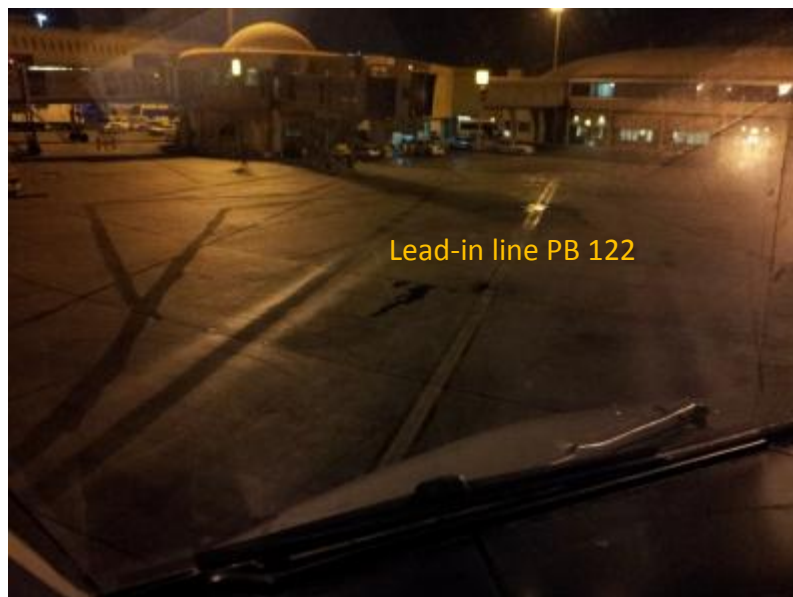
Photo 3 Cockpit View After Wingtip Contact looking forward

Wing walkers are not used for the pushback from this parking stand. The minimum 7 meter wingtip to wingtip clearance distance is achieved if the pushback is performed on the correct radial from the pushback stand. Actual, nominal separation distance is 13.4 meters [dry wing] based on a Path planner analysis
