# **NATIONAL TRANSPORTATION SAFETY BOARD**

## **AIRCRAFT ACCIDENT REPORT**

RYAN AIR SERVICE, INC.,  
FLIGHT 103, BEECH AIRCRAFT CORPORATION  
1900C, N401RA,  
HOMER, ALASKA,  
NOVEMBER 23, 1987

NTSB/AAR-88/11

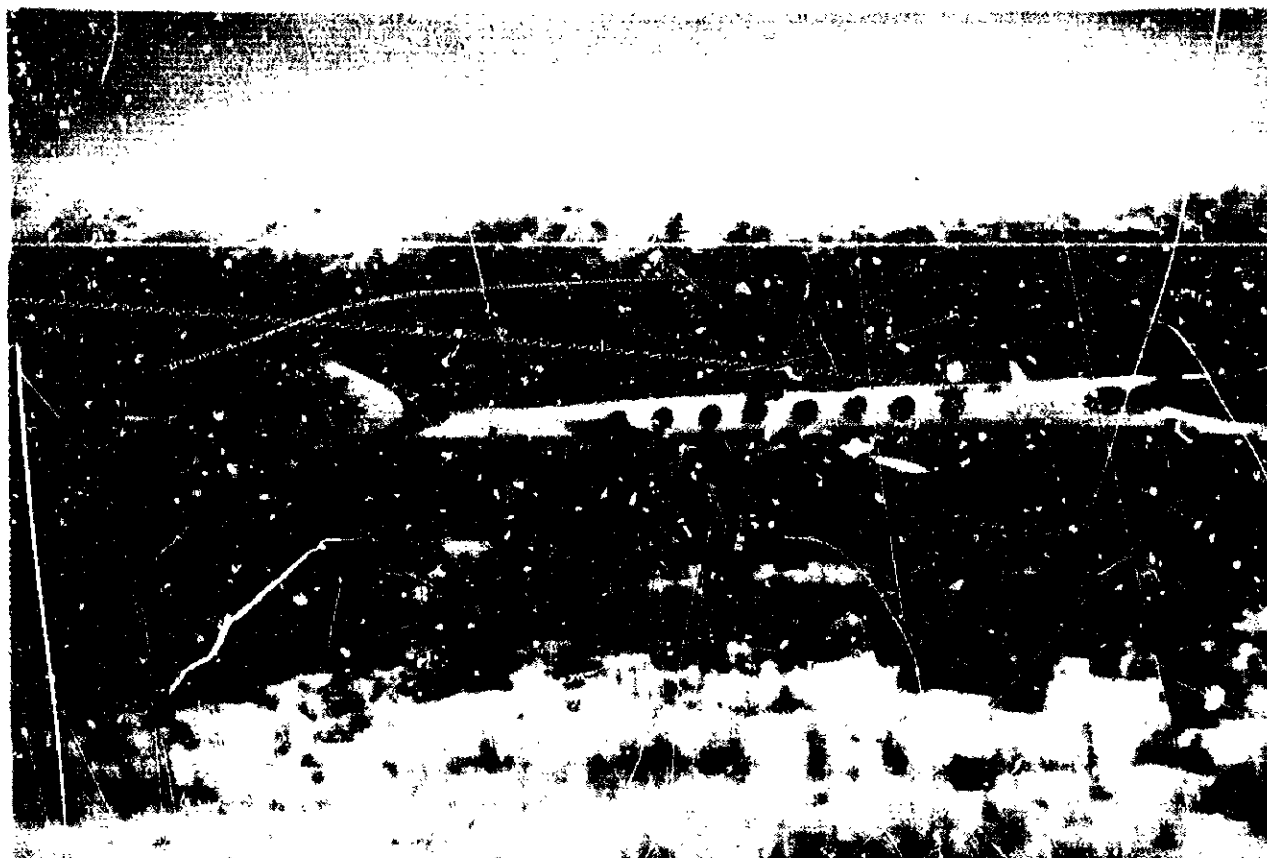
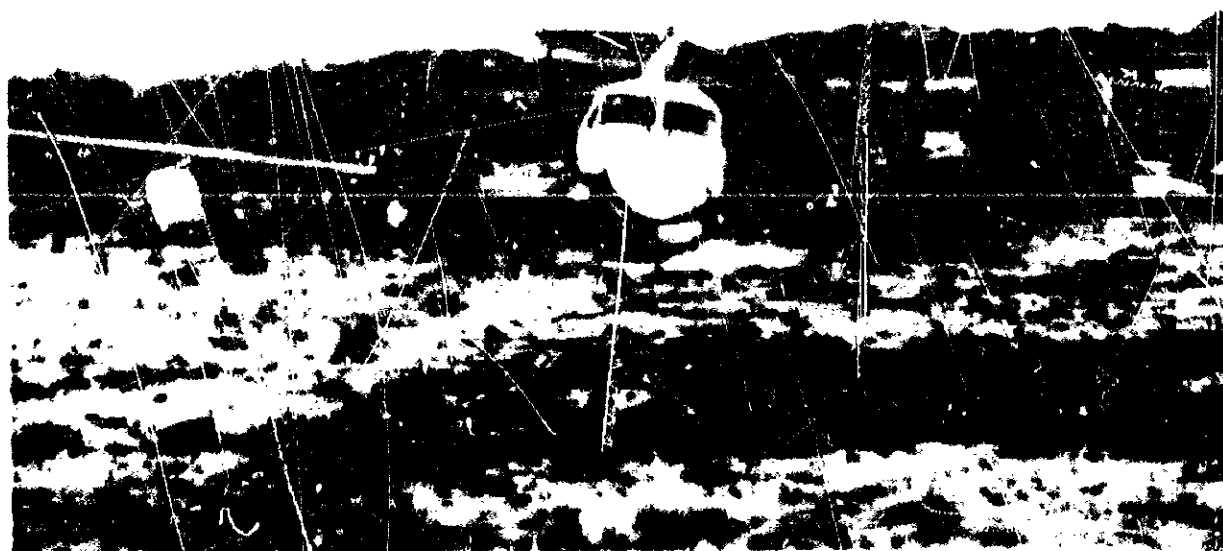
The airplane wreckage, located west of runway 3, was distributed along a distance of 159 feet, on a heading of approximately 355°. A video tape taken 4 hours after the accident revealed a thin ice accumulation up to 3/8 inch on the leading edges of the wings, horizontal stabilizers, stabilons, tailsets, vertical stabilizer, and nose cone. No other ice accumulation was observed on the airplane. The gear actuators indicated that the gear was down and locked at impact. (See figure 2.) The propeller blades of both engines, which were composed of composite material, were broken away at their hubs and were scattered along the wreckage path.

The lower wing surfaces were heavily damaged from their root end to outboard of the landing gear well. Numerous ribs were broken and/or crushed. The flap handle was in the up position. The left flap actuator attachment brackets were broken. The right flap actuator was found in an intermediate position, between 7° and 12°. Company procedure was to select full (35°) flaps when landing was assured.

Figure 2.--Wreckage of RYA 103.
