**SERIOUS INCIDENT**

| <b>Aircraft Type and Registration:</b> | ATR 72-211, G-CLNK | |
| <b>Location:</b> | Guernsey Airport | |
| <b>Nature of Damage:</b> | Damage to cargo rail, rollers and locks. | |

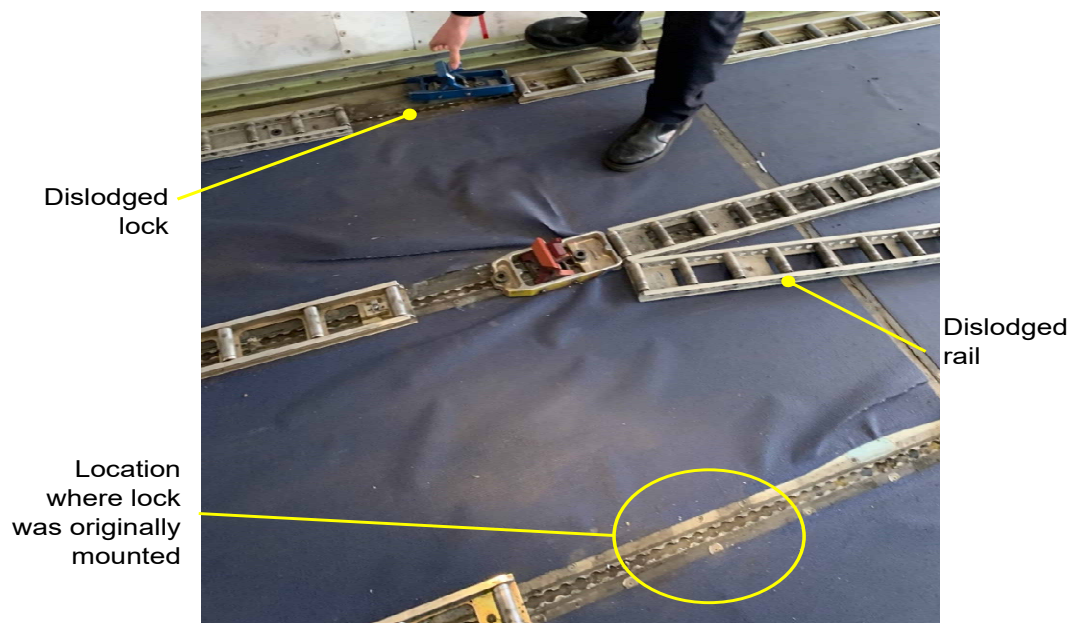
**Figure 4**

Examination of the aircraft by the operator found that the locks and rails between bays C2 and C3 were damaged and dislodged (Figure 4), and the locks to the rear of bay C3 were DOWN. The locks between bays C2 and C3 had been pulled out of the tracks in the cargo bay floor within which they were attached.

An investigation by the ground handling organisation identified that when the ULD in bay C3 was moved into location, the locks between bays C3 and C4 were not raised and remained in the DOWN position; however, the forward locks were raised. During the takeoff roll the slight thud heard by the crew was probably the ULD in bay C3 sliding rearwards to bay C4 and stopping against the forward locks which restrained the ULD in C5. During the landing the ULD would have slid forward as the aircraft decelerated, breaking the locks between bays C2 and C3 which were in the UP position. Its movement would then have been arrested when it hit the raised locks to the rear of the ULD in C1.

Damage to rails and locks between bays C2 and C3 (reproduced with permission)

Normally when loading ULDs into position, they are pushed until they contact the rear locks and the ULD cannot move any further rearward. The forward locks are then raised. In this event, with the rear locks in the DOWN position, the handling organisation was unable to determine how the ULD stopped in a position that would allow the forward locks to be raised and engage with the front of the ULD. It was considered that a combination of friction of the ULD as it was moved rearward on the rails, the visual cues of the green marker on the fuselage wall, and the forward locks becoming visible on the bay floor as the container moved over them probably resulted in the ULD being positioned so that the forward locks could be engaged without the rear locks being UP (raised).

The ground handling organisation has revised their loading procedures to introduce an independent check to verify that all locks are positioned in the correct position when the aircraft is loaded.
