SERIOUS INCIDENT

Aircraft Type and Registration:	Boeing 747-436, G-CIVU	
No & Type of Engines:	4 Rolls-Royce RB211-524G2-T-19 turbofan engines	
Year of Manufacture:	1998 (Serial no: 25810)	
Date & Time (UTC):	20 December 2019 at 1543 hrs	
Location:	London Heathrow Airport	
Type of Flight:	Commercial Air Transport (Passenger)	
Persons on Board:	Crew - 17	Passengers - 328
Injuries:	Crew - None	Passengers - None
Nature of Damage:	Damage to the No 1 engine cowl and to the rear of a fuel transfer vehicle	
Commander's Licence:	Airline Transport Pilot's Licence	
Commander's Age:	60 years	
Commander's Flying Experience:	28,400 hours (of which 14,800 were on type) Last 90 days - 201 hours Last 28 days - 56 hours	
Information Source:	Aircraft Accident Report Form submitted by the pilot, reports submitted by the operator, the refuelling company and the airport authority, and further enquiries by the AAIB

Synopsis

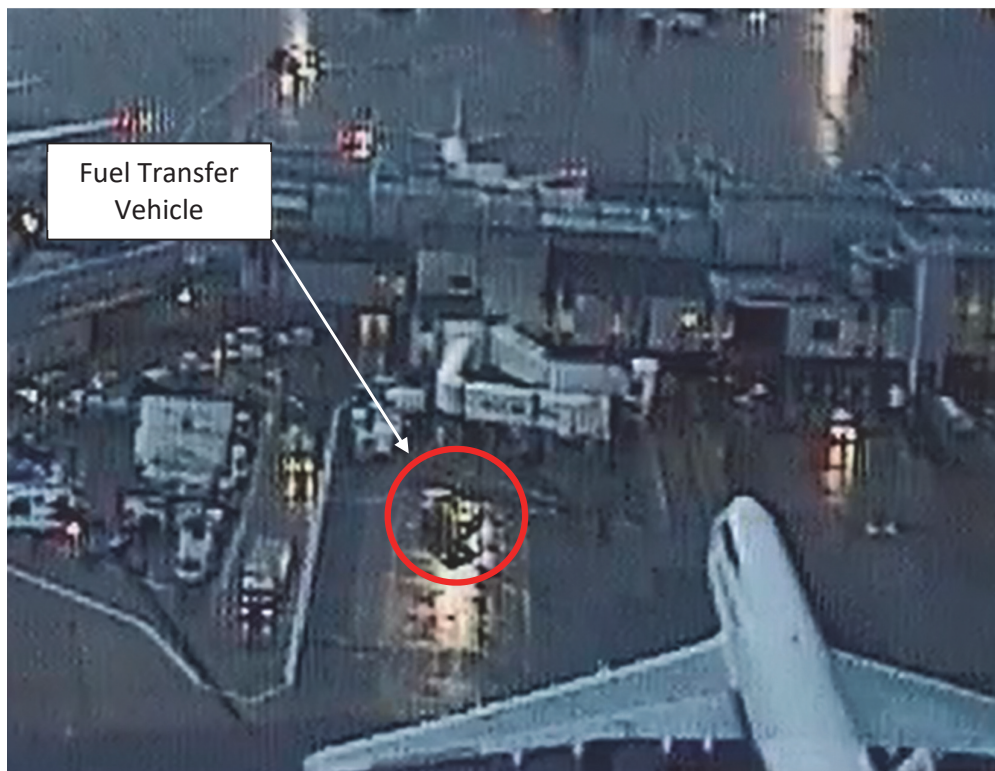
**Figure 2**

CCTV showed the Airbus commence push back at 1539 hrs. The FTV can be seen parked by the Airbus's left wingtip. The supervisor can be seen walking the centreline behind the pushback tug. The collision occurred at 1543 hrs. Figure 2 shows an image from the CCTV just prior to the collision.

CCTV image showing the B747 approaching the stand and the parked FTV

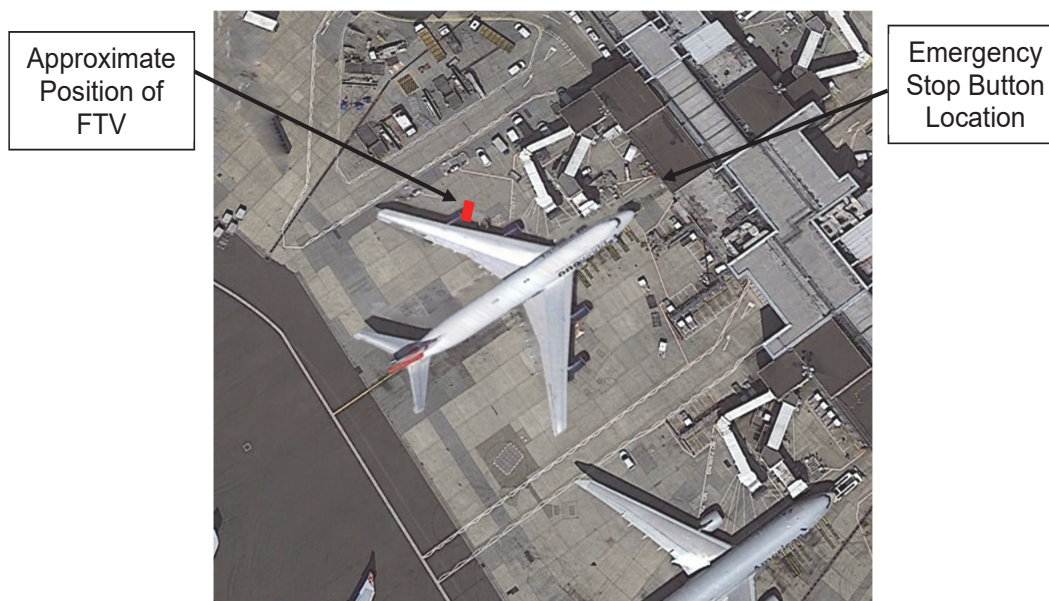
Figure 3 shows an aerial view of Stand 331 at Heathrow with a Boeing 747 superimposed on the image. The approximate position of the FTV when the collision occurred is shown.

Aerial view of Stand 331 with B747 superimposed

The airport authority has changed the parking arrangement on Stand 331 to prevent vehicles obscuring the view from the head of stand.

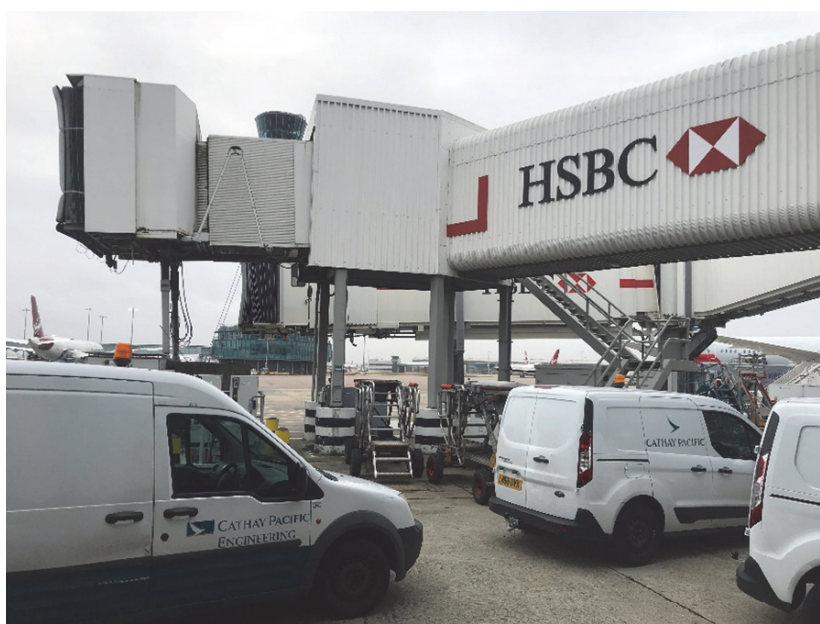
Figure 4 is a photograph taken from the emergency stop button position at the head of the stand looking towards the right where the FTV was parked. The photograph shows the obscured view in that direction.

View to the right of the stand from Emergency Stop Button Location

The ground staff remained near the emergency stop button during the arrival, but they could not see the FTV from this position. The jetty structure and parked vehicles obscured part of the stand from the stop button position. The operator will take the following safety action:

The operator will establish a procedure to ensure all visually restricted stands have a 'mid-man', in the line of sight, to act as an additional pair of eyes for the colleague manning the emergency stop button at the head of the stand.

The airport authority is undertaking a review of the emergency stop button locations on all stands.
