Collision during pushback between Boeing B737-8FE, VH-YID and Airbus A320-232, VH-VGR

Melbourne Airport, Victoria | 10 August 2013

ATSB Transport Safety Report
Aviation Occurrence Investigation
AO-2013-125
Final – 18 August 2016

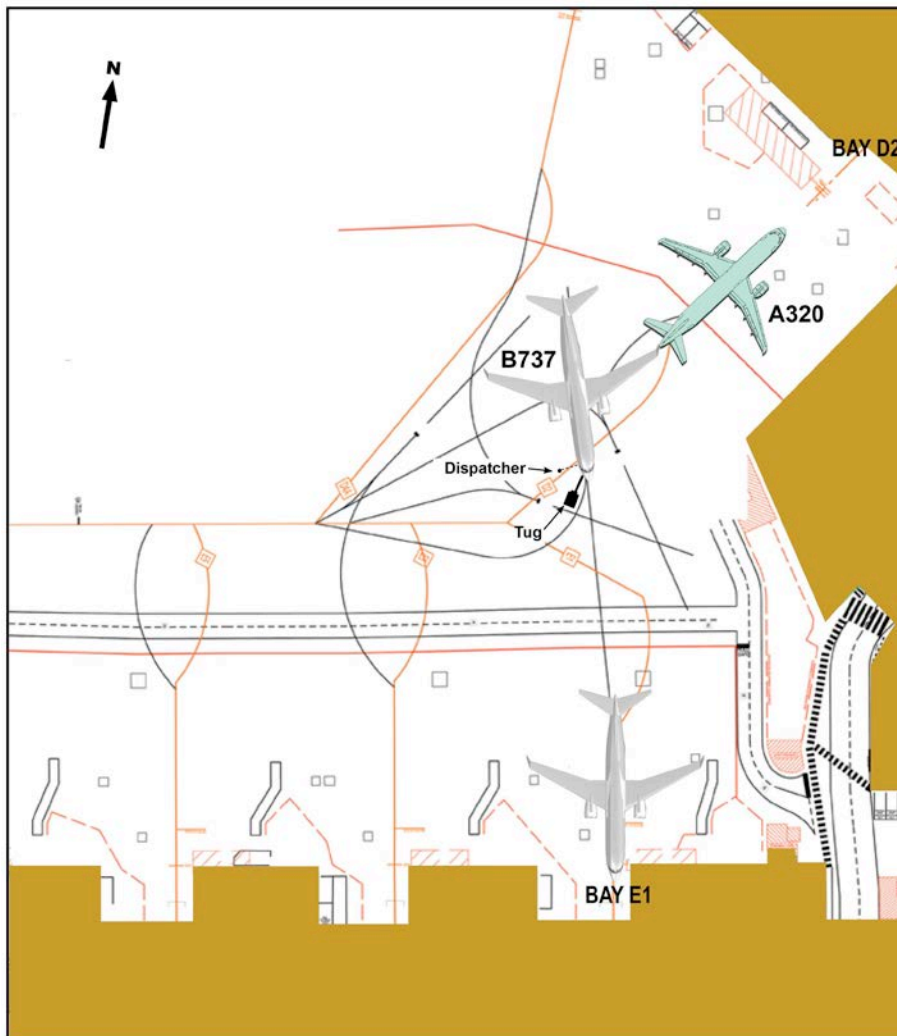
At 0930 Eastern Standard Time¹, VGR entered the apron en route to gate D2, when a Boeing B737-800, registered VH-YID (YID), requested pushback approval from gate E1 (Figure 1). YID was being operated by Virgin Australia Airlines Pty Ltd. on a flight to Maroochydore, Queensland. The controller advised the crew of YID that a Jetstar A320 was entering the apron behind them for bay D2 and that when that traffic was 'on the gate'², pushback from bay E1 was approved.

Figure 1: Position of A320 VGR (in green), holding short of gate D2, and B737 YID (in grey) during pushback from Bay E1 at the time of the collision. The position of the dispatcher and tug for YID are also shown

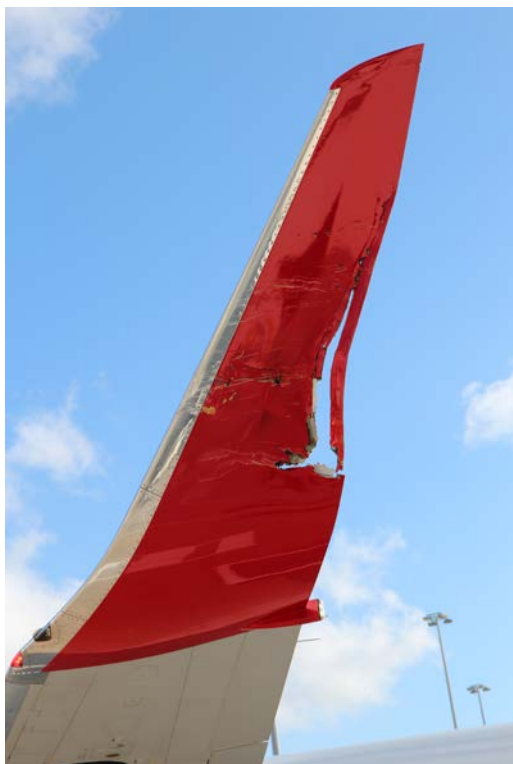
At 0933:03, the left wingtip of YID contacted the tail cone of VGR immediately aft of the operating auxiliary power unit. The tail cone of VGR immediately aft of the auxiliary power unit separated from the aircraft and fell to the ground. The left wingtip of YID was damaged during the collision.

The left wingtip of YID was damaged during the collision (Figure 2).

Figure 2: Damage to the left wingtip of YID

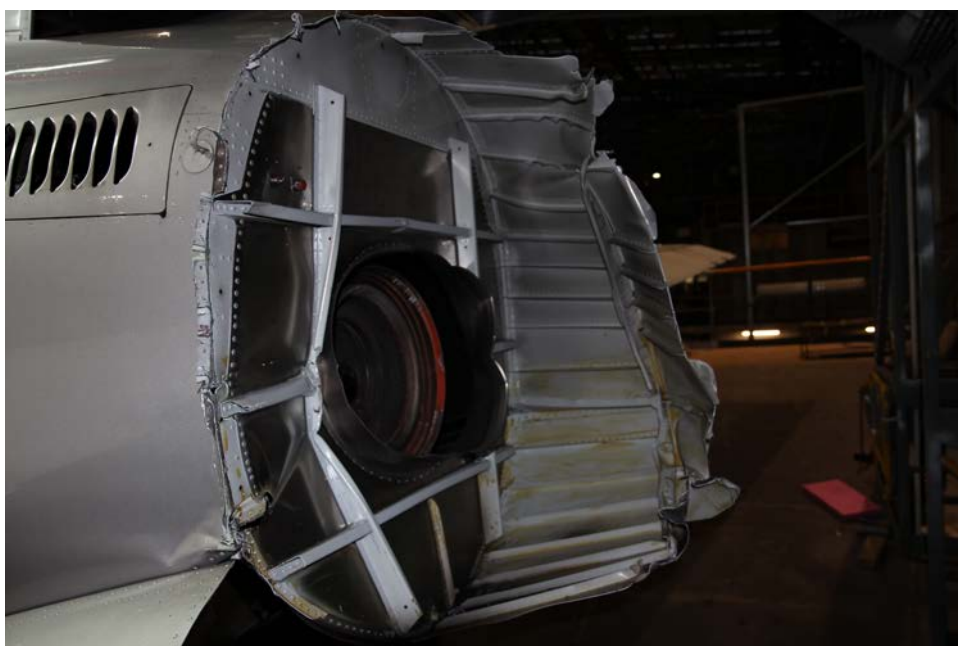
The tail cone of VGR aft of the auxiliary power unit (APU) and the APU exhaust duct separated from the aircraft (Figure 3). The bulkhead aft of the APU was buckled and there was also minor localised damage to the external skin.

Figure 3: Damage to the tail cone of VGR aft of the APU, looking from left to right of the aircraft

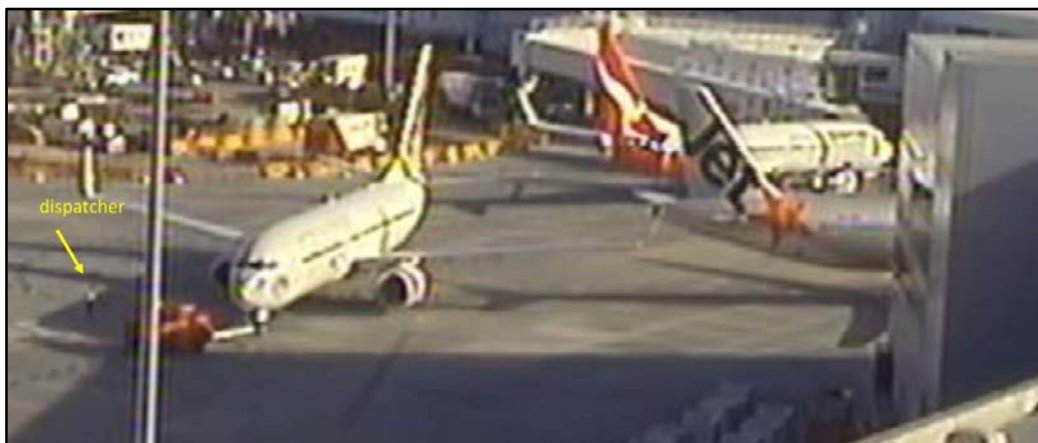
From the dispatcher's position to the front-right of YID on the day of the occurrence, it was not possible to see the left side of the aircraft during the pushback (Figure 4). During the ATSB's observation of operations at Bay E1 the following day, it was similarly noted that the dispatcher's position meant that the dispatcher could not see the left side of the aircraft (Figure 5).

Figure 4: Screenshot of YID during pushback, 5 seconds before the collision with VGR and showing the position of the tug and the dispatcher

After observing that VGR was stationary for a period of time, the dispatcher signalled the pushback driver to commence YID's pushback. From the dispatcher's walking position, it was not possible to see the clearance lines for bay D2 marked on the apron. It was also not possible for the dispatcher to see VGR's fuselage or its position in relation to the gate. From the dispatcher's perspective, YID obscured most of VGR. The operator's standard operating procedures required the dispatcher to have 'clear visibility of the aircraft wingtips or wing walkers and potential obstructions at all times'.

Virgin advised that following this occurrence, they issued a local instruction to ground staff, mandating the use of wing walkers from certain bays at Melbourne Airport, including bay E1.

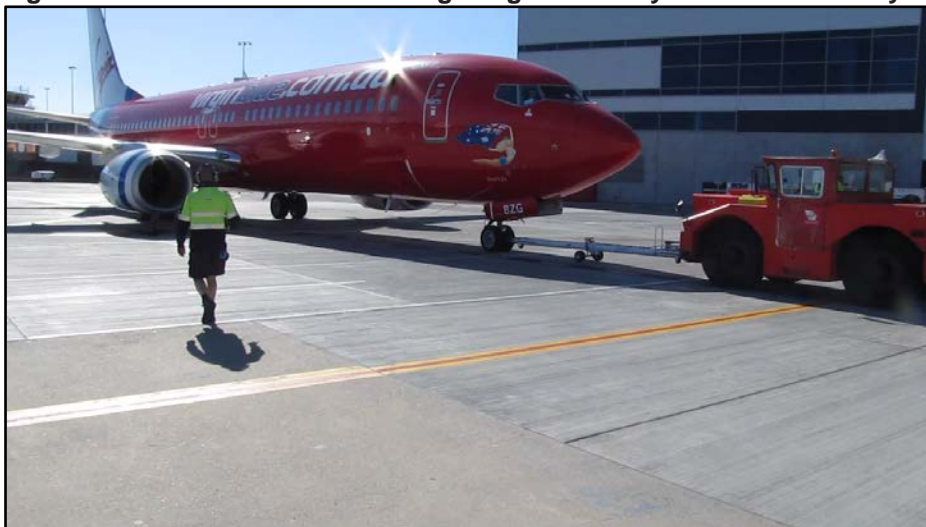
Figure 5: Pushback of the same Virgin flight from bay E1 on the next day
