Civil Aviation Authority  
**SAFETY NOTICE**  
Number: SN–2023/003

## **Risk of Controlled Flight into Terrain during 3D BARO-VNAV and 2D Approaches (Altimeter Setting Procedures)**

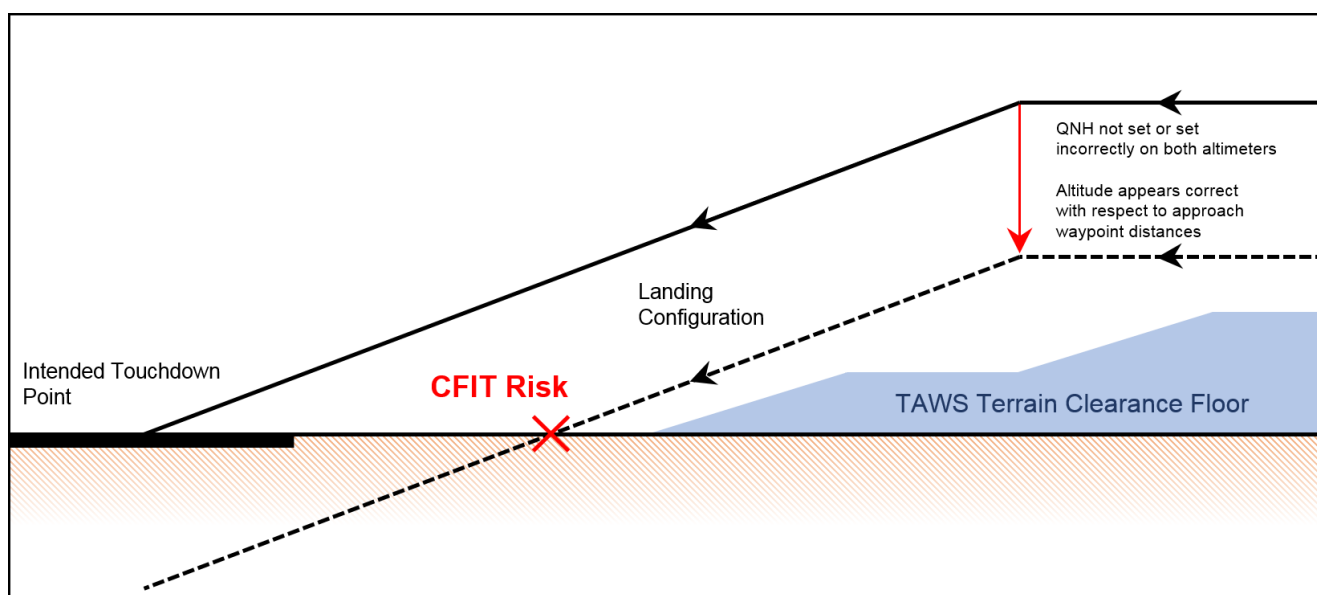
## 2 Diagram

- 1.6 Non-precision approach procedures (NPAs) and approach procedures with vertical guidance (APVs) rely heavily on the accuracy of altitude information provided by the pressure altimeters. If the appropriate pressure setting is set incorrectly on the altimeter sub-scale, the aircraft could be significantly above or below the safe vertical profile as determined by the procedure.
- 1.7 The risk of setting incorrect QNH may increase in a congested R/T environment, during times of high cockpit workload, or when transitioning to an approach via a Standard Terminal Arrival Route (STAR).
- 1.8 It is emphasised that a Terrain Awareness Warning System (TAWS) may not provide a ground proximity alert close to an aerodrome when the aircraft is in the landing configuration.

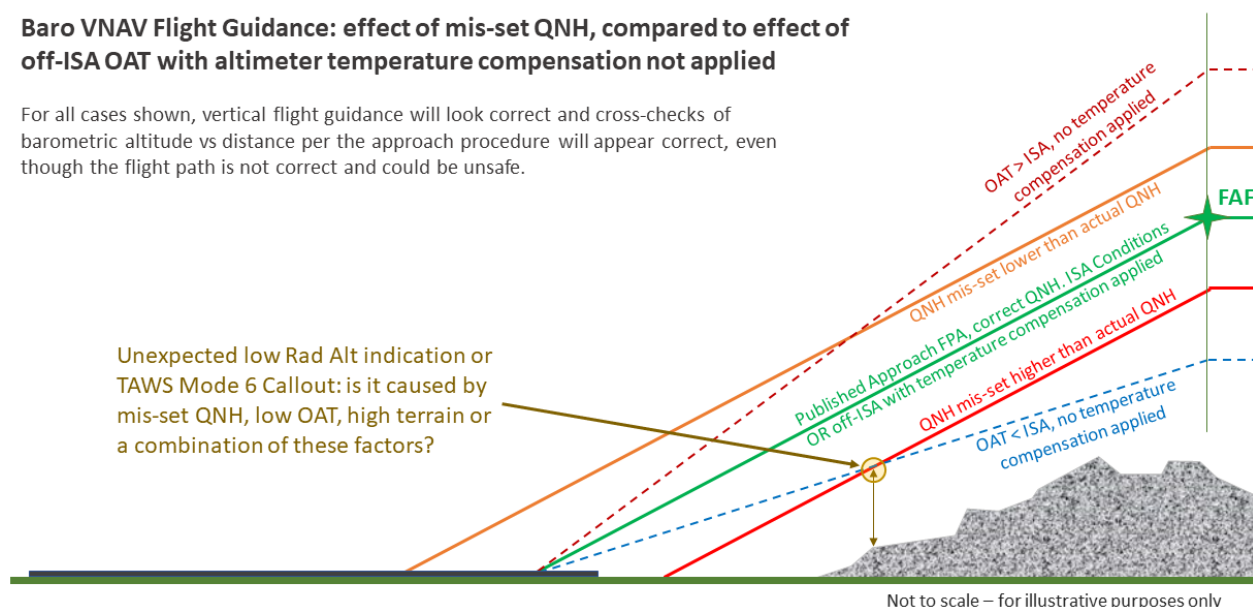
**Baro VNAV Flight Guidance: effect of mis-set QNH, compared to effect of off-ISA OAT with altimeter temperature compensation not applied**

- 3.7 Operations at temperatures differing from ISA will cause Barometric Temperature Error. Even a small difference from ISA temperatures can cause the approach flightpath to be steeper or shallower than published. Whilst this is allowed for in instrument procedure design within charted limits, it changes the relationship between indicated Barometric Altitude and Radio Altitude (RA) during the approach. This might make it more difficult to detect a mis-set QNH or could give the appearance of a mis-set QNH when in fact the flightpath error is caused by non-ISA temperatures. The diagram below refers. For further information see [here](#).

For all cases shown, vertical flight guidance will look correct and cross-checks of barometric altitude vs distance per the approach procedure will appear correct, even though the flight path is not correct and could be unsafe.
