ATSB TRANSPORT SAFETY REPORT Aviation Occurrence Investigation AO-2009-034 Final

Aircraft loading event Sydney Airport, NSW 4 July 2009 VH-EBB Airbus A330-202

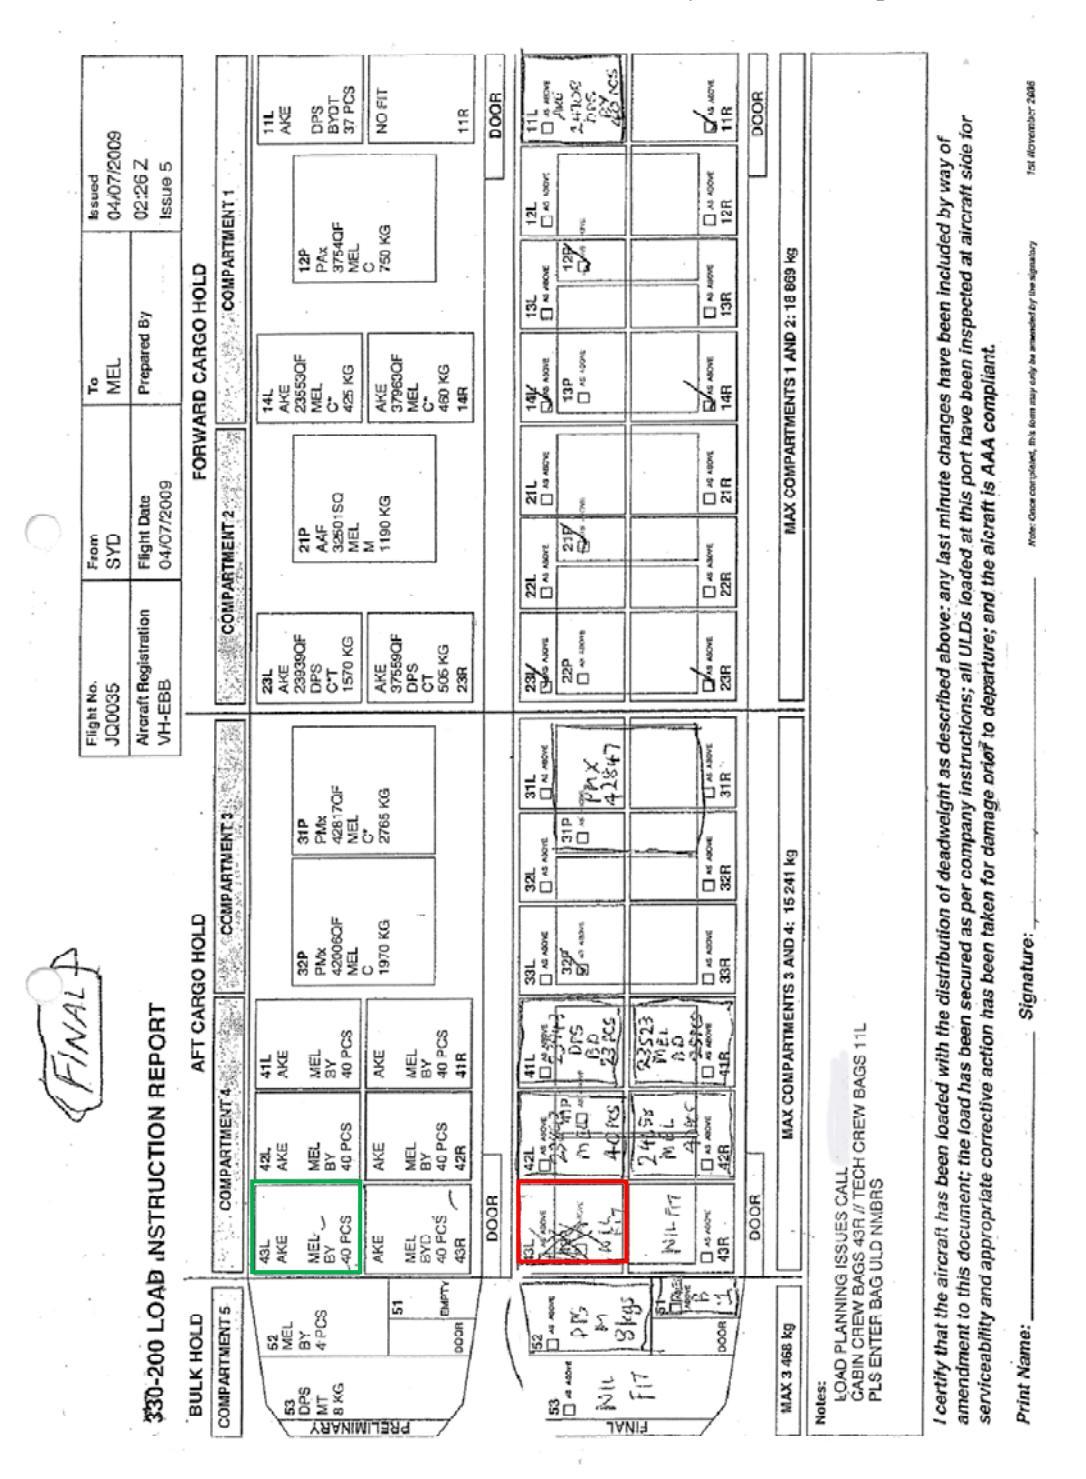
# **APPENDIX A: LOAD INSTRUCTION REPORT**

The following copy of the load instruction report has been digitally altered to remove information that could identify the aircraft operator or personnel. In the preliminary load plan, position 43L (outlined in green) was originally assigned to baggage, but was not required and was changed to a No-Fit (outlined in red) in the final load distribution. ULD AKE 23532 was actually loaded in that position.
