# GHOST

## GROUND HANDLING OPERATIONS SAFETY TEAM

### ULD Pull Straps

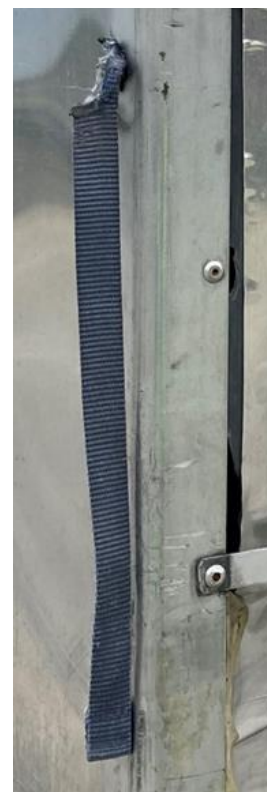
1. The first is when some kind of non-manual force is applied to the hand strap, perhaps through the use of an additional piece of rope or other mechanism that is used to connect the container to a mechanical force such as a tractor. This is the sort of process that can occur when ground staff try to pull a loaded container across a concrete floor. Such an activity will far exceed the capacity of human manpower and will require that a force greatly in excess of 1000lb be exerted on the strap. The best outcome in such a case is that the strap or its attachment simply breaks but quite often what may occur is that they do not fail completely but are simply damaged, setting the scene for failure at a future time and at a lower load.

2. The second failing is where straps are simply damaged through normal operational wear and tear, banging up against other containers or other airport infrastructure. In such cases the webbing and/or the attachment hardware can be degraded to the point that their capacity is far below the 1000lb requirement.

The probability of a serious fall should one of these straps fail during use, is extremely high. Over the years, there have been more than one fatal accident involving ground staff falling backwards off high loaders, when a pull strap fails suddenly during use.

- Airlines and other owners of containers should implement a program of strap replacement every 2 years. Some airlines already do this, using straps of different colour to indicate the year of installation.
- Repair providers should be instructed to specifically check straps and attaching points on each shop visit. On average, an AKE container visits the repair shop 1.5 times a year, so there is ample opportunity to do so.
- All personnel with related responsibilities should be trained to never start building up a container when the straps are not in good condition. Staff in the cargo shed may not be at risk from a weak strap, but those on the ULD loader or in the aircraft hold, most certainly are.

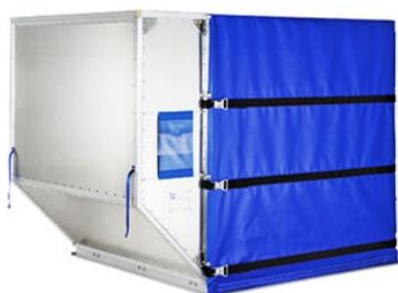
As previously mentioned, all components of a ULD must meet specific airworthiness criteria, defined in the Component Maintenance Manual (CMM) and inspections must identify and remove unserviceable units for repair. As it would not be practical for ground staff to carry a copy of the CMM, each ULD has an Operational Damage Limits Notice (ODLN).

This decal provides detailed information on what damage is acceptable. If the damage is greater than the limits provided, the unit must not be used. The ODLN which has for some years now been fitted to all new ULDs, clearly states that there should be “no damaged worn out or missing pull straps”.

Others	Webbing	WP	No damaged, worn-out or missing pull-straps
--------	---------	----	---

As it is a requirement that every container is to be inspected before use and the condition of the pull strap is not difficult to determine, there should be absolutely no excuse for any ULD to be in operation with a strap that is not 100% serviceable.

Once the first bag or piece of cargo has been loaded into a ULD, there is a strong likelihood it will travel, even if a defective strap is found afterwards. Because of the potential consequence, the absolute importance of inspecting not only the pull straps but the entire container before even the first step of the loading process takes place, can never be underestimated. The bag room or cargo shed will be the best opportunity to inspect, in terms of conditions (lighting etc.) and time available.
