Steep Climb and Uncontrolled Descent During Takeoff  
National Air Cargo, Inc., dba National Airlines  
Boeing 747 400 BCF, N949CA  
Bagram, Afghanistan  
April 29, 2013

NTSB/AAR-15/01  
PB2015-104951

# Aircraft Accident Report

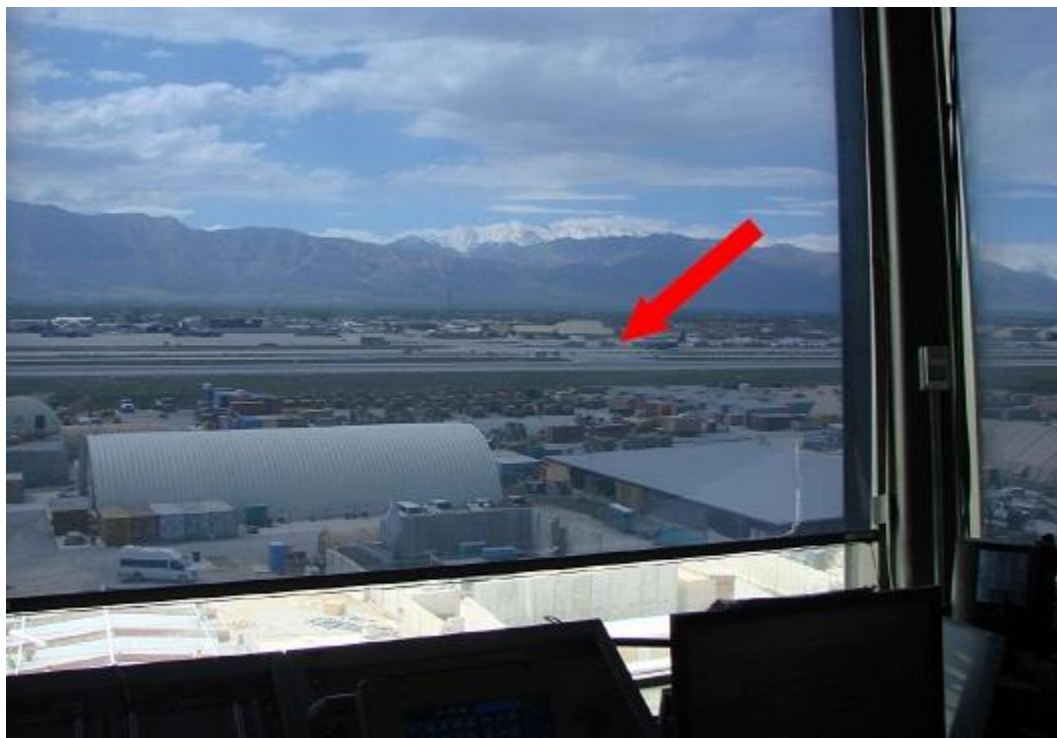
**Figure 4.** Photograph showing the view from the Bagram control tower looking west toward runway 3.

**Note:** The accident airplane departed to the north (from left to right). The red arrow indicates the location of the taxiway C intersection, near where the airplane reportedly rotated.

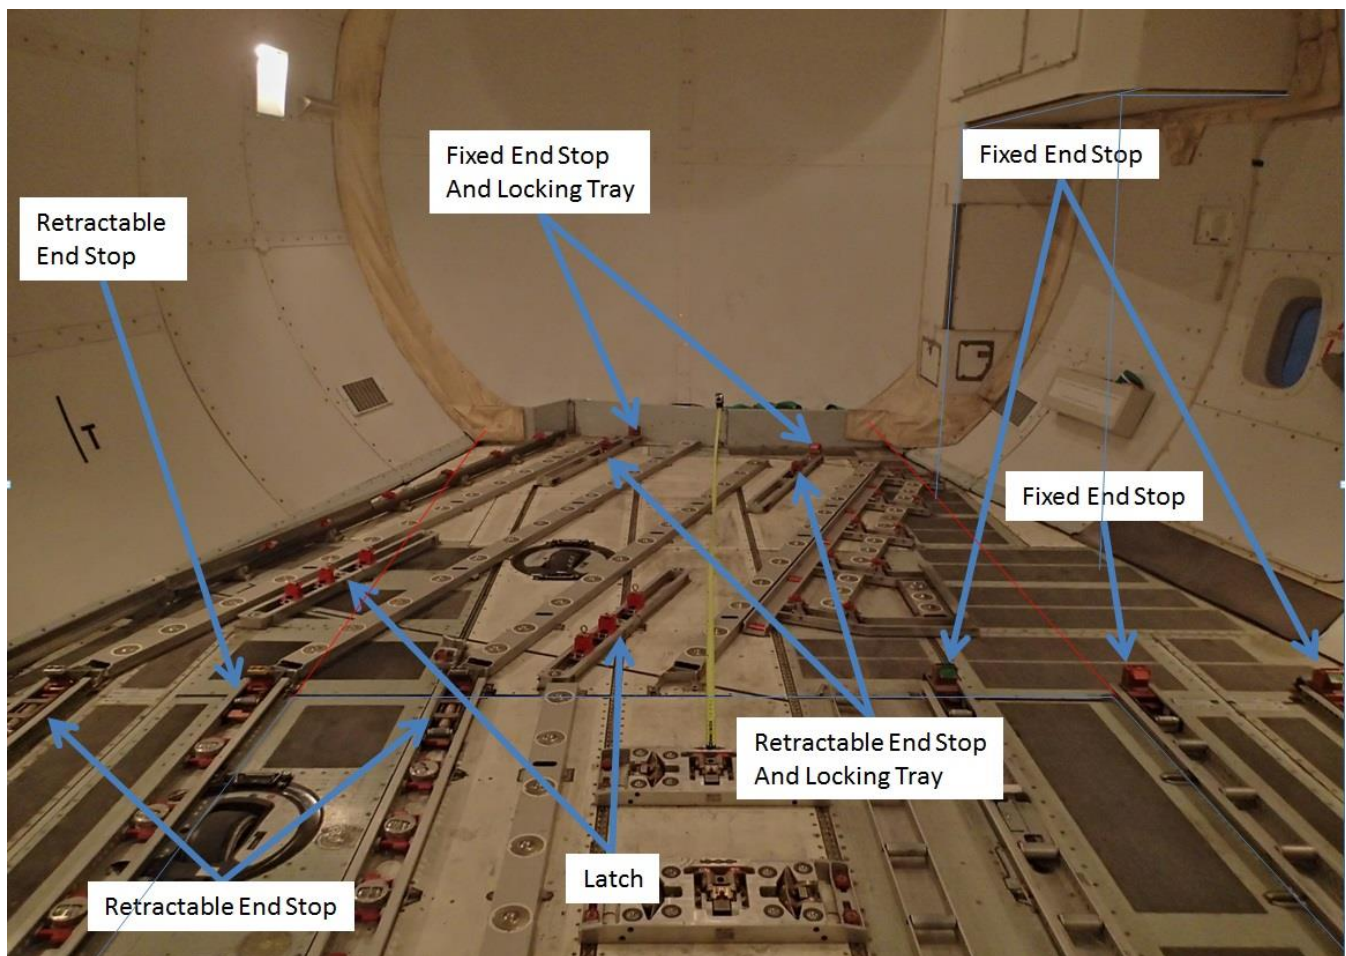
**Figure 6.** Photograph of a section of main deck flooring in the back of an exemplar airplane, looking aft.

**Note:** The locations of various fixed and retractable end stops and latches of the cargo handling system are noted with blue arrows. Note: The CVR and FDR shelf is in the upper right corner of the picture.

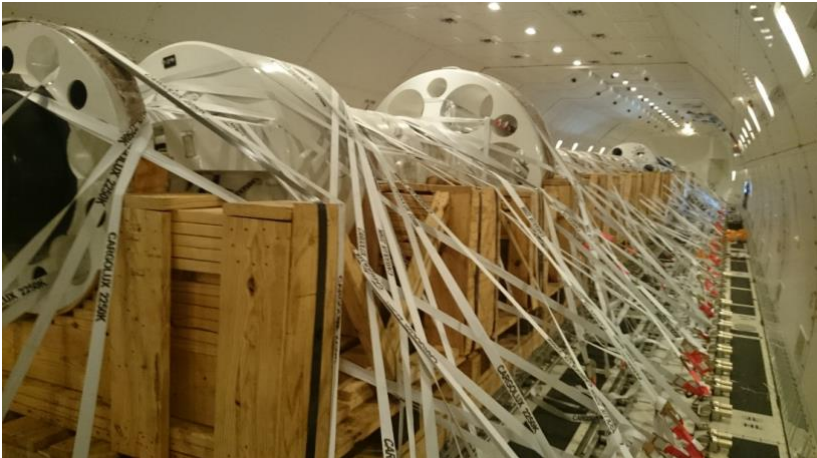
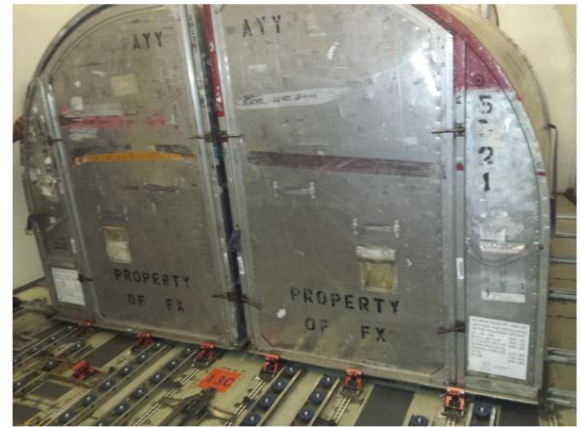
The accident flight's MRAP vehicle cargo (which was secured to G-code pallets and centerline-loaded) was considered a heavy vehicle special cargo load because its size precluded use of ULD containers capable of locking into the airplane's cargo handling system.<sup>13</sup> Such cargo instead required special handling or restraint devices such as approved tie-down straps secured to approved locations in the main cargo deck floor (see figure 7).

**Figure 7.** Photographs of other operators' airplanes showing an exemplar special cargo load (left) secured to floor structures using straps and an exemplar ULD (right) secured by integrated locking devices.

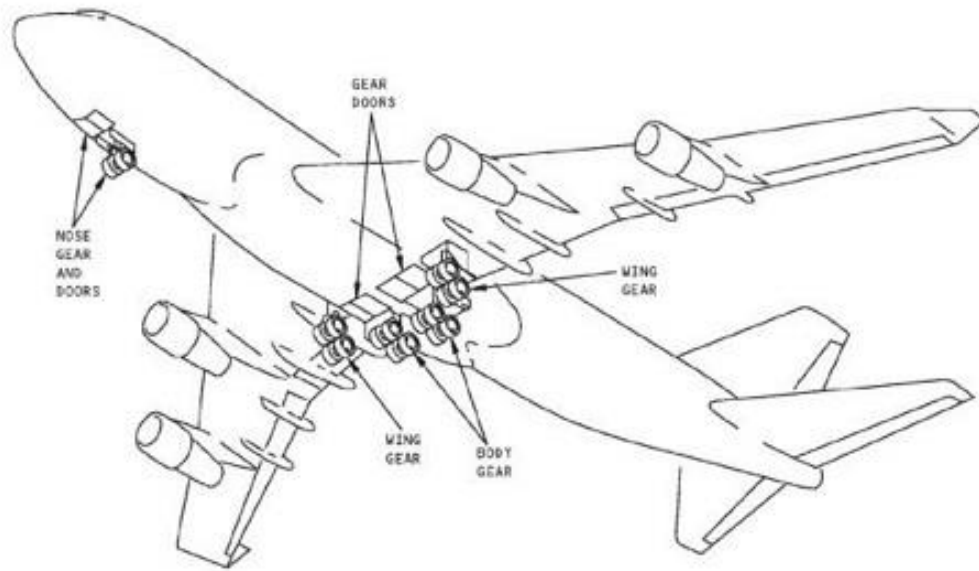
**Figure 14.** Diagram showing the respective locations of the nose, wing, and body landing gear on a Boeing 747-400 BCF.

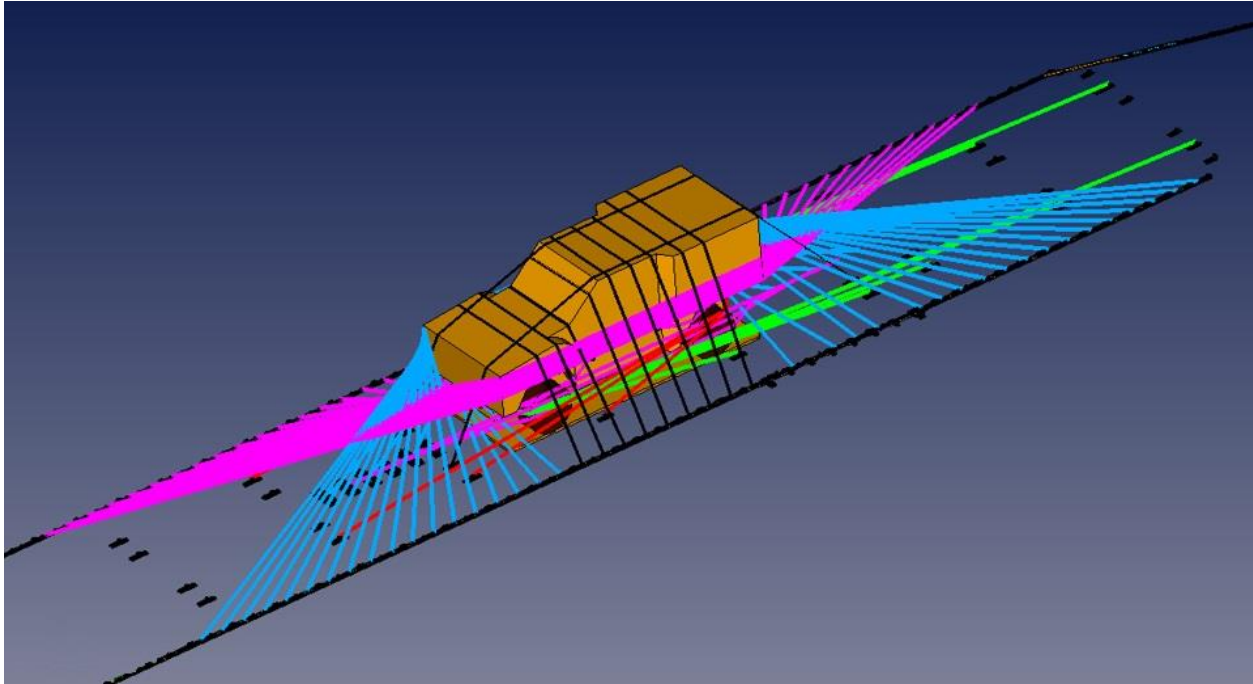
After the accident, both Boeing and Telair performed studies to determine if it was possible to transport centerline-loaded MRAP vehicles on pallets in compliance with the TRC requirements. In its study, Boeing determined that one centerline-loaded M-ATV on a G-code floating pallet could be transported in accordance with the guidelines in the Boeing and Telair weight and balance manuals. The study determined that, to meet the TRC requirement, the M-ATV must be positioned no farther forward than BS 1281, secured by 60 5,000-lb-rated tie-down straps, and be positioned aft of a specified quantity of frangible cargo in ULDs (see figure 16).

**Figure 16.** This line drawing provides an exemplar configuration showing how about 60 straps could secure a M-ATV to approved floor structures.
