# **AIRCRAFT ACCIDENT REPORT 1/2015**

**Report on the accident to  
Airbus A319-131, G-EUOE  
London Heathrow Airport  
24 May 2013**

**Air Accidents Investigation Branch**

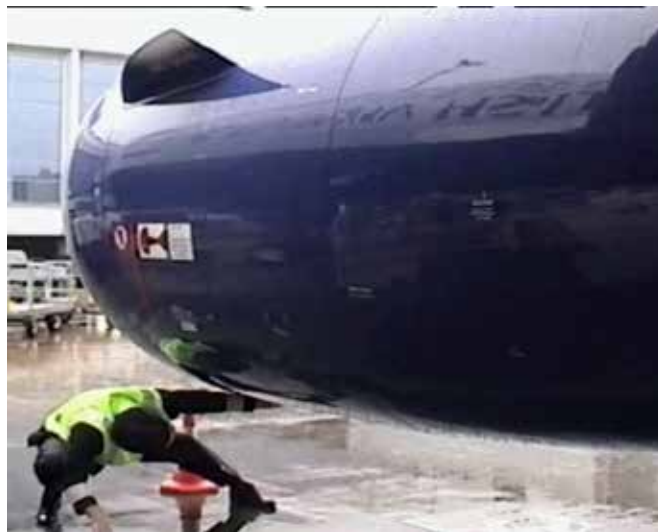
**Figure 23**

*'Start with the left hand side. Remember you're always looking for skin damage, the access doors for the magnetic chip detector (IAE engines only) and the oil filler are here. Now check the fan cowl doors, it's the latches that need special attention here, [Figure 23]. They're weighted and painted red [Figure 24] so they'll hang down and should be easily seen if they're not properly closed. Make sure that you see that they are all flush. The cowls should be faired with*

Pilot inspection of latch positions

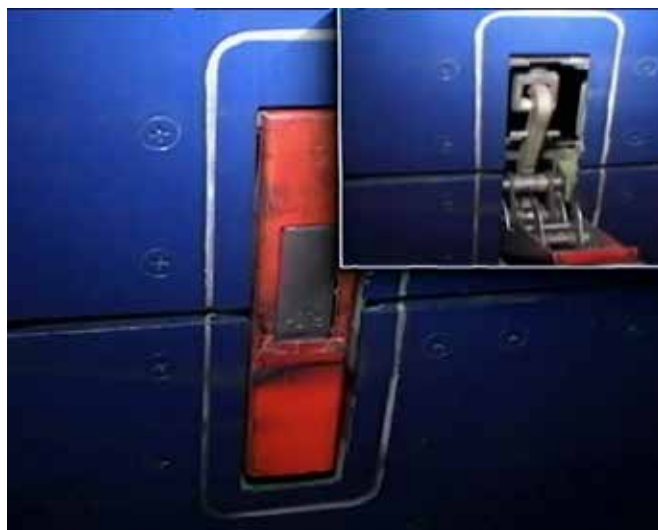
**Figure 24**

Latch colour and position from operator's video

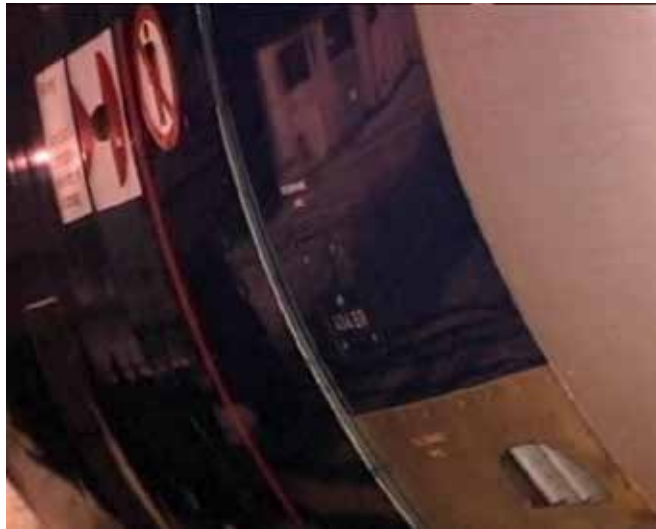
**Figure 25**  
Door “flush” from video

*the engine intake like this [Figure 25]...an embodied structure mod just forward of the cowl door will show this gap if the doors are not properly secured....'*

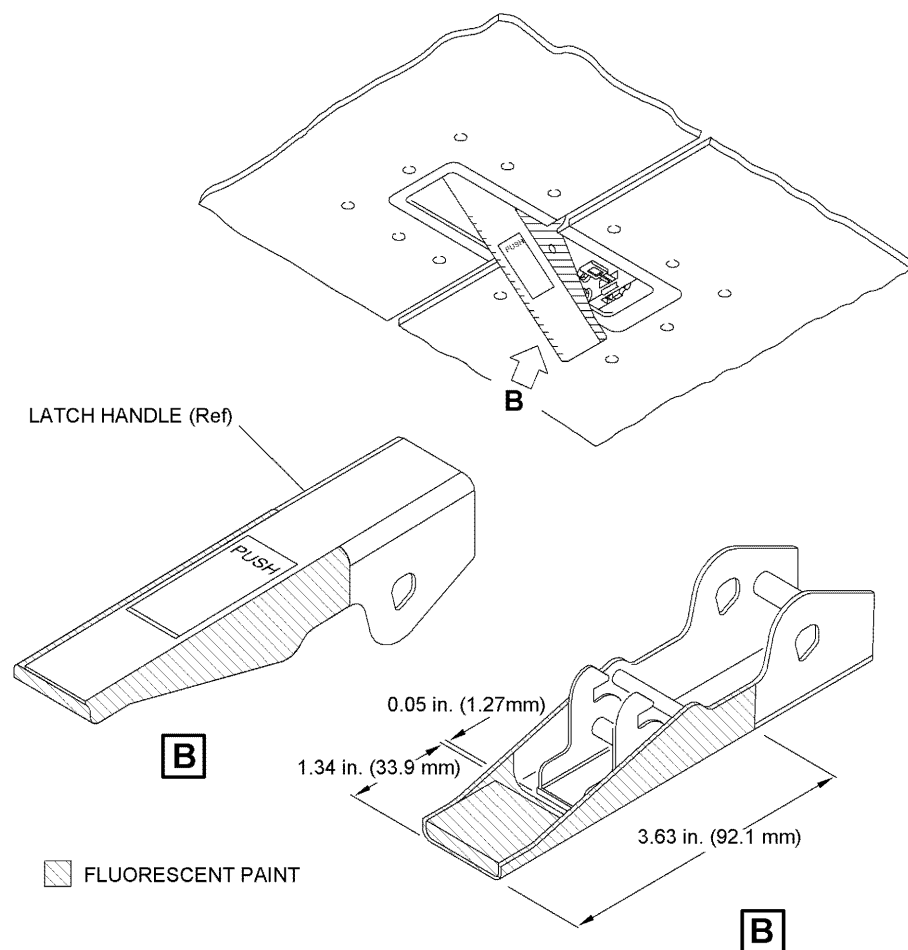
**Figure 28**

The area of the latch to repaint identified above was different from the painted area as defined in the engine manufacturer's August 2008 Revision 1 of Service Bulletin SB V2500-NAC-71-0227, which included the following diagram (Figure 28):

Latch painted area as defined by SB V2500-NAC-71-0227 Revision 1
