# AIR ACCIDENT INVESTIGATION SECTOR

## SERIOUS INCIDENT INVESTIGATION REPORT

### Pushback Collision

Airbus A330-243 [A6-EYN]

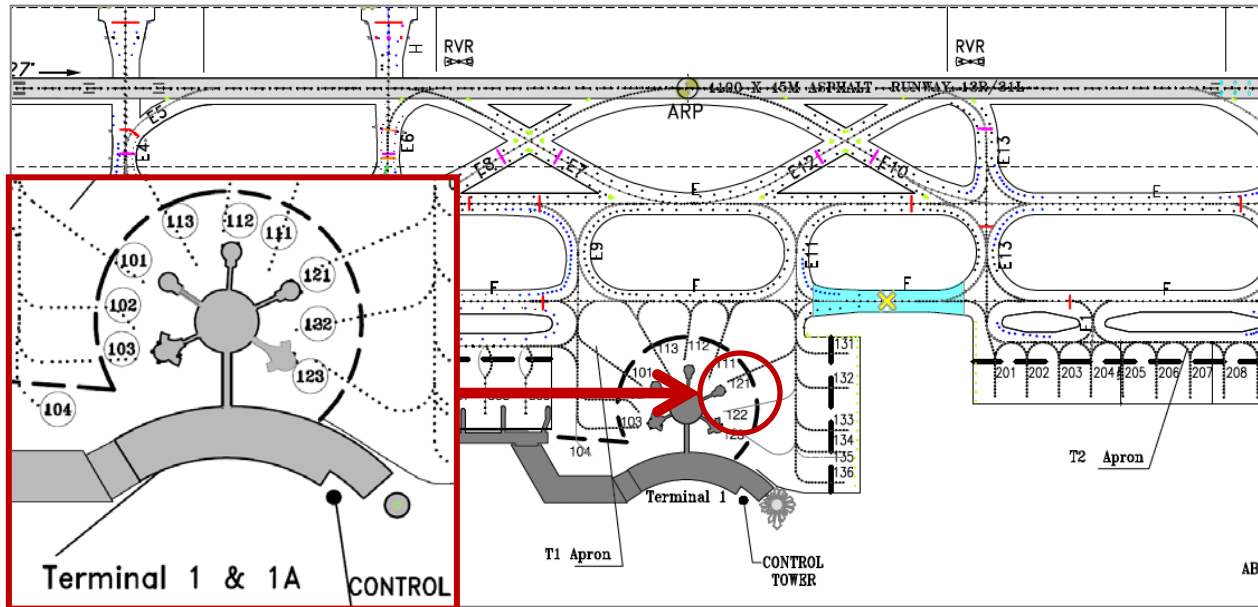
Figure 1 AUH AIP with insert of Terminal 1

The two aircraft were positioned at Terminal 1, at parking stands 121 and 122

On May 5<sup>th</sup> 2012 at 22:22 UTC, during push back from parking position 122 at Abu Dhabi International Airport [AUH], the right winglet of an Airbus A330 [A6-EYN], contacted the left wing tip of a Boeing 777 [A6-ETD] parked in the adjacent parking position 121 to the righthand of the Airbus

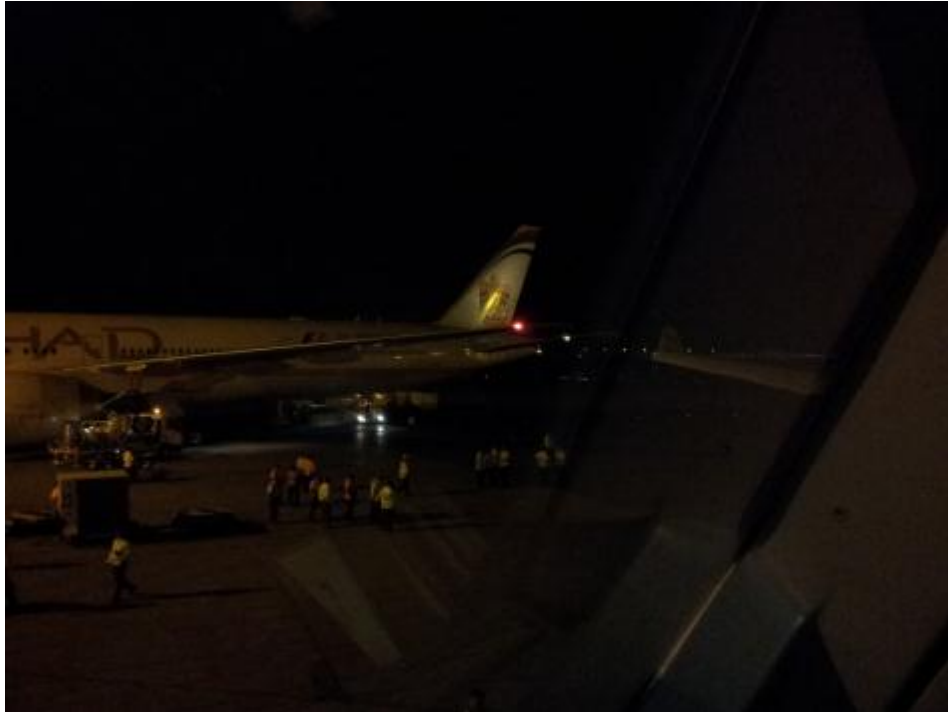
Photo 1 View from F.O. Position

Pilot's view from the First Officer position when seated, head up in the F.O. seat, with the seat restraints attached [seat belts] is limited to a cone range of 135° from the aircraft's longitudinal axis.

From 135°-180° from the static position is a wingtip blind spot. The visual field of the human eye spans approximately 120 degrees of arc from the static position, most of the arc range is peripheral vision only.

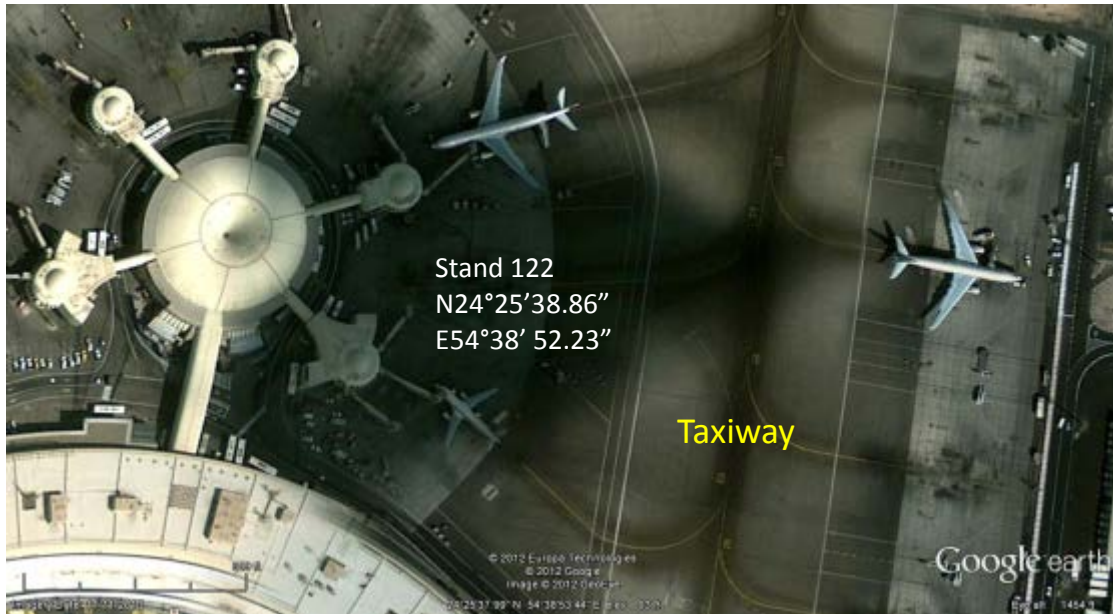
Figure 10: AUH T1 Stand 122

Overview of the parking stand position and location.

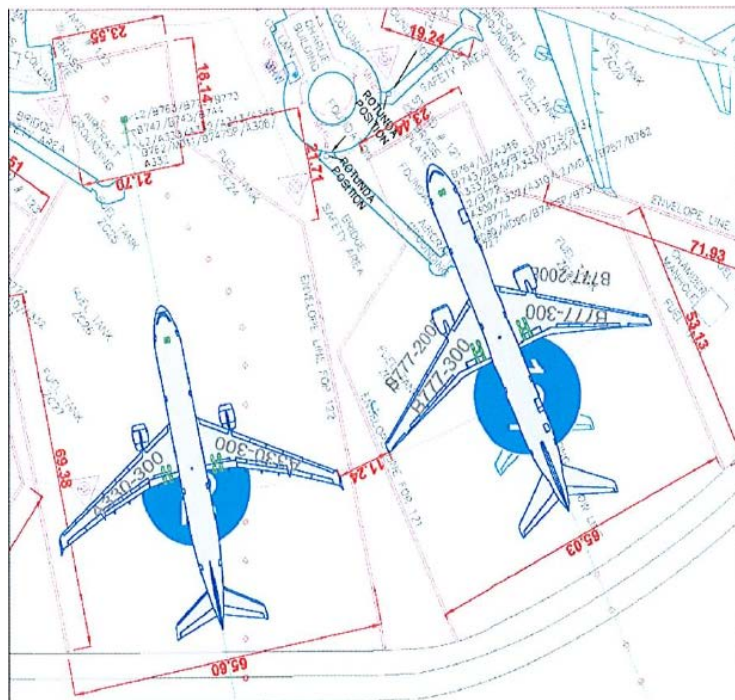
Figure 11 Stand 121/122 CAD Simulation

An airport planner computer model of the aircraft positions and wingtip clearance distances
