**SERIOUS INCIDENT**

| <b>Aircraft Type and Registration:</b> | ATR 72-211, G-CLNK | |
| <b>Location:</b> | Guernsey Airport | |
| <b>Nature of Damage:</b> | Damage to cargo rail, rollers and locks. | |

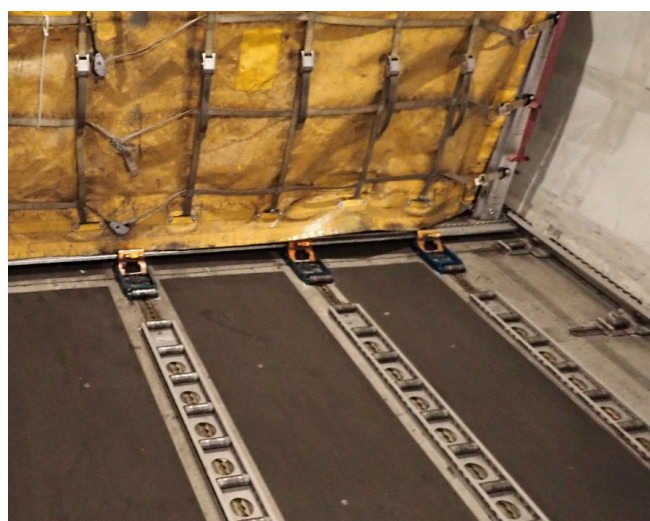
**Figure 2**

ULD rails and locking mechanisms

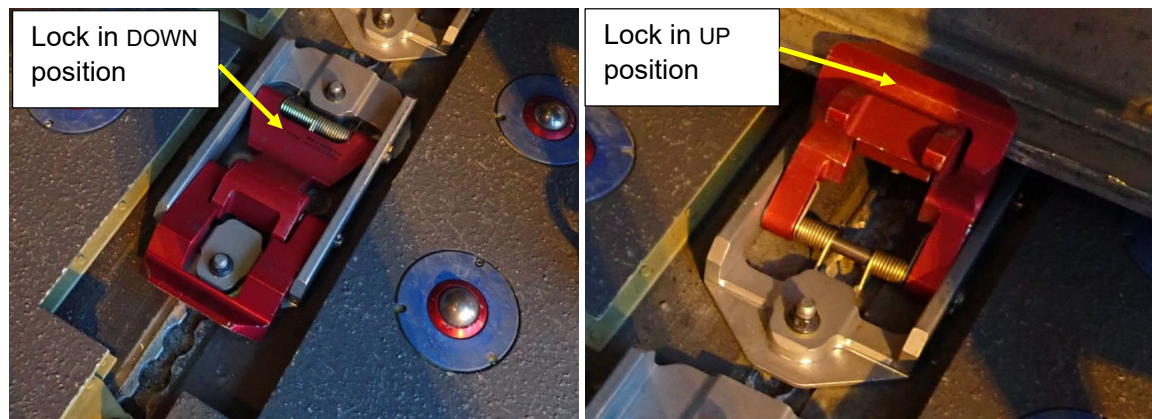
**Figure 3**  
ULD lock positions

Locks that secure the ULDs in position are located between the bays and like the rails are attached to the fittings on the floor. The position of each bay is indicated by green markers on the cargo bay walls. The locks can be positioned DOWN to allow ULDs to slide over them and UP to lock ULDs in position (Figure 3).
