Aircraft Maintenance Incident Analysis

CAP 1367

Published by the Civil Aviation Authority, 2015

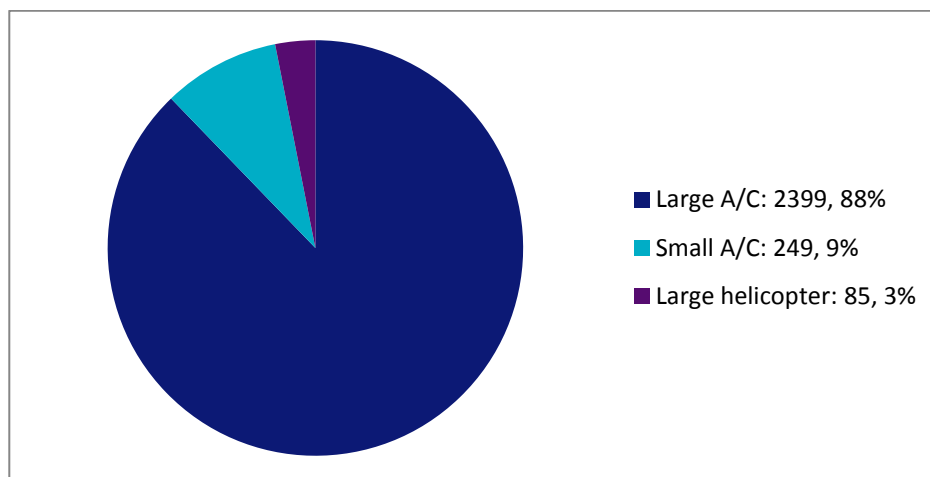
Figure 1: Overall breakdown of analysis

- 4.13 The resulting data set for the period covered 2733 events and these were analysed in accordance with the above taxonomy. The breakdown by aircraft category is shown in figure 1.

- 4.14 It can be seen that with 88% the largest proportion of events relate to large aeroplanes. This is not surprising as the 'mandatory' elements of the MOR scheme apply to these aircraft rather than the smaller, more General Aviation focused sectors.
- 4.15 Large helicopters, the bulk of which are operated in support of the North Sea oil industry or for search and rescue purposes made up only 3% of the data set. The total UK fleet of such helicopters is small in relation to the equivalent fixed wing fleet. Despite this, the relatively low level of reported events is surprising given the knowledge that there is a greater intensity of maintenance activities on such aircraft.

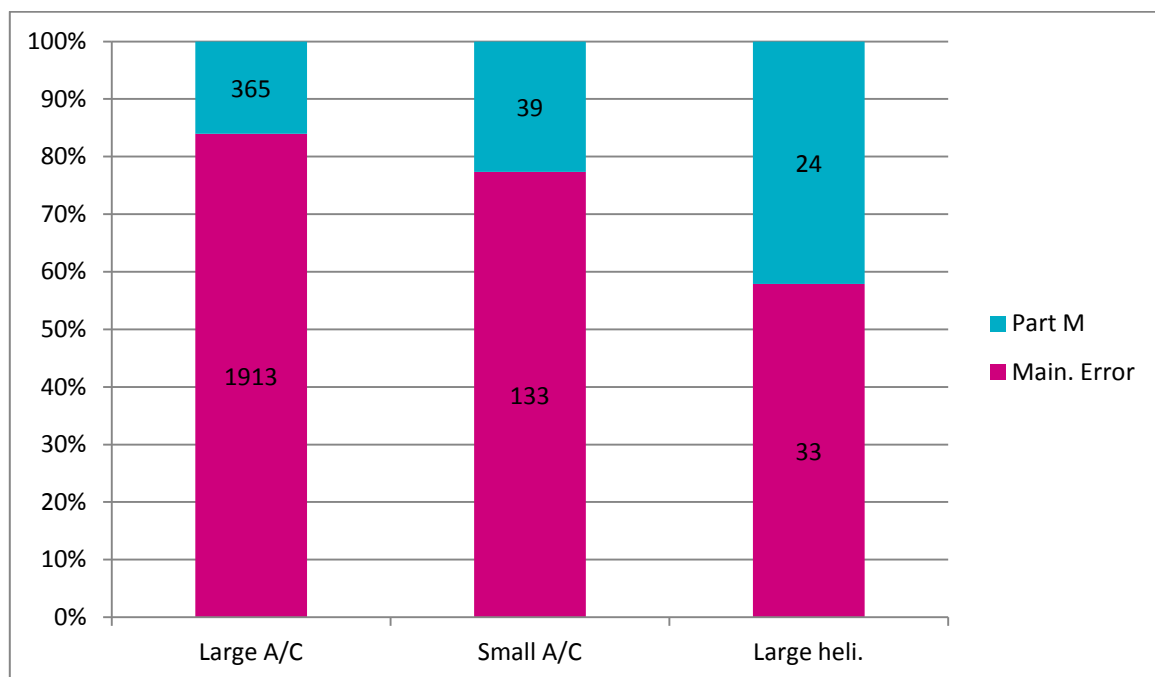
Figure 2: Breakdown of events, Part M vs maintenance error

- 4.17 The data set broke down into events related to Part M – maintenance management issues and maintenance error events. The analysis is shown in figure 2. It can be seen that, whilst there were small variations in the balance between the two classes of events the proportion was relatively consistent across the aircraft categories. What is significant is the slightly larger proportion of Part M – maintenance management issues reported for large helicopters. Since these relate mainly to maintenance overruns on life limited components this is not surprising given the much larger number of life controls and overhaul periods prescribed for such aircraft. This can also be linked to errors introduced during the migration of data to new computer systems.

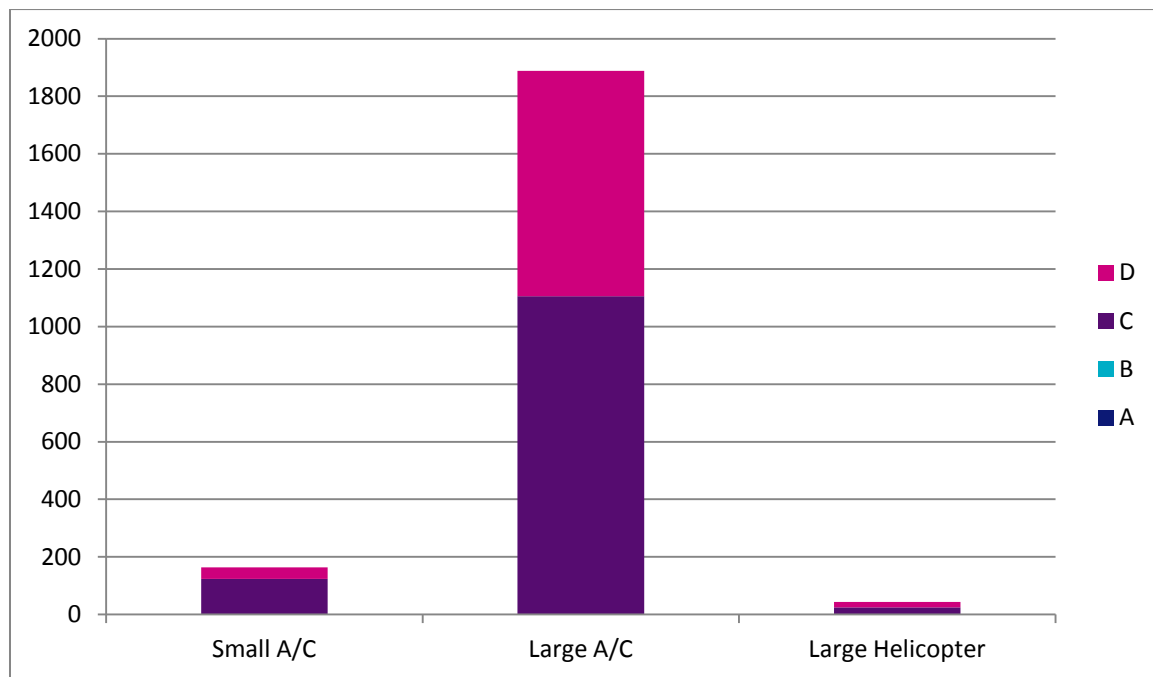
Figure 3: Maintenance error-risk distribution, all categories 2005-2011

- 4.18 The occurrences of maintenance error can be further analysed at a high level to show a correlation with the CAA classification of the MOR when received by the CAA. This is shown in Figure 3. The most significant MORs, typically involving accidents, are classified as category A with the lesser reports, usually closed on receipt by the CAA as category D.

- 4.19 It can be seen from this that the bulk of the maintenance related MORs are classified by the CAA as Category C. That does not mean they are not significant and many require CAA investigation of the circumstances surrounding the MOR.
- 4.20 There are two reasons for this. The first is to ensure that the operator or maintenance organisation is reacting properly to the occurrence. This will initially be to rectify the problem in order to return the aircraft to service. The secondary function will be to further analyse the event and determine the root cause in order to put in place corrective measures to prevent a reoccurrence.
- 4.21 By comparison, the further high level analysis of the Part M related errors yields the results shown in figure 4.

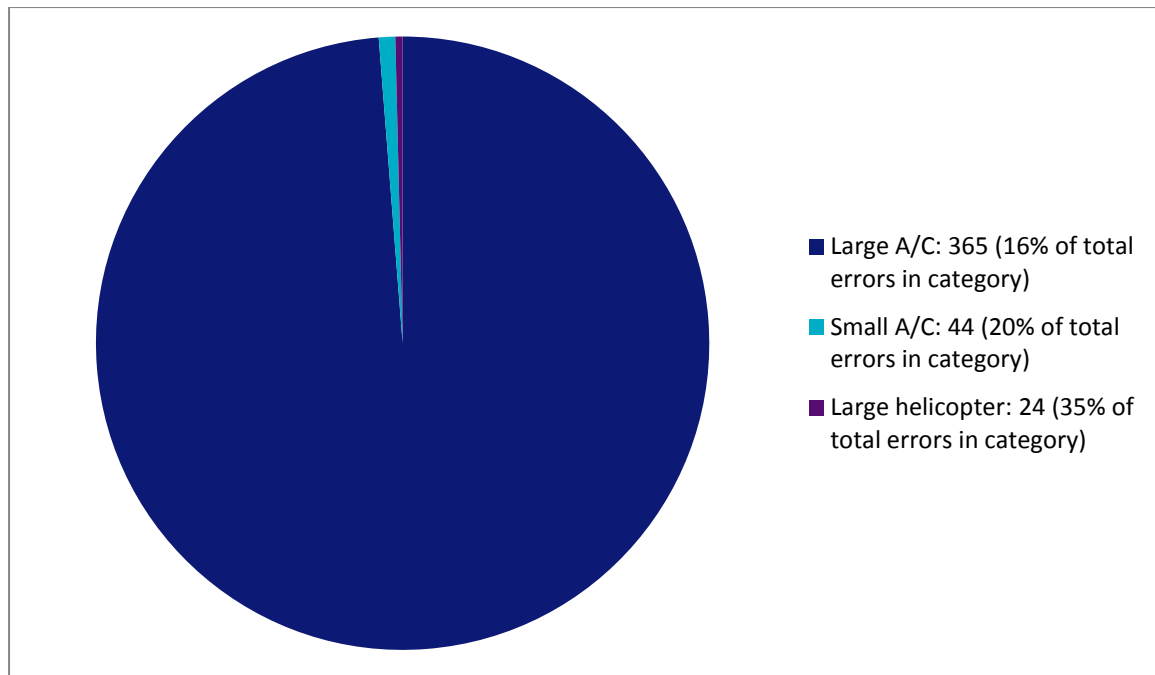
Figure 4: Distributions of Part M errors reported 2005-2011

- 4.22 Figure 4 shows that there were 433 reported Part M errors. Of these 303 (70%) related to overrun of overhaul lives, airworthiness directives or maintenance inspections called out as part of the Approved Maintenance Programme, of these approximately 40 reports indicated a non-compliance with an Airworthiness Directive. This is often a reflection of poor maintenance planning where due maintenance is not carried out and not re-planned within the appropriate timescale. In some instances the overrun is linked to a data entry issues. A more detailed review of the contributing causes also suggests that there may be some evidence of a conflict between the accomplishment of the work and commercial pressures to continue operating the aircraft.

- 4.23 A further 130 (30%) reports highlight errors in setting up the data in the first place. These errors are often simple transcription errors between the hard copy paperwork following maintenance and the electronic database used to manage the planning function. For example, inputting component life data following their fitment to the aircraft and forecasting next due tasks. Such errors can lead to an overrun if not detected by some other intermediate means, such as unscheduled component replacement or a detailed audit of the database.

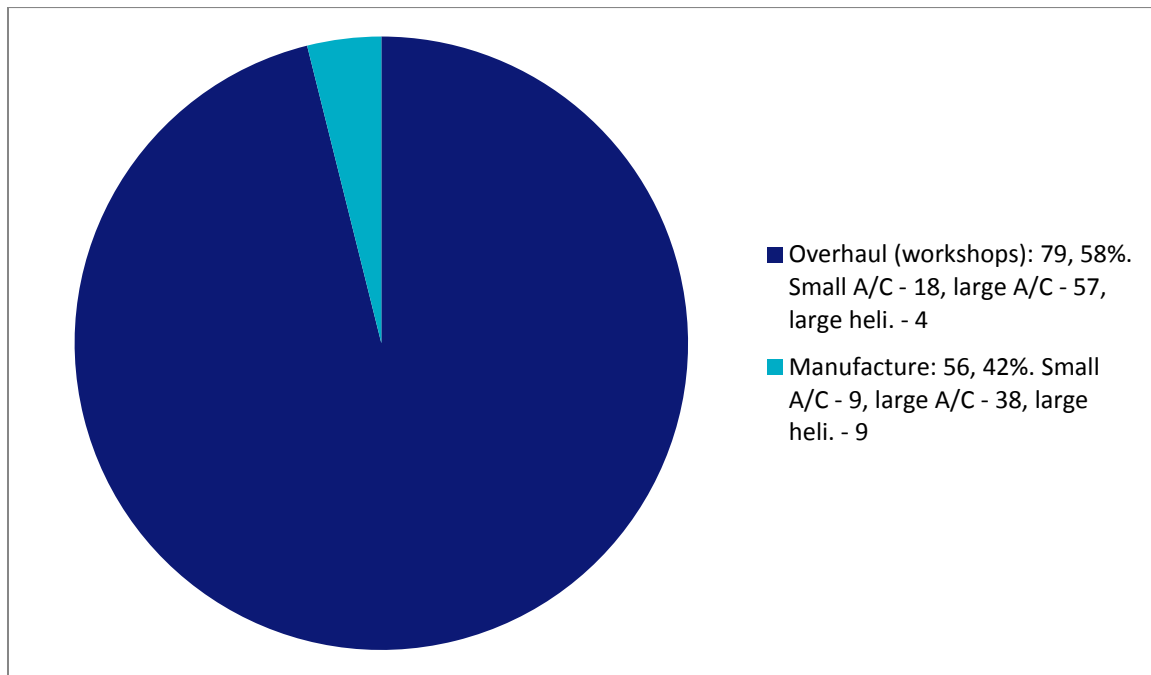
Figure 5: Distribution of events considered as manufacturer or overhaul errors, data 2005-2011

- 4.25 These are events which, following analysis of the underlying circumstances, are issues that have their roots in an error at the time of manufacture or which are attributed to an overhaul agency and not therefore a direct error within the operator's system. Both of these failures can involve human error but the fact that they occurred in third party organisations clouds the available data and the ability to mine the data and find the underlying root causes.

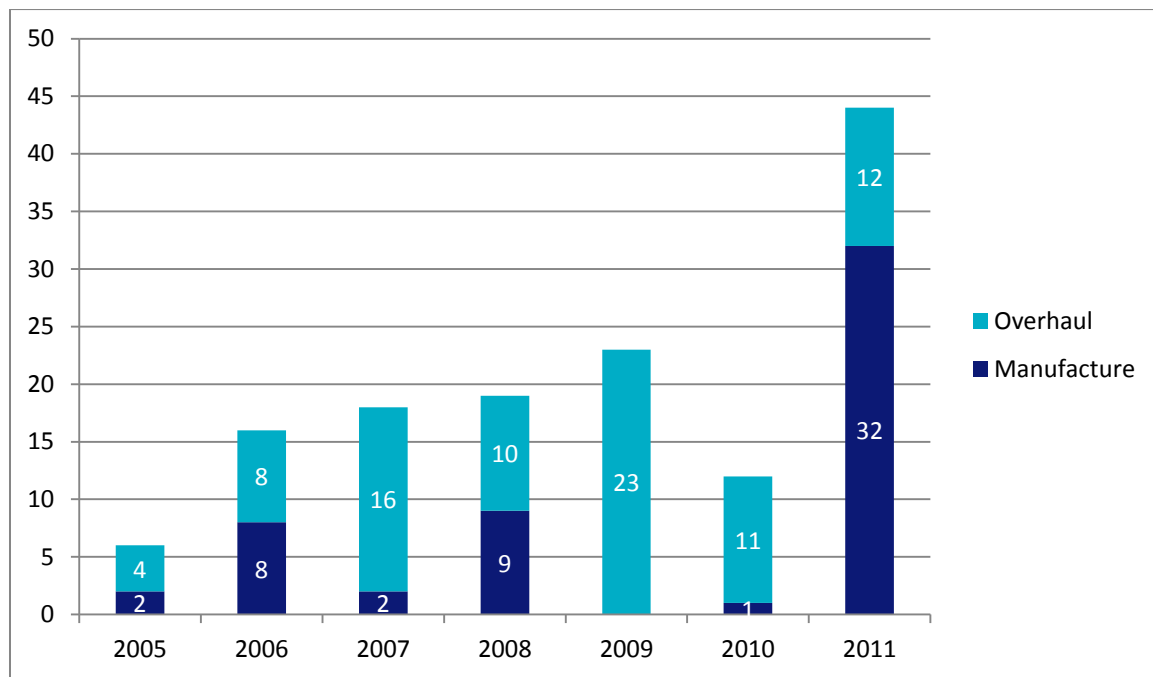
Figure 6: Error reports attributable to manufacture or overhaul

- 4.28 The manufacturing and overhaul events together constitute 135 events or approximately 4.9% of the total reported MORs. It is interesting to note that not all of the manufacture events are down to a physical error. Many are due to technical authorship errors in the approved data. The distribution over the period from 2005 – 2011 is shown in figure 6.

- 4.29 It is clear that the inclusion of manufacture or production events in the data suggests these activities should indeed also be considered in the context of the application of an error management system. The potential for an incident or accident is equally as significant as for maintenance activities.

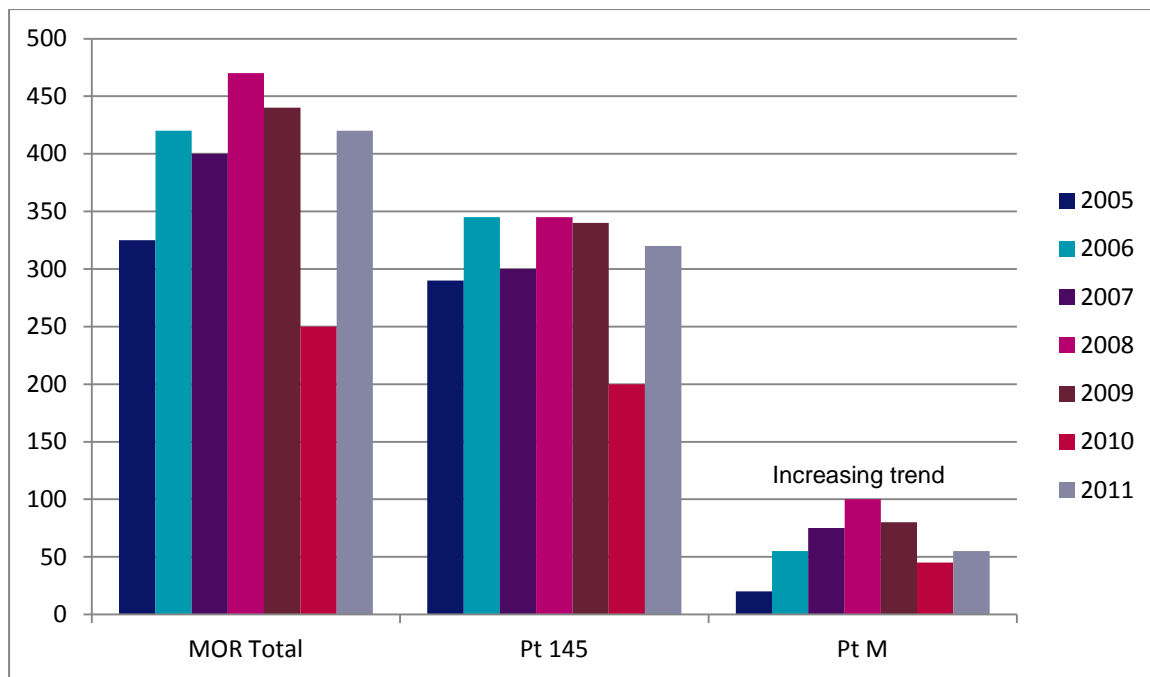
Figure 7: Maintenance MOR reporting levels 2005-2011

- 4.31 The number of maintenance related MORs received each year is shown in figure 7. It can be seen that the overall reporting levels are fairly consistent.

- 4.32 No explanation can be made for the apparent decrease in reporting in 2010 although it is recognised that the overall level of industry activity, in terms of aircraft operation had decreased as a result of the global financial crisis. The increase in reports for 2011 perhaps reflects increasing ‘commercial’ pressure and the resulting impact of manpower reductions increasing the risk of an error being made.

- 4.33 The increasing trend noted in Part M reflects the introduction of the Part M requirements in 2005 and the learning curve associated with the transition to the new structure. Further detail on the typical error causes is given in later Chapters.

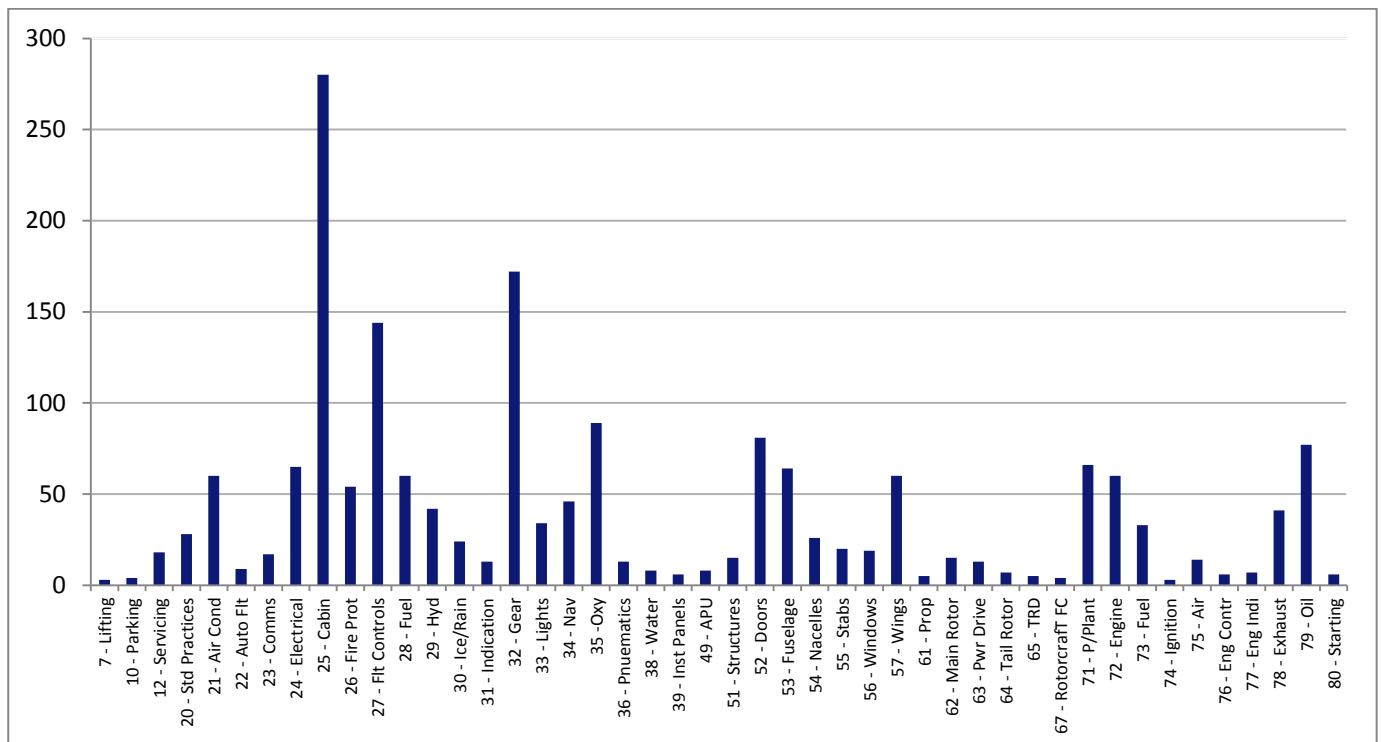
Figure 8: Global maintenance error events by ATA chapter

4.34 The high level analysis allowed identification of maintenance errors by ATA Chapter, presented graphically in Figure 8.

- 4.35 From this it can be seen that the main ATA Chapters that appear to attract a maintenance error events are:

- 5.6 This, not unsurprisingly, reflects the data presented in figure 8 and paragraph 4.3.23 above. The figures for ATA 25 are slightly higher reflecting the more complex and voluminous cabin configurations on large aircraft. There is simply more to go wrong. Similarly ATA 35 and ATA 52 are up slightly.

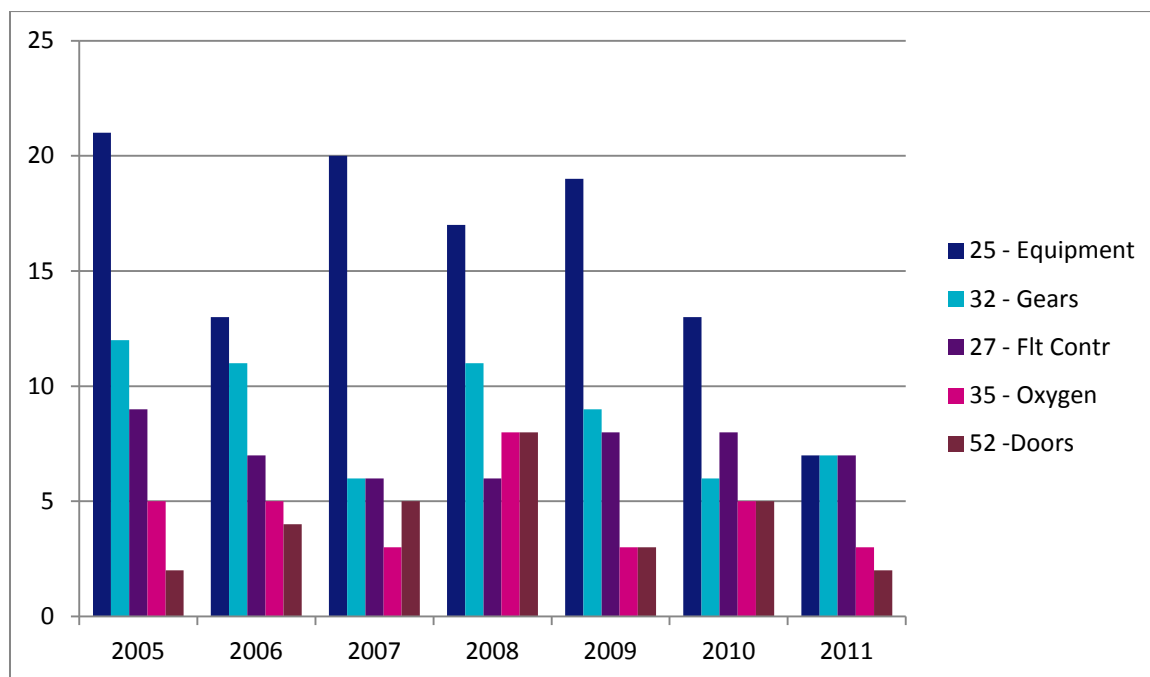
Figure 9: Reporting trends primary ATA chapters as % of total yearly maintenance error MOR

- 4.37 Figure 9 shows the change in reporting trends over the period analysed. Although there is some variation year on year the overall figures for these ATA Chapters is fairly consistent with the exception of ATA Chapter 25, Cabin/Safety Equipment. There is no obvious explanation identifiable in the MOR data for the apparent reduction in the number of incidents for ATA 25. It can only be concluded that the incidents are not being reported as they ought to be or tasks not read as frequently.

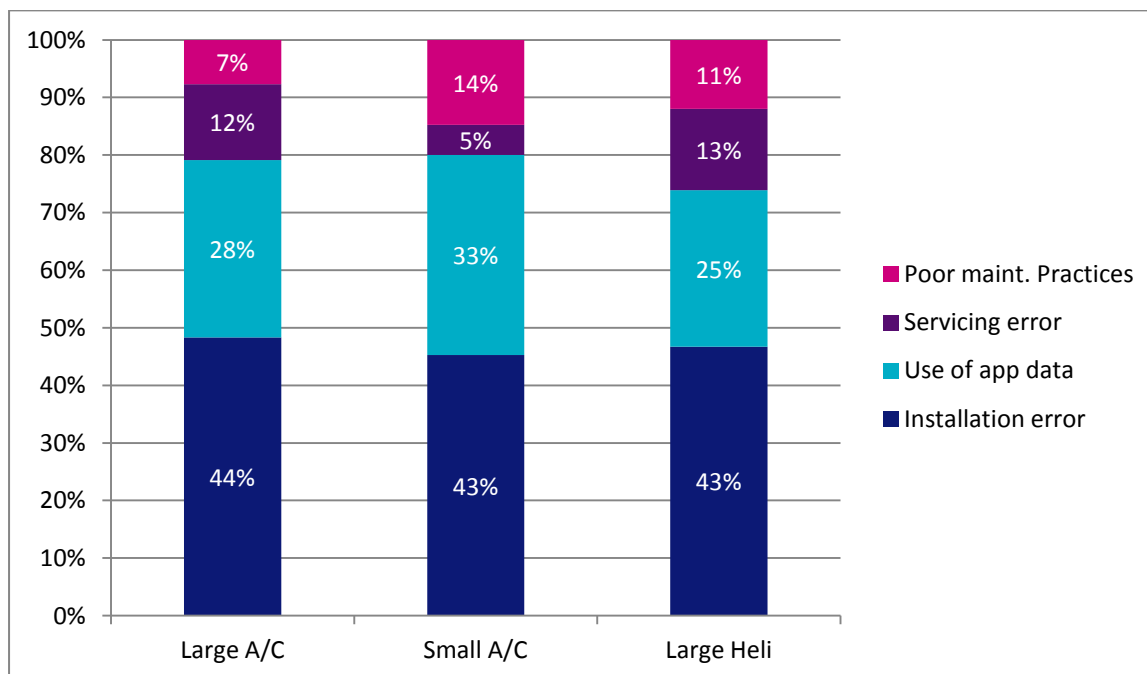
Figure 10: Maintenance error distribution comparison, common categories 2005-2011

4.38 The more detailed analysis of the root cause of the events is also able to be derived. This is shown in Figure 10 for the global data set.

4.39 The 100% figure represents 2108 MORs overall, 1890 for large aircraft, 174 for small aircraft and 44 for large helicopters.

4.40 From these figures it can be seen that the most likely error type is 'incorrect installation'. The next highest is the use of approved data, or rather the

likely lack of it. Incorrect installation includes failure to fit all required components (e.g. seals or spacers), incorrect routing of electrical cables and incorrect applied torque. 'Use of approved data' includes the proper use of approved data such as the maintenance manual, service information or repair drawings.

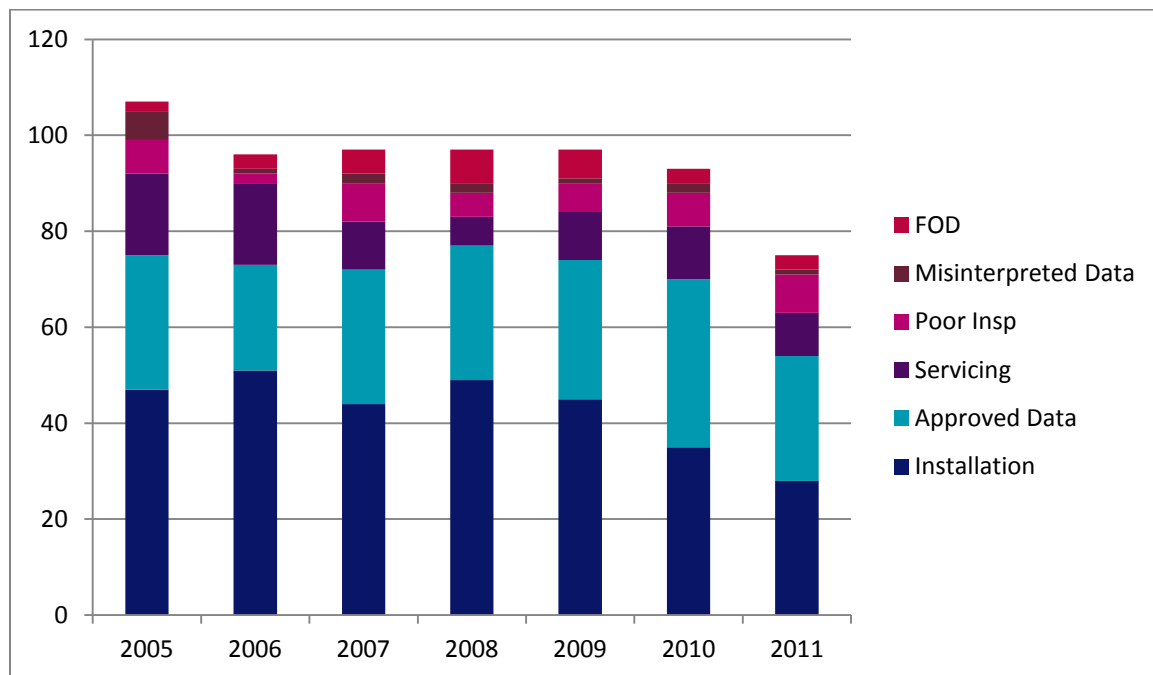
Figure 11: Key maintenance error types as % of total each year, all aircraft categories

- 4.41 Again, Figure 11 shows the change in reporting trends for maintenance error types over the period analysed. Although there is some variation year on year the overall figures for these ATA Chapters is also fairly consistent with the exception of 'Installation Error'.

- 4.42 There is no obvious explanation identifiable in the MOR data for the apparent reduction in the number of incidents for installation error other than the possibility that internal inspection is catching the error before release to service. This would mean that the events are still happening but, despite being caught, are not being reported as required under the CAA MOR scheme and the European Directive on Occurrence Reporting.

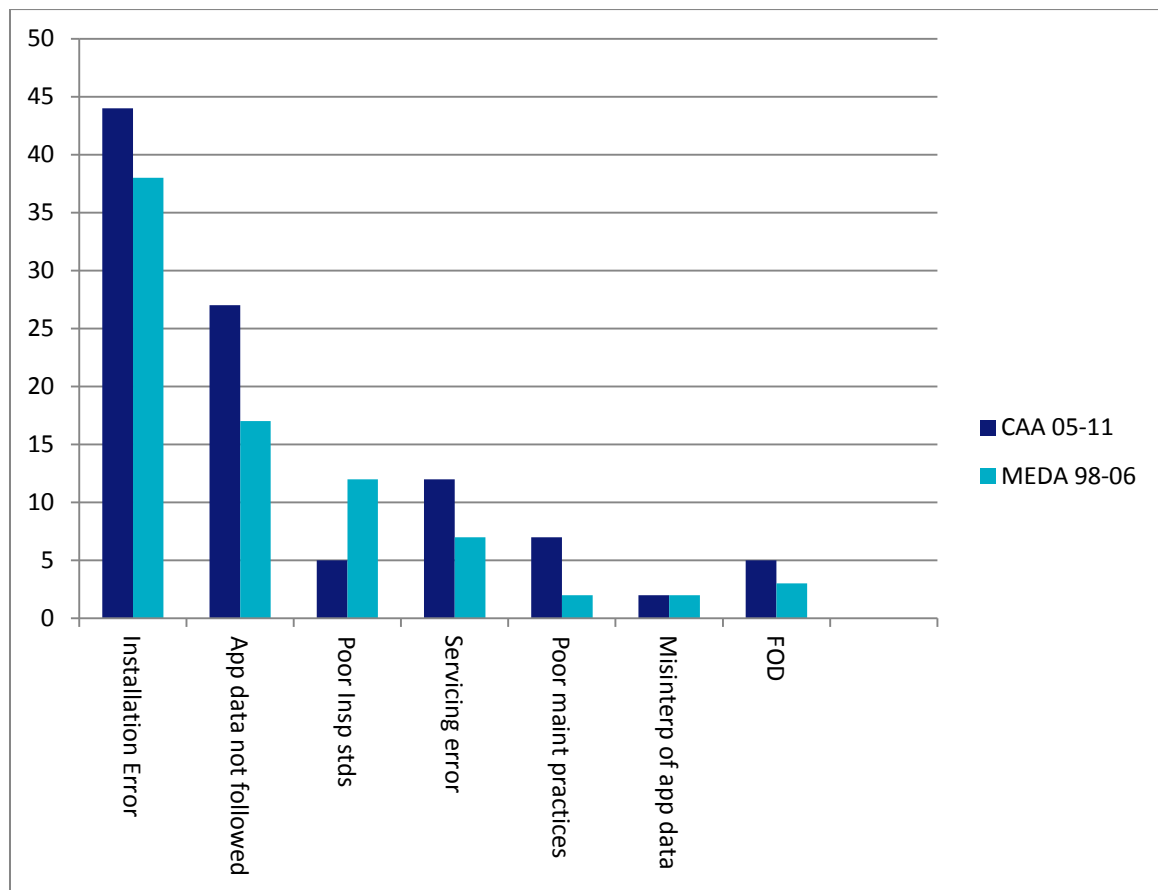
Figure 12: Comparison of CAA MOR and MEDA maintenance event analysis, large aircraft, shown as % of total

- 5.3 This represents the MOR total of 1890 as noted in 4.3.27 above. There were 584 MEDA events.
- 5.4 Those 1890 MORs can be broken down by ATA Chapter and the results are shown in Figure 13.

- 5.2 As mentioned previously, the analysis identified a significant discrepancy between the number of maintenance event MORs reported to the CAA and the submission of MEDA data to UK-MEMS. This is understandable given the fact that not all Part 145 organisations are necessarily aware of UK-MEMS or the need to contribute to the database. Figure 12 shows the relevant results. It should be noted that the MOR data set covers the period 2005 to 2011 whilst the MEDA data (UK-MEMS) shows a wider period from 1998 to 2006. Whilst this is not wholly representative of a like for like comparison it does suggest that the UK-MEMS system could have produced much more information of value to the industry had it received information on all of the events?

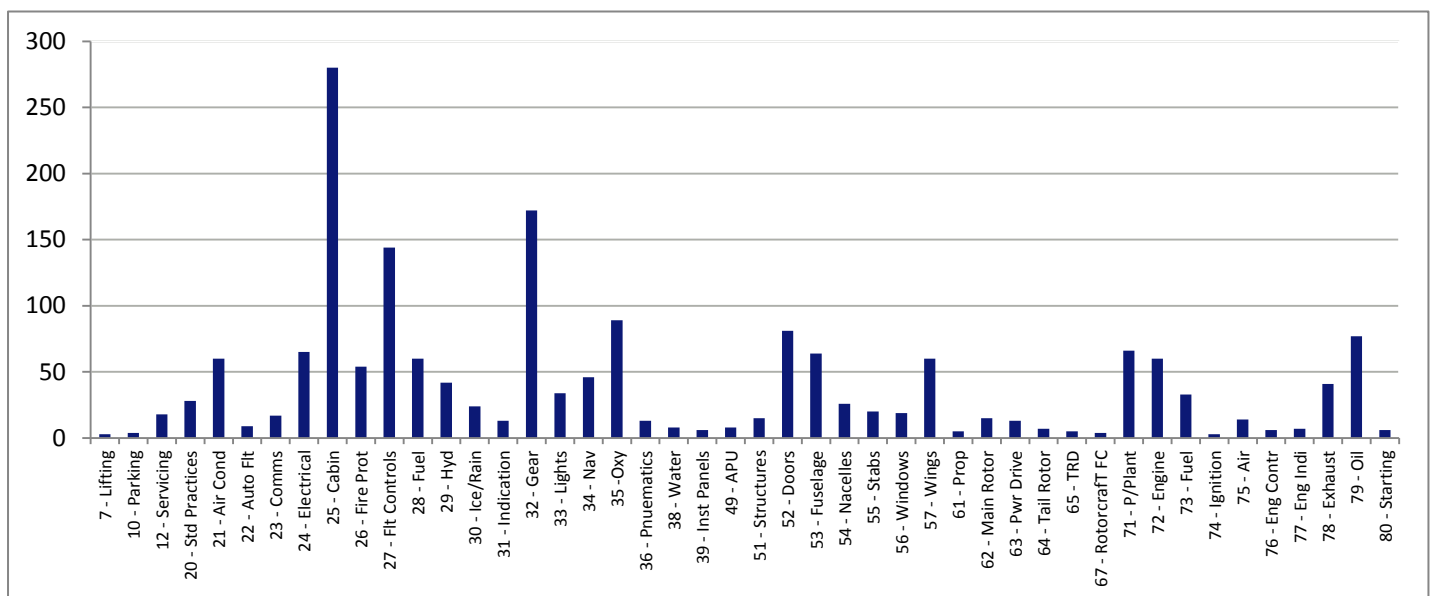
Figure 13: Breakdown of maintenance error MORs by ATA chapter, 2005-2011

- 5.5 Once again, the top six ATA Chapters can be identified and the percentage of MORs shown against the total maintenance error number. These are:

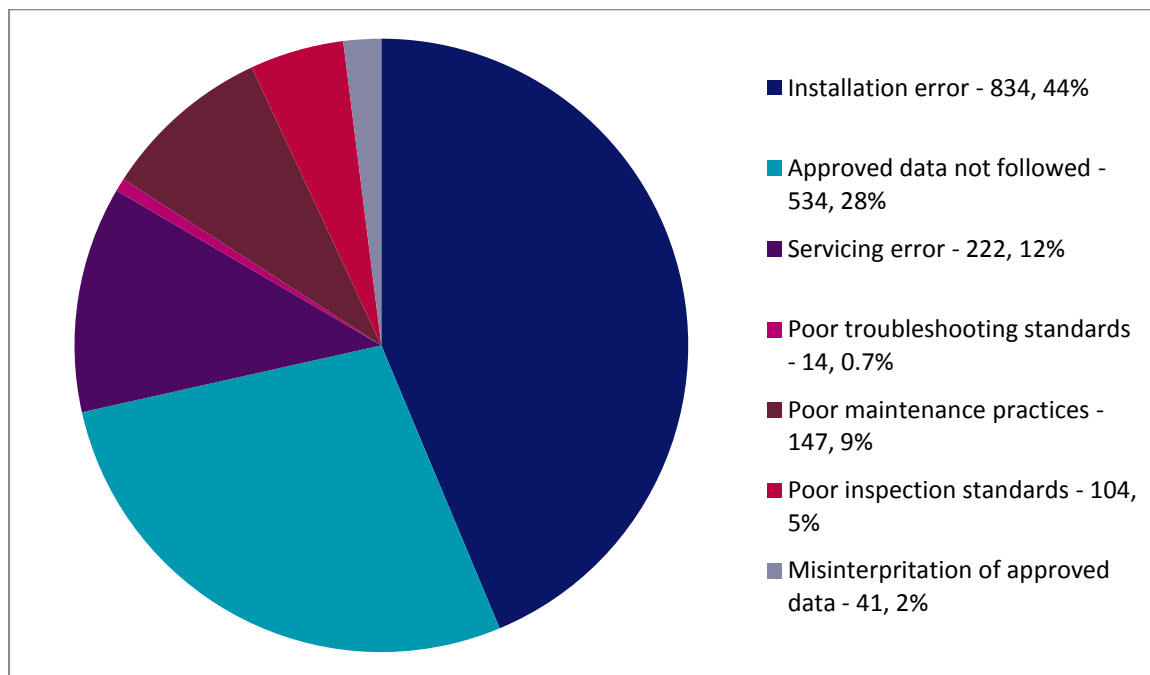
Figure 14: MOR maintenance error types 2005-2011

- 5.11 It is clear from the supporting data behind the reports that in many cases the engineer concerned did not use the latest available manuals or approved data to carry out the task. This highlights a cultural issue where, due to the information perhaps not being readily available, the engineer reverts to basic engineering skills. This does not, however, cater for critical dimensions or tasks when carrying out rigging etc.
- 5.12 Figure 14 provides an illustration of the MOR maintenance error types for the period 2005 – 2011. This tends to speak for itself.

- 5.13 This clearly shows that installation error and not following approved data collectively represent around 72% of the reported events. The failure to use approved data is, of course, a key underlying causal factor in the case of incorrect installation events.
- 5.14 Of the 834 events relating to installation error the following list represents a broad analysis of the associated factors (a few random events are not included):

- 6.11 In a similar manner to the analysis of maintenance error types for large aircraft, as shown in paragraph 5.2.2. and Figure 14, Figure 21 provides that information for the small aircraft category.

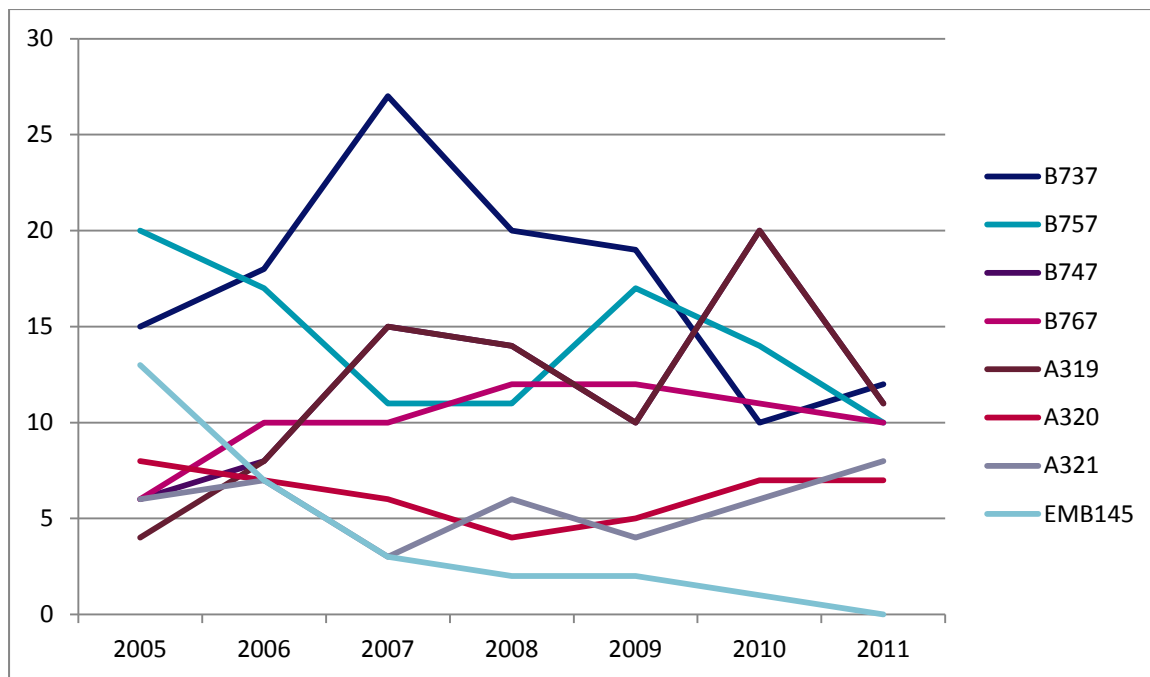
Figure 15: Reporting trends as % of total M/E MOR by type

Figure 15 provides an indication of the reporting trends as a percentage of the total maintenance error MORs by aircraft type, for the main aircraft types in UK service.

- 5.23 It is difficult to understand exactly why the trends spike as shown in figure 14. For example, the Boeing 737 fleet was reduced as the Airbus A319 type was introduced into service. The increasing MOR trend may be a reflection on the lack of engineering commitment to a type that was being run down. Likewise the increasing spike for the Boeing 747 in 2010 perhaps reflects the stand-down of some aircraft due to over-capacity or alternatively a more intensive scheduling without ample time to carry out maintenance. However, without looking at the specific details against a particular operator these reasons are purely speculative.

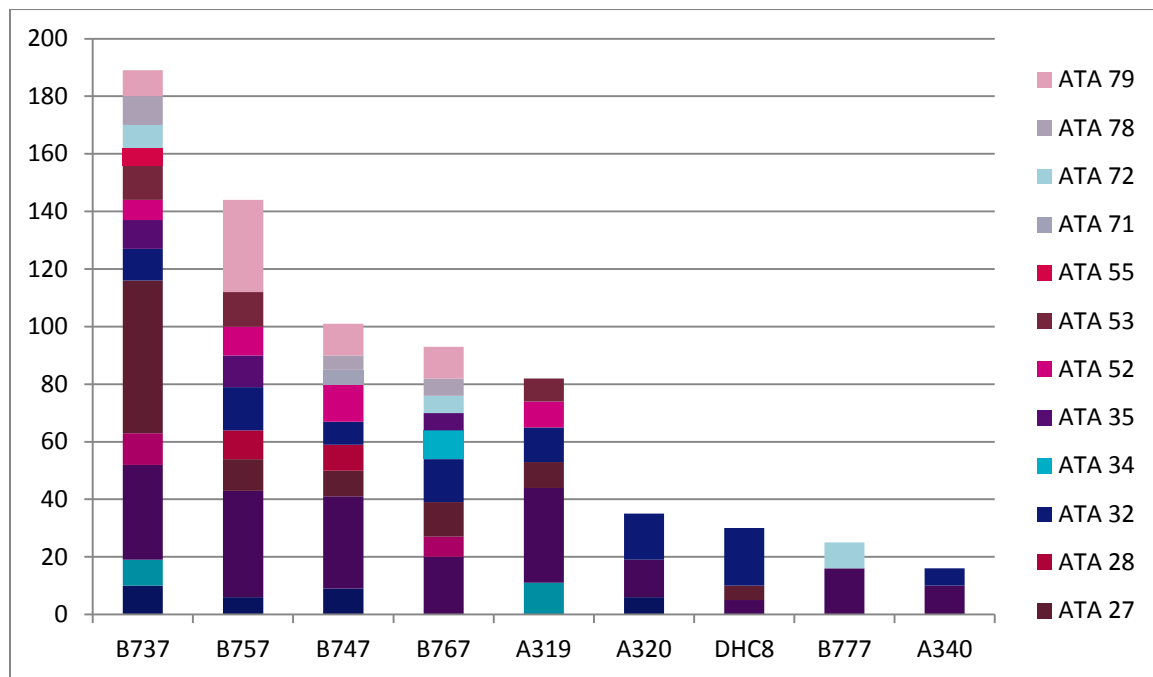
Figure 16: Top 9 aircraft types / ATA (large aircraft category) 2005-2011, 6 errors or more identified in each ATA chapter

- 5.24 What may provide a better indication of the prevalence of an aircraft type to maintenance error is a look at the errors relating to key ATA Chapters for specific aircraft types. Figure 16 shows the ATA Chapters for each type where there are 6 errors or more reported. This information has again to be considered in context. The data covers all aircraft of that type within the UK register so a more numerous aircraft type such as the Boeing 737 will give rise to larger numbers of error reports. However, what is of use is to look at the ATA Chapters for each type to see the proportion of maintenance errors shown for each ATA Chapter.

- 5.25 For most aircraft types, the incidence of errors for ATA Chapter 25 is noticeable. What is also noticeable is that the Boeing 737 appears to suffer a lot of errors relating to flying controls. Analysis of the actual reports shows that elevator, flap and configuration warning issues were of note. The Boeing 757 suffers from errors related to Chapter 79, engine oil. This reflects a known issue with overfilling of the engines. It has been identified that a number of organisations were found not to have been following the manufactures recommendations and had not being topping up the engine oil correctly. The DHC-8 has seen its fair share of undercarriage issues.

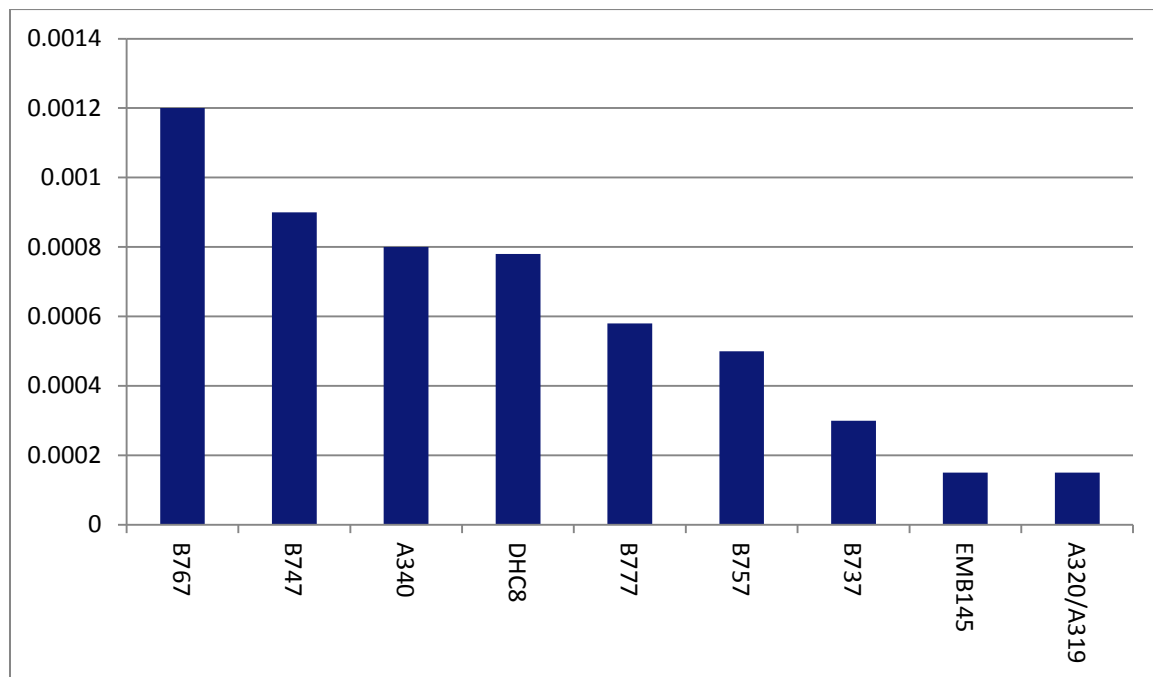
Figure 17: Maintenance MOR rate per flight by aircraft type

- 5.26 As noted in paragraph 5.3.4 the raw data is of little value in determining the relative risk unless it can be standardised. By taking into account aircraft utilisation data a Maintenance Error rate per flight can be derived. The resulting figures are shown in figure 17.

- 5.27 This gives a better, although not perfect, view of the relative likelihood of an occurrence for various types. However, the information does not account for the stage of the aircraft's useful life that the graphs represent. Obviously for an aircraft that is at a mid design life point or nearing end of useful design life, it will be more maintenance intensive. There will therefore be a greater likelihood of a maintenance error taking place unless suitable mitigation is put in place.

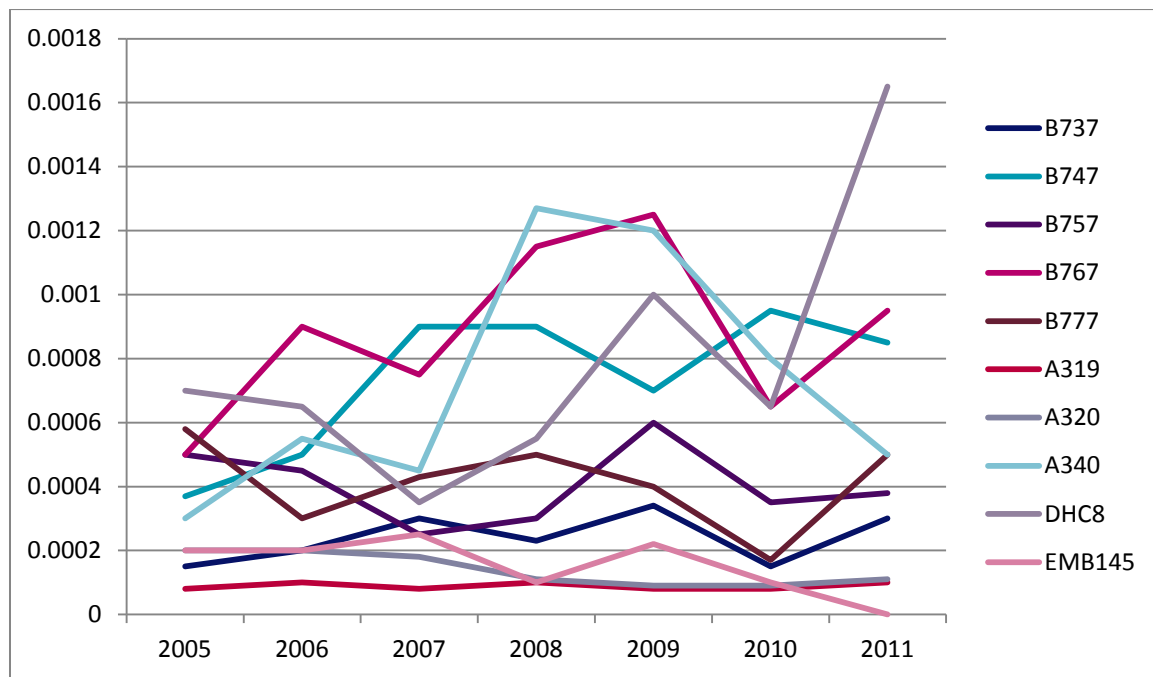
Figure 18: Maintenance MORs / flight for selected aircraft types

- 5.34 Figure 18 uses the cumulative fleet number of flights from 2005 – 2011 to present the data. Table 1 show the actual yearly breakdown of flights for the types. This allows a trend analysis to be developed and this is shown in Figure 16.

- 5.35 This is more useful as it indicates aircraft where a developing trend is identified, or vice versa, an improving trend. This can often be reconciled against a detailed understanding of the issue that the aircraft type is experiencing. By a combination of the two, organisation can identify a strategy to try and contain the likelihood of maintenance error on that aircraft type, in relation to the particular ATA Chapter or actual component where there are known issues. This strategy can then be fed into the engineering and maintenance system by internal notices to engineers and staff and through the medium of continuation training.

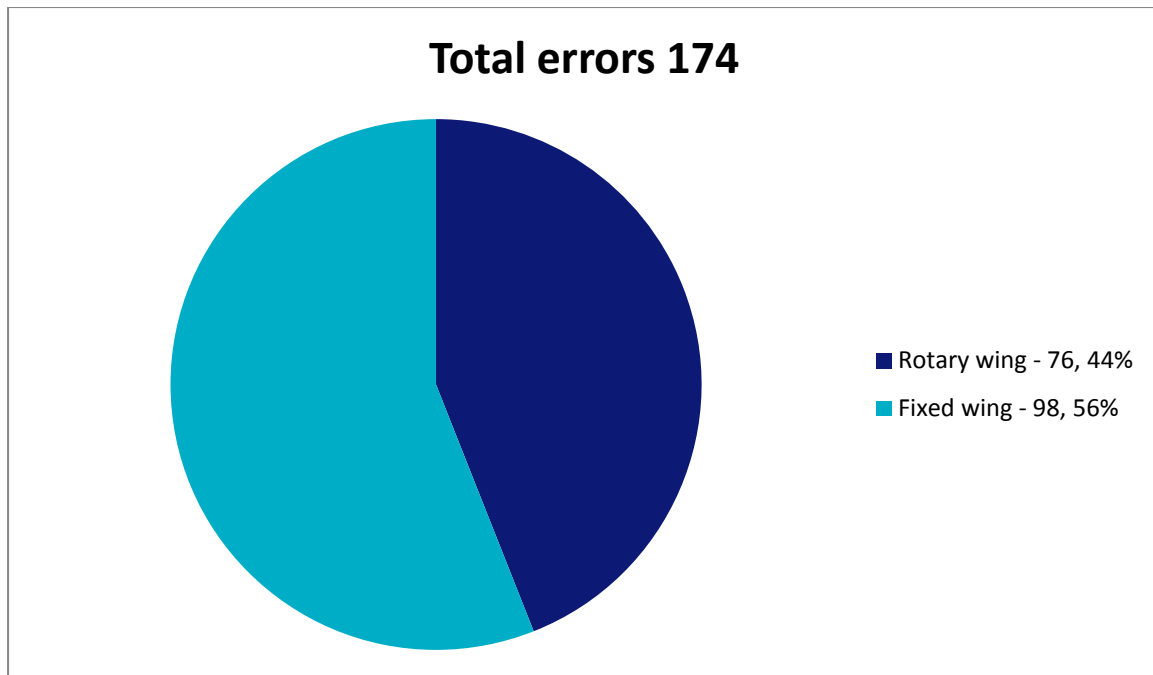
Figure 19: Global MOR data for maintenance error, small aircraft

- 6.3 Figure 19 shows the global data for the small aircraft category. A total of 174 events were analysed ranging across a range of fixed wing aircraft such as the DHC-1 Chipmunk to BN-2 Islander and smaller rotary wing types such as the Robinson R22 to the Sikorsky S76. Fixed wing was responsible for 98 of these events (some 56%) with the remaining 76 events (44%) relating to rotary wing. Proportionally however there are far more small fixed wing aircraft than rotary wing so it tends to reinforce the belief that there are fewer reports on large helicopters than there ought to be.

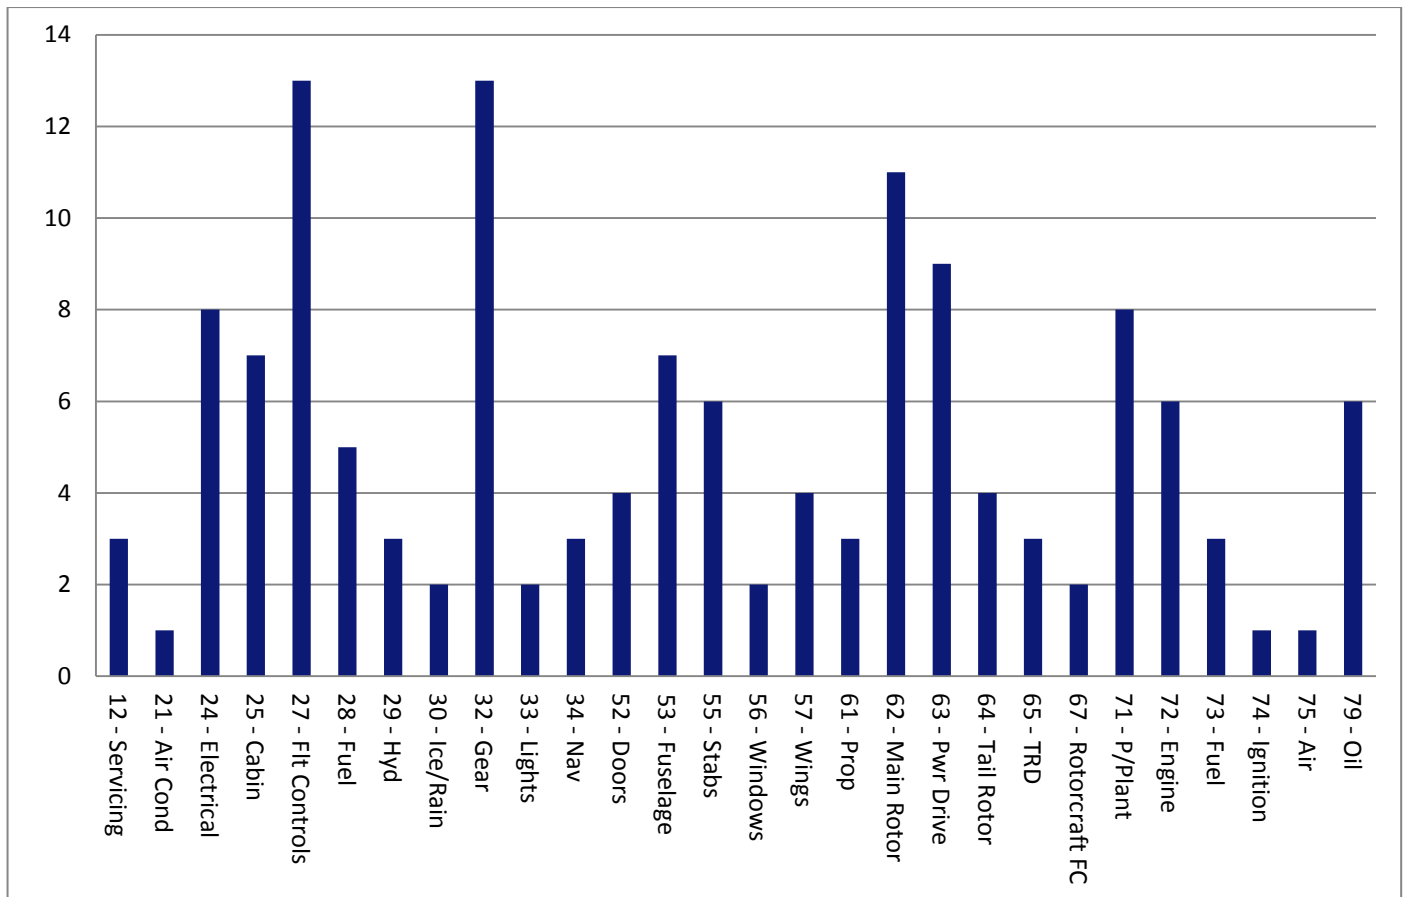
Figure 20: Breakdown by ATA chapter, small aircraft

- 6.4 Obviously small aircraft are not as complex as their larger counterparts. Systems tend to be simpler in design with less redundancy and system protection. This means that they can be more prone to the effects of maintenance error.
- 6.5 Figure 20 shows the breakdown by ATA Chapter. It should be noted that not all small aircraft manufacturers use the ATA Chapter system for defining and coding maintenance activity. In the analysis of the data, CHIRP assigned the relevant ATA codes to the report in order to provide some consistency of analysis and to provide a comparison against large aircraft if anyone was interested.

6.6 The 6 top ATA Chapters can be shown as a percentage of the total reports as follows:

6.7 Problems and errors on landing gear or undercarriage systems (ATA Chapter 32) amounted to some 7% of the reports. Looking at the source data, many of these events were attributable to poor lubrication, incorrect rigging, excessive wear in retraction mechanism and incorrect tyre fitting causing it to foul on the structure during retraction.

6.8 Flying Controls (ATA Chapter 27) shows instances of control being incorrectly installed (reverse sense) despite duplicate inspections having been performed. The incorrect installation of bellcranks, cable routing and improper use of tools during installation (leading to subsequent component

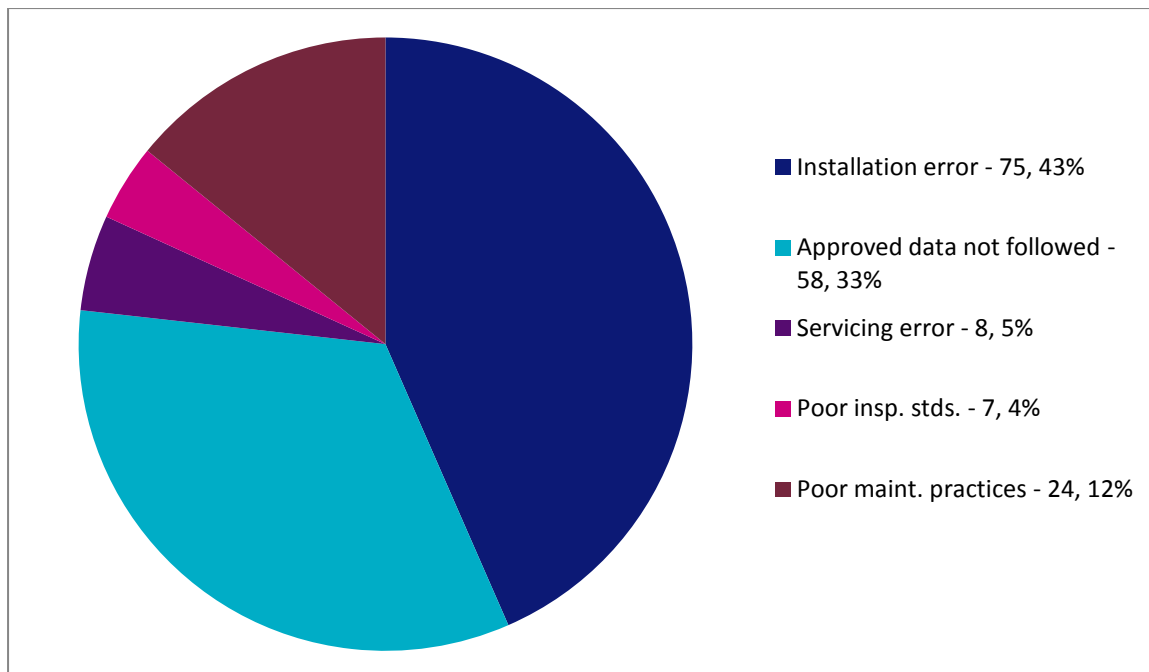
Figure 21: MOR maintenance error types 2005-2011, small aircraft

- 6.12 Whilst, based on the limited data available, Installation Error was similar in proportion to large aircraft, the percentage of Approved Data not Followed (33% against 28%) and Poor Maintenance Practices (14% against 9%) for small aircraft is higher than for large aircraft. This may well be a reflection on the culture of small aircraft maintenance, the lack of organisational focus on quality control and the absence of training available for new entrants. However, without carrying out an individual re-assessment of each MOR the actual reasons cannot be determined.
