Aircraft Maintenance Incident Analysis

CAP 1367

Published by the Civil Aviation Authority, 2015

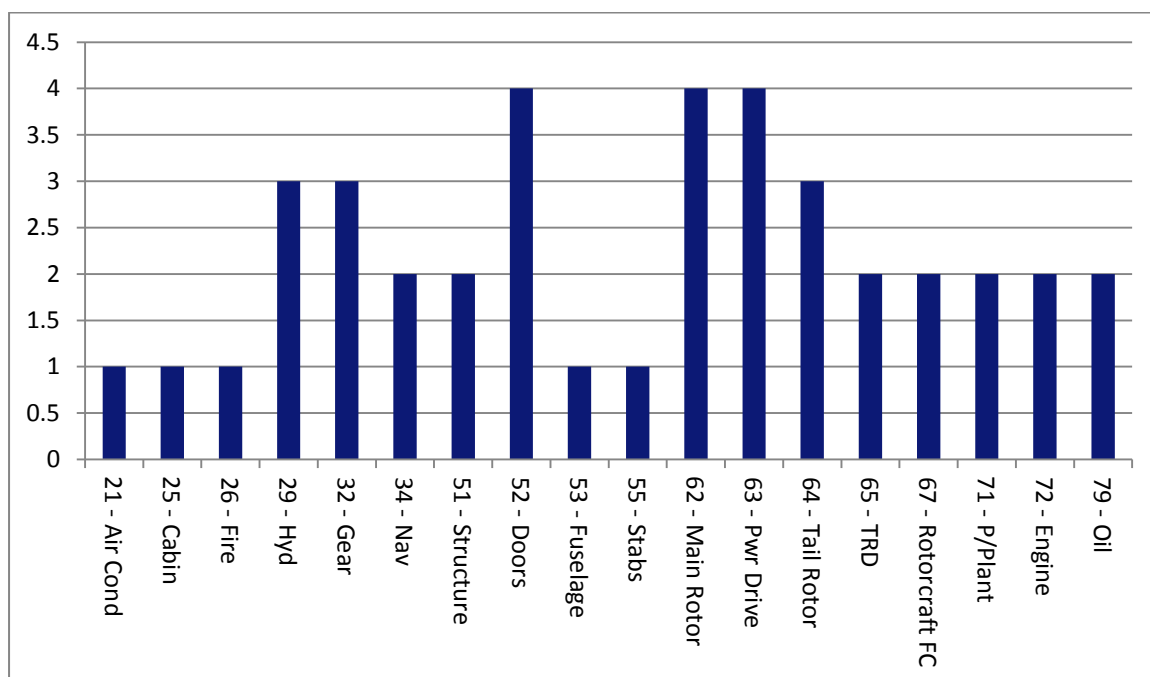
Figure 22: Breakdown of large helicopter maintenance MORs by ATA chapter

- 7.1 The number of maintenance related MORs for large helicopters was substantially smaller than it was for large aircraft. This is in part a reflection of the smaller size of the large helicopter fleet but there is a question as to the number for reports on record, given the differing technologies and more complex systems.
- 7.2 A total of 44 MORs were analysed and the results are presented in this section. Once again, the analysis by CHIRP correlated the available information from the UK MEMS database with the CAA MOR record.
- 7.3 The breakdown of the MORs by ATA Chapter is shown in figure 22.

- 7.4 It can be seen that there are a few ATA Chapters that show a higher level of maintenance error events. These include:
- Chapter 52 – Doors 9%
 - Chapter 62 – Main Rotor 9%
 - Chapter 63 – Power Drive Train 9%
- 7.5 At a secondary level of interest we can see issues within:

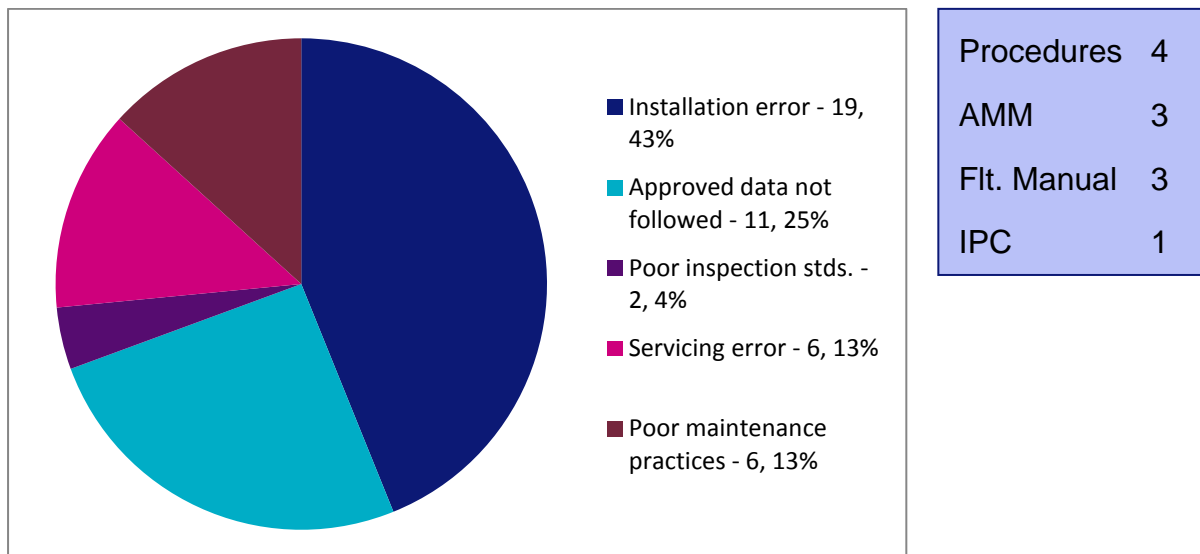
Figure 23: Large helicopter MOR maintenance error types

7.8 A further more detailed breakdown of the maintenance error types is shown in Figure 23.

7.9 The highest proportion of error as shown in Figure 21 relates to incorrect installation. This accounted for some 43% or 19 of the 44 events. The more detailed breakdown of these events was as follows:
